Purdue University

Steel Bridge Research, Inspection, Training, and Engineering (S-BRITE) Center

Member-level Redundancy of Built-up Steel Girders Subjected to Flexure

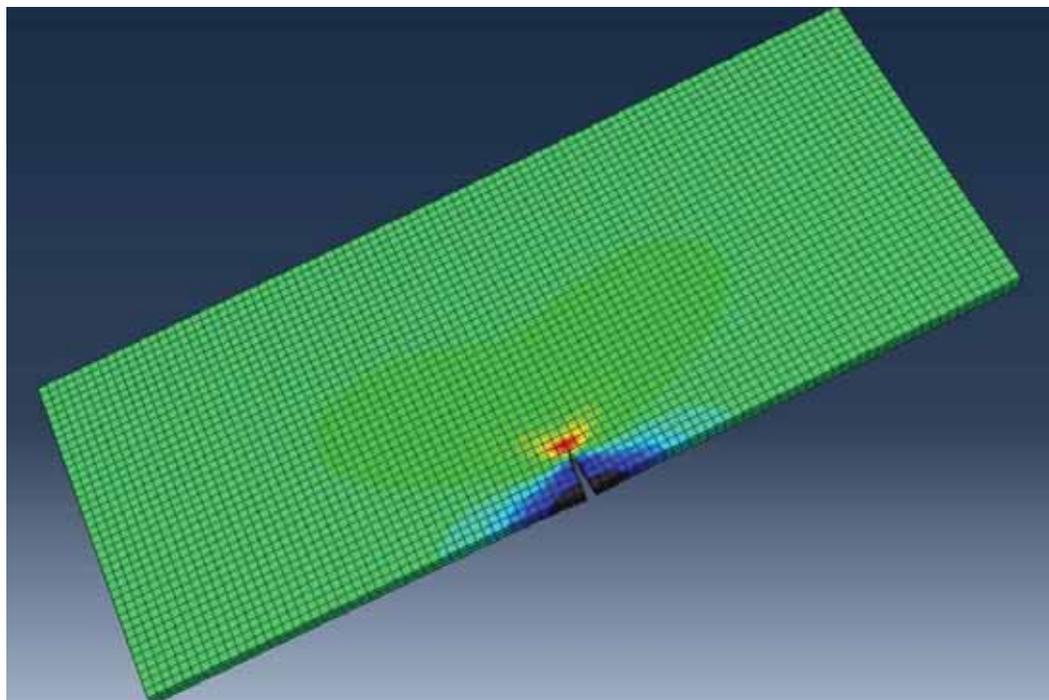
The data indicated that, regardless of the number of cover plates, the largest effect on the longitudinal stresses was in the component most adjacent to the failed component. This indicated that a localized stress concentration, similar to one found in a partially cracked plate loaded in tension (see Figure 4-32) existed in the built-up girders with a single component failure. The resulting longitudinal stress increase in the first component was then compared to determine whether the number of cover plates in the model affected the stress increase of the adjacent most component. As is shown in Figure 4-33, there largest stress increase typically occurs in components of models with a single cover plate.

Figure 4-32 Stress concentration at cracked plate

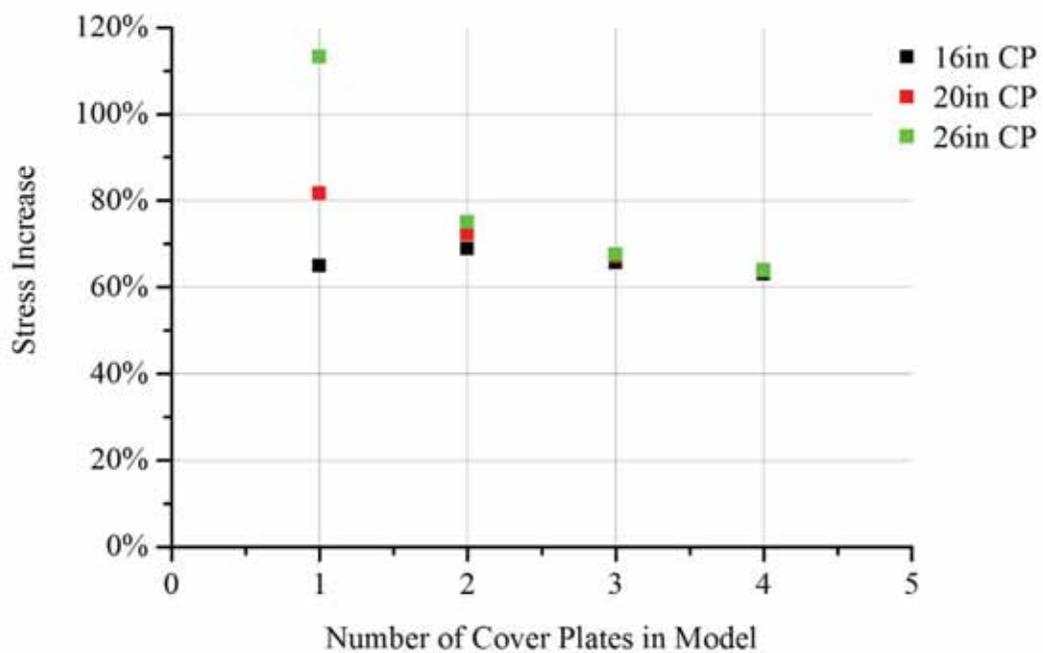
Figure 4-33 Stress increase in models with multiple cover plates

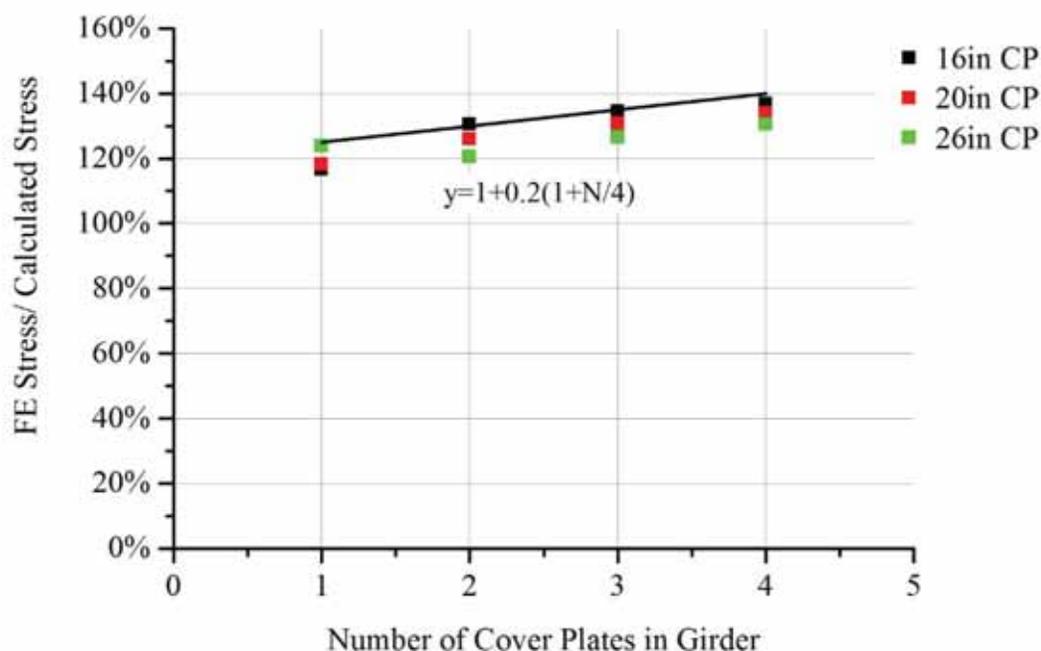
In order to determine a method by which a calculated after failure net-section stress could be amplified to reflect the true stress condition of a partially failed cross section, the calculated net-section stress was compared to the net-section stress from each of twelve different models with varying number of cover plates and cover plate widths. Three sets of models were made (16", 20", and 26" cover plate widths), with 1, 2, 3, and 4 cover plates. First, the after-failure net-section stress was obtained from the FE models (following the procedure described in Section 4.1.3). Next, the after-failure net-section stress was calculated using mechanics of materials (My/I). Then the FE net-section stress was divided by the calculated net-section stress. The resulting values for each of the sets of models can be seen in Table 4-9, along with a graph of these values corresponding to the number of cover plates used in each model in Figure 4-34. A line was fit to the upper bound of the data, in order to conservatively capture the influence of the multiple cover plates. The equation of the line was used as an amplification factor which can be used to conservatively determine the resulting stress in a partially failed cross section from the calculated net-section stress:

Figure 4-34 Net-section stress comparison (FE model vs. calculated)

resulting stress increase for each model is shown in Table 4-10, in addition to models previously constructed having a single cover plate. Based on the values shown, the β_{AF} factor of 1.25 (shown in Figure 4-34) was a conservative upper bound.

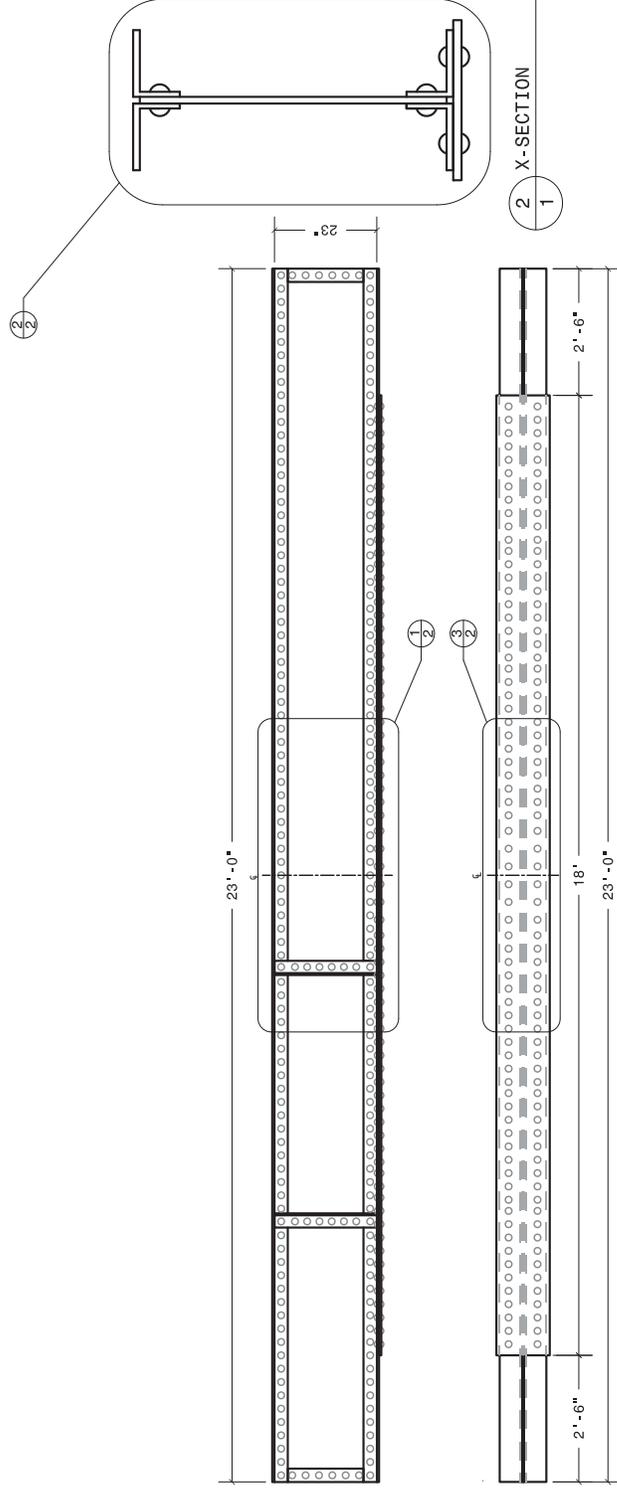
SHEET NO.: 1 of 2

23" Specimen
Design Drawings

1 ELEVATION/PLAN VIEW

2 X-SECTION

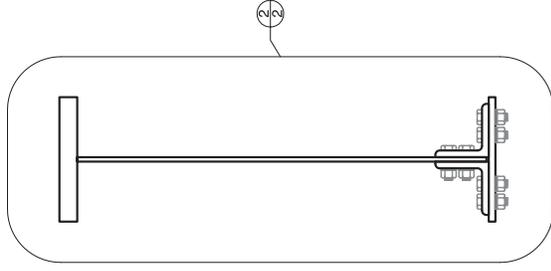
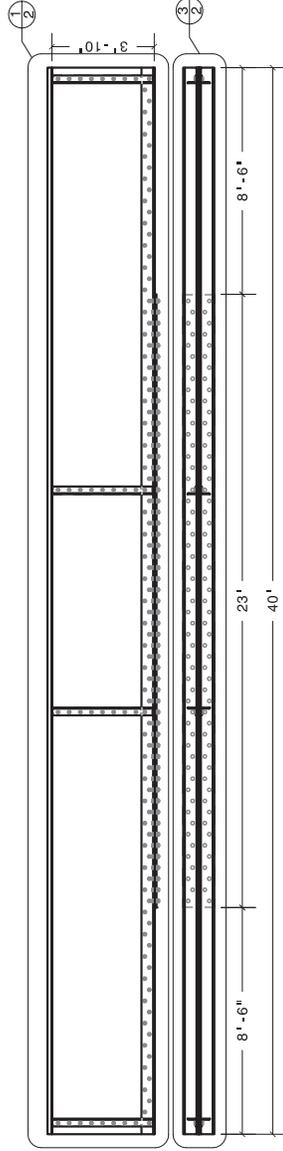
SHEET NO.: **1 of 13**

SPECIMEN 1:
46" PLATE GIRDER

2 SPEC. 1 X-SECTION
1

1 SPEC. 1 ELEVATION/PLAN VIEW
1

NOTE: ALL HOLES SHALL BE PUNCHED AND SHALL NOT BE REAMED. THIS IS TO REPLICATE HOLE CONDITIONS FOUND IN OLDER BRIDGES.

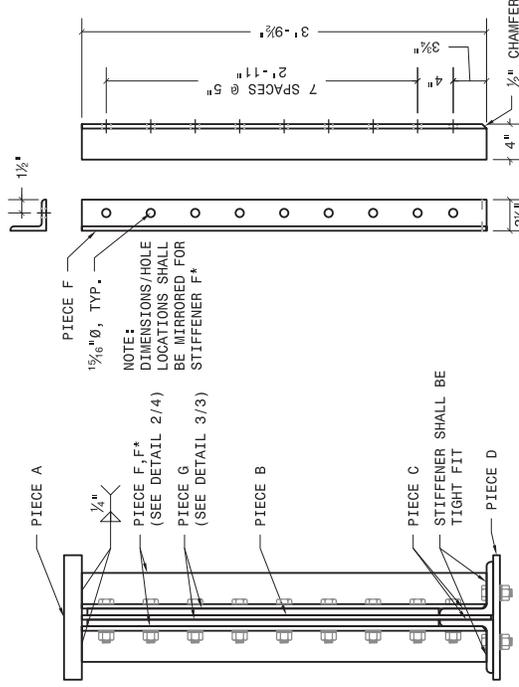
1 BOLTED BRG. STIFFENER
4

2 BRG. STIFFENER ANGLE
4

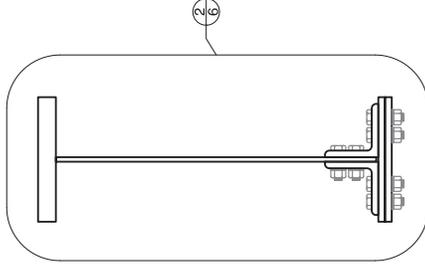
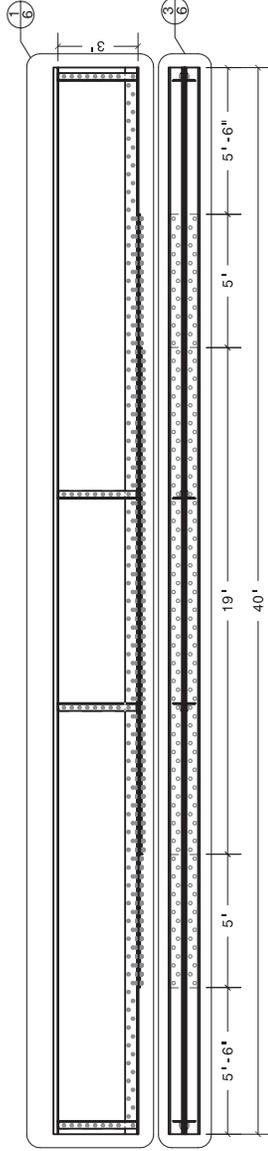
SHEET NO.: **5 of 13**

**SPECIMEN 2:
36" PLATE GIRDER**

2 SPEC. 2 X-SECTION

1 SPEC. 2 ELEVATION/PLAN VIEW

NOTE: ALL HOLES SHALL BE PUNCHED AND SHALL NOT BE REAMED. THIS IS TO REPLICATE HOLE CONDITIONS FOUND IN OLDER BRIDGES.

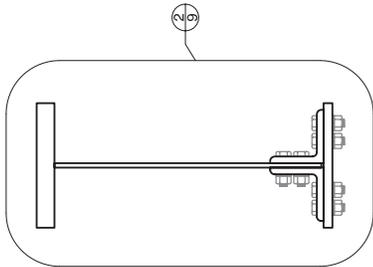
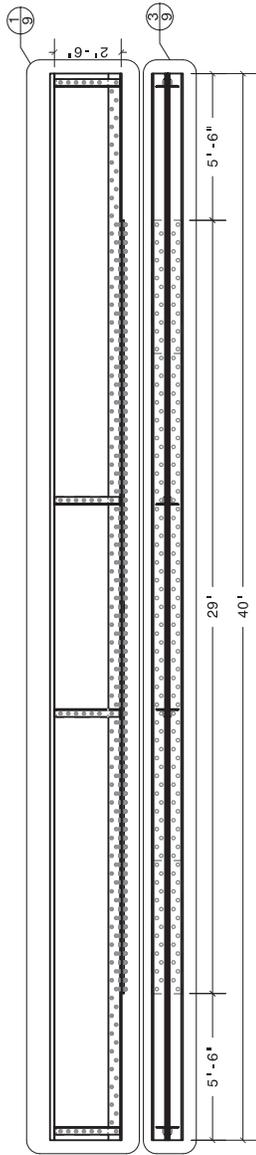
SHEET NO.: **8 of 13**

**SPECIMEN 3:
30" PLATE GIRDER**

2 SPEC. 3 X-SECTION
8

1 SPEC. 3 ELEVATION/PLAN VIEW
8

NOTE: ALL HOLES SHALL BE PUNCHED AND SHALL NOT BE REAMED. THIS IS TO REPLICATE HOLE CONDITIONS FOUND IN OLDER BRIDGES.

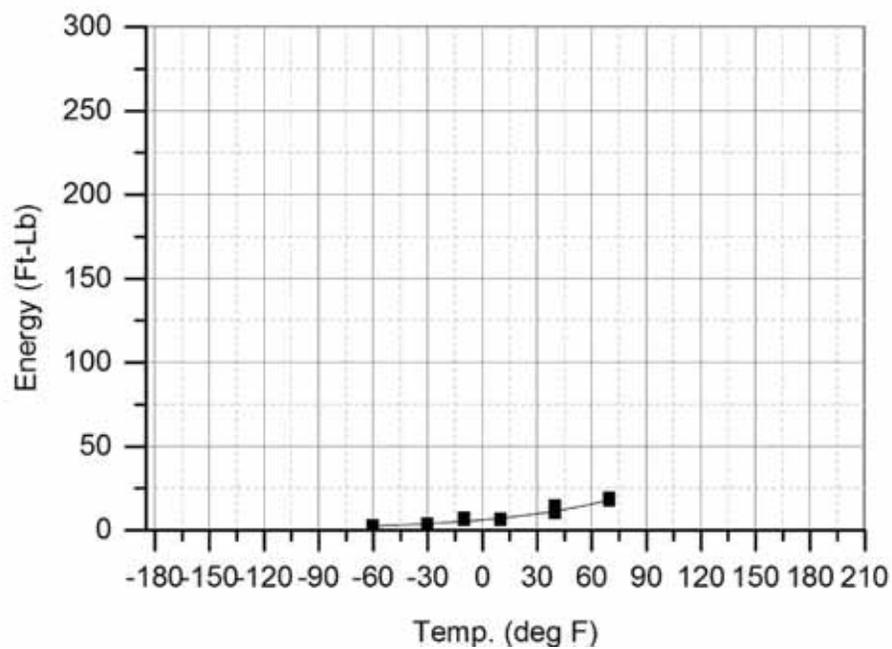
Figure D-1 CVN Data: Specimen 23-1 flange angles

Specimen 23-1						
Component	Web Plate		Flange Angle		Cover Plate	
Dimensions	23"x3/8"		5"x3-1/2"x1/2"		5/8"x12"	
Heat No.	N/A (Historical)		N/A (Historical)		1015896	
Grade					A36	
CVN	°F	Energy	°F	Energy	°F	Energy
			-60	2.67	-60	3
			-60	2.67	-60	3
			-60	2.00	-60	2.5
			-30	3.33	-50	4
			-30	3.33	-50	3
			-30	4.00	-50	4.5
			-10	6.00	-20	12
			-10	7.33	-20	13.5
			-10	6.00	-20	11.5
			10	6.67	10	16
			10	6.00	10	16.5
			10	6.00	10	16.5
			40	10.00	40	22
			40	10.00	40	21.5
			40	14.67	40	19
			70	17.33	70	29.5
		70	18.00	70	25.5	
		70	19.33	70	28.5

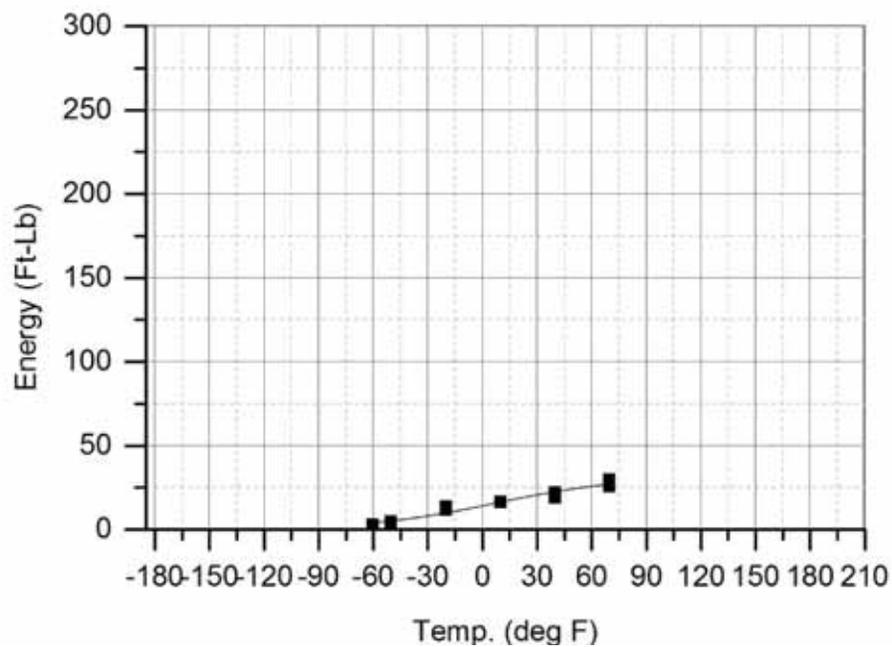
Figure D-2 CVN Data: Specimen 23-1 cover plate

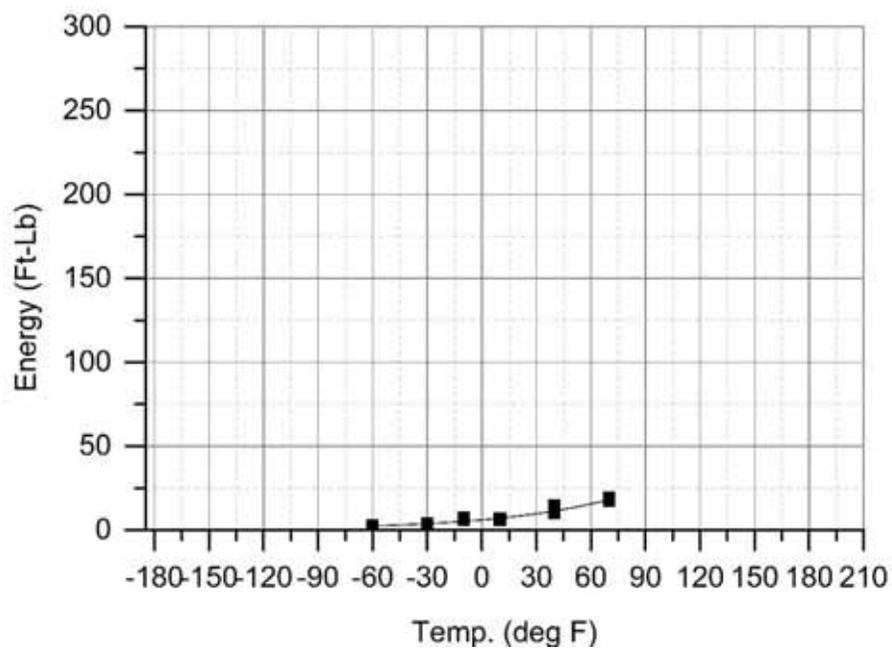
Figure D-3 CVN Data: Specimen 23-2 flange angles

Specimen 23-2						
Component	Web Plate		Flange Angle		Cover Plate	
Dimensions	23"x3/8"		5"x3-1/2"x1/2"		1/2"x12"	
Heat No.	N/A (Historical)		N/A (Historical)		G126358	
Grade					A36	
CVN	°F	Energy	°F	Energy	°F	Energy
			-60	2.67	-60	8.5
			-60	2.67	-60	3
			-60	2.00	-60	3
			-30	3.33	-50	8
			-30	3.33	-50	9
			-30	4.00	-50	3
			-10	6.00	-20	4.5
			-10	7.33	-20	15
			-10	6.00	-20	7
			10	6.67	10	22
			10	6.00	10	18
			10	6.00	10	16.5
			40	10.00	40	27.5
			40	10.00	40	21.5
			40	14.67	40	25.5
			70	17.33	70	30.5
		70	18.00	70	30.5	
		70	19.33	70	30

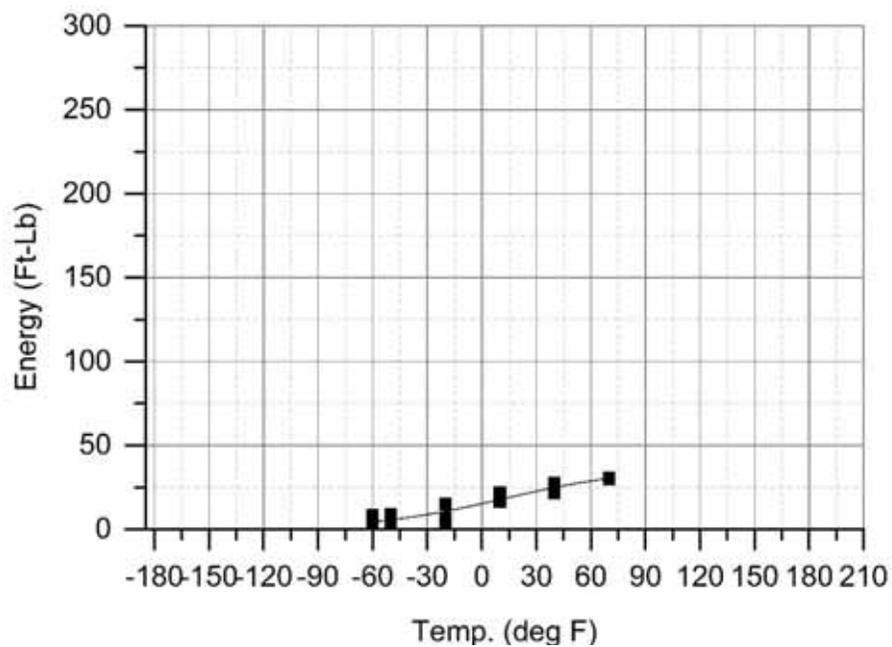
Figure D-4 CVN Data: Specimen 23-2 cover plate

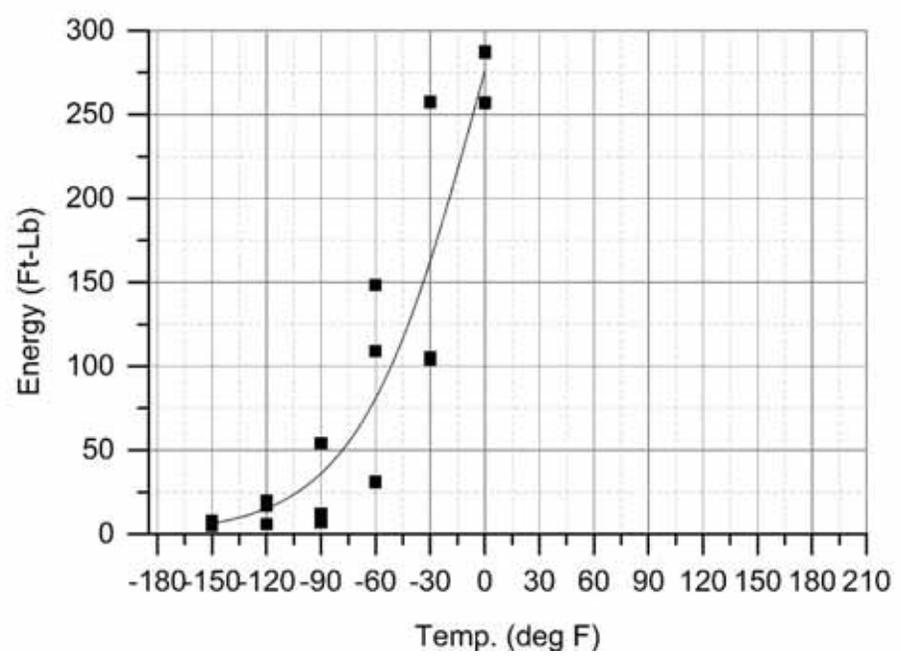
Figure D-7 CVN Data: Specimen 30-1 web plate

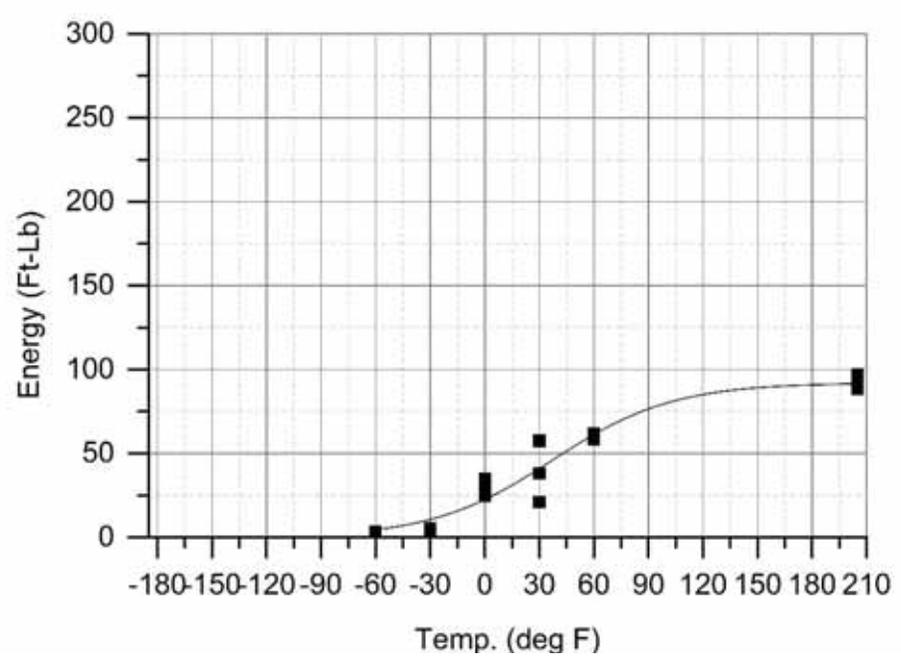
Figure D-8 CVN Data: Specimen 30-1 flange angles

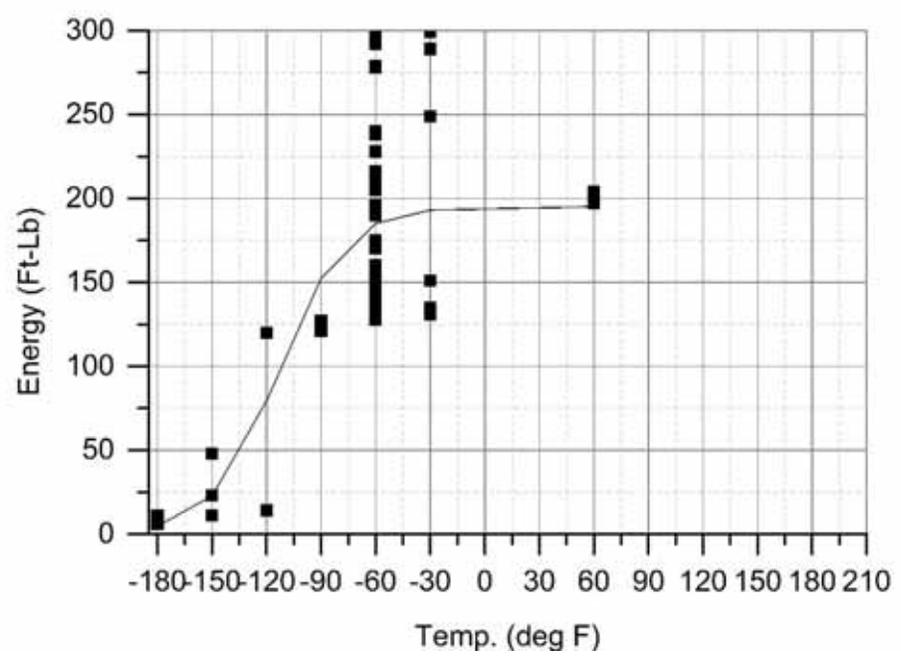
Figure D-9 CVN Data: Specimen 30-1 cover plate

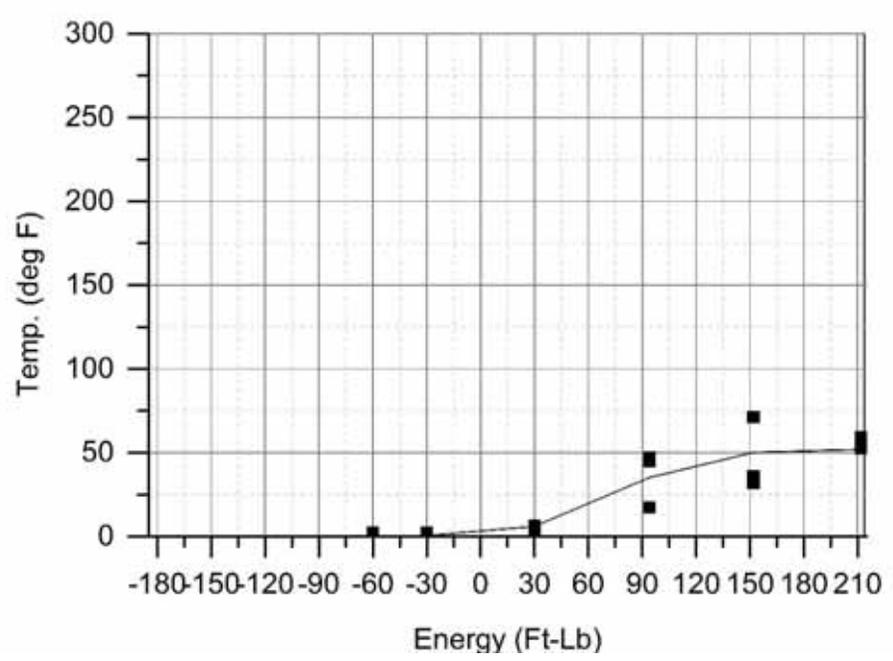
Figure D-10 CVN Data: Specimen 30-1 cover plate fuse

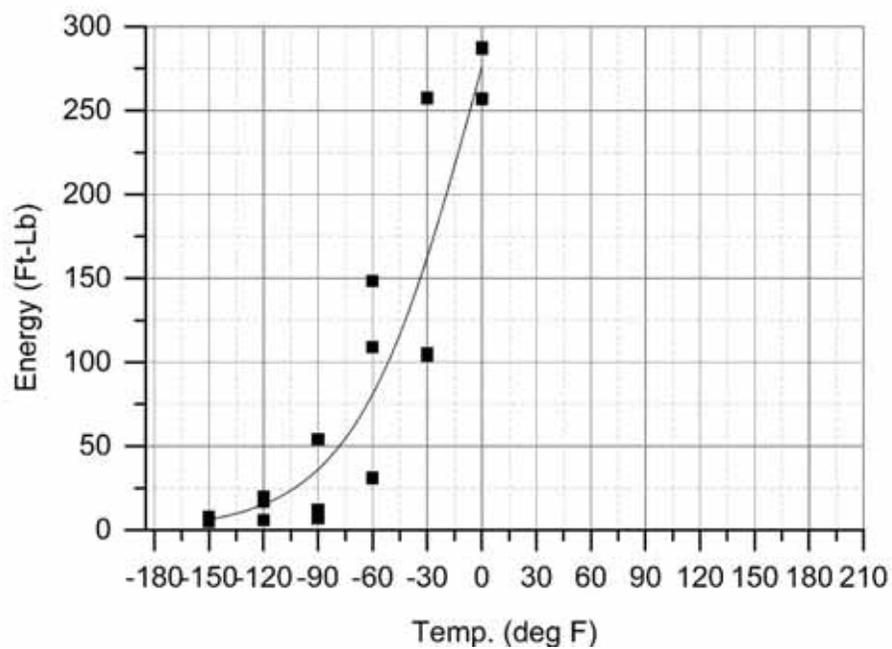
Figure D-11 CVN Data: Specimen 36-1 web plate

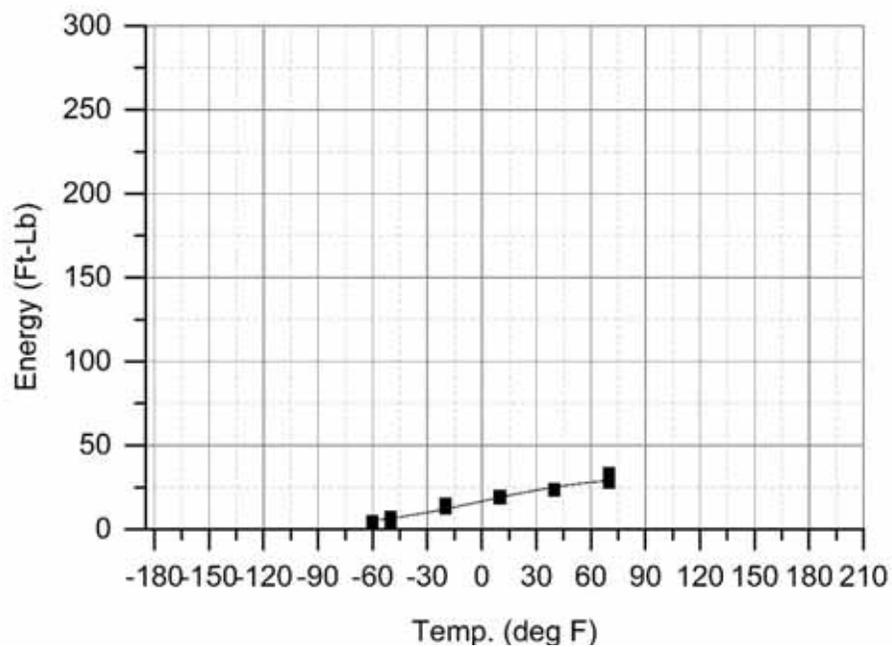
Figure D-12 CVN Data: Specimen 36-1 flange angles

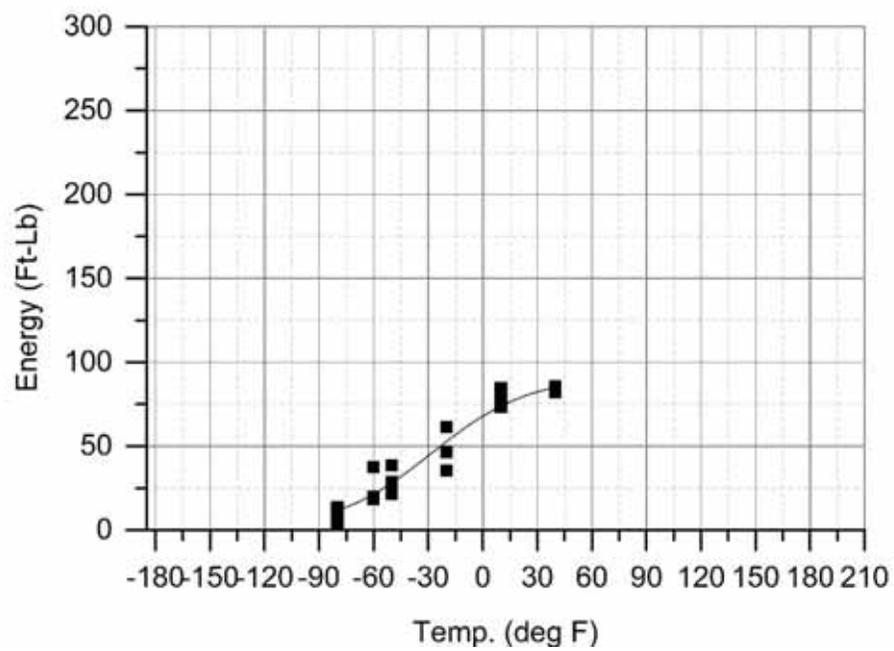
Figure D-13 CVN Data: Specimen 36-1 upper, lower cover plates

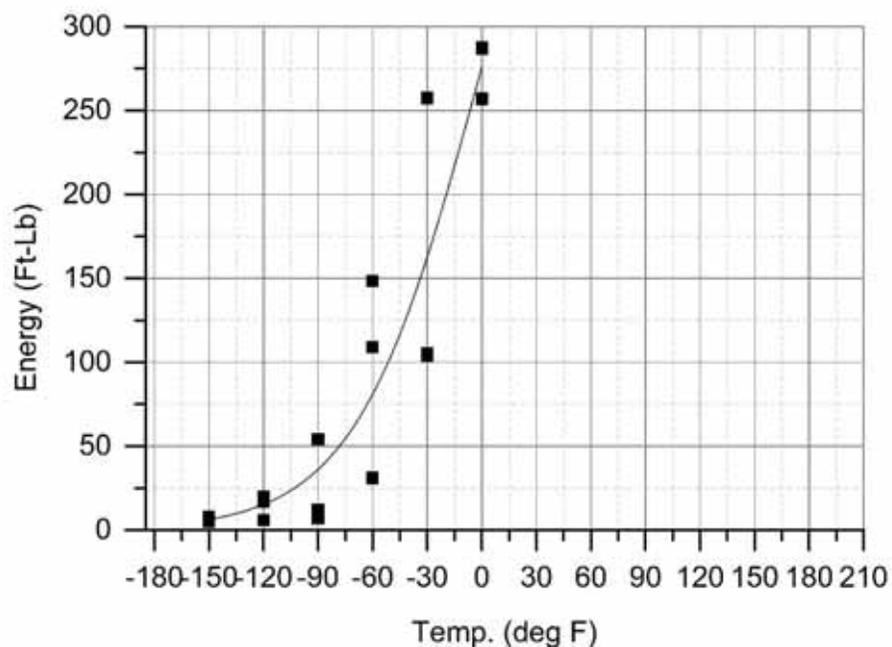
Figure D-14 CVN Data: Specimen 36-2 web plate

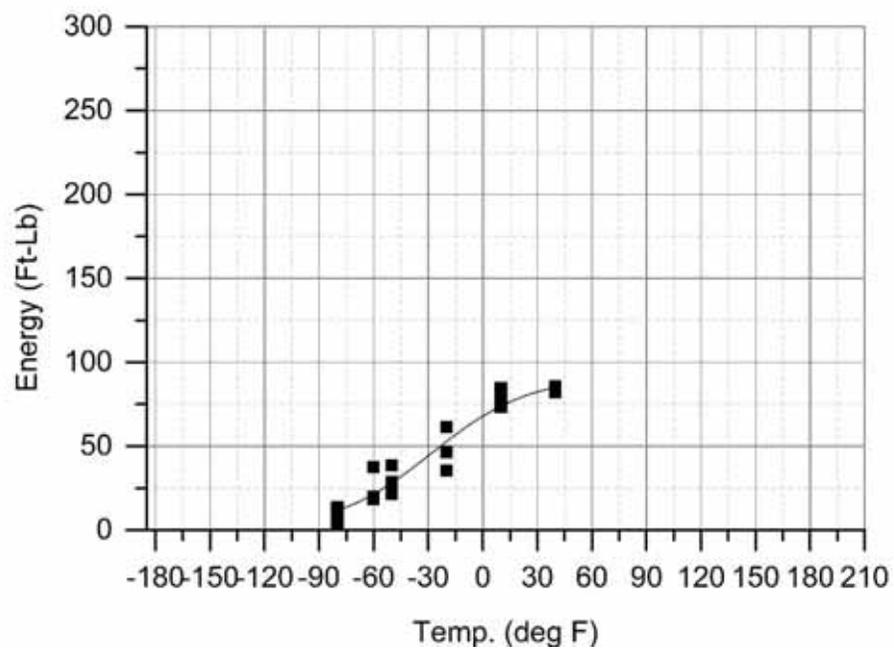
Figure D-16 CVN Data: Specimen 36-2 upper, lower cover plates

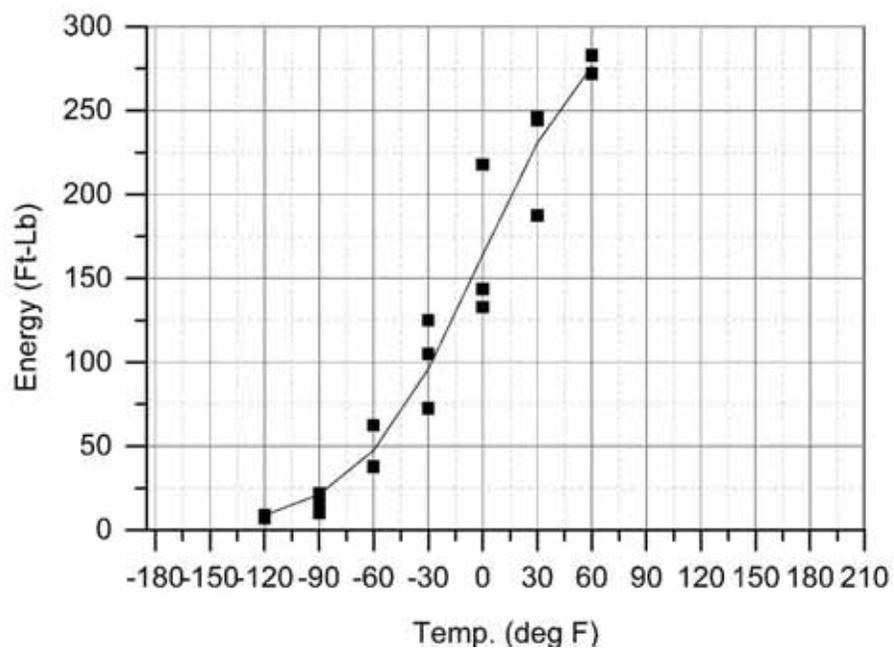
Figure D-19 CVN Data: Specimen 36-3 upper, lower cover plates

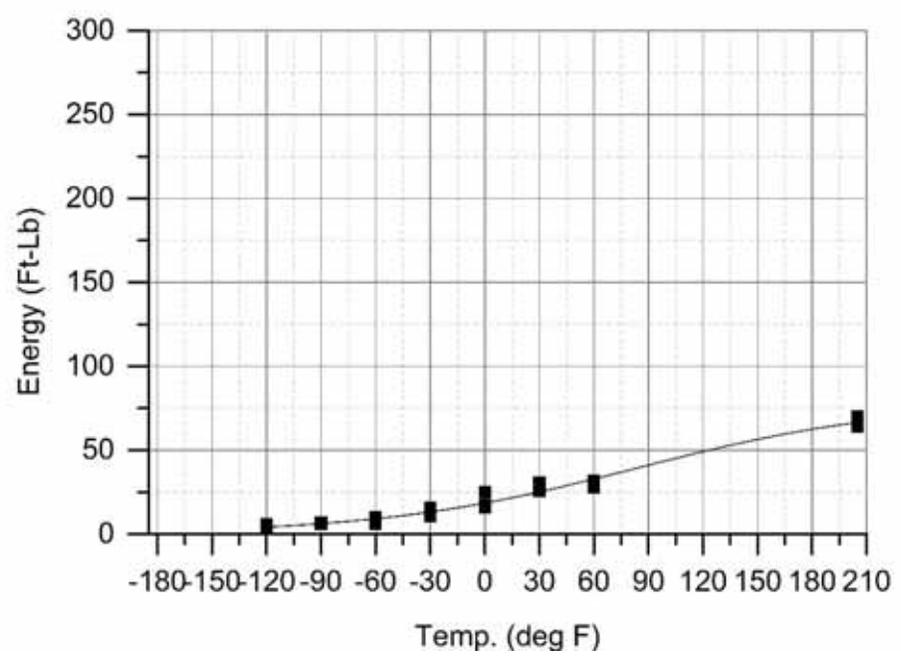
Figure D-20 CVN Data: Specimen 36-4 web plate

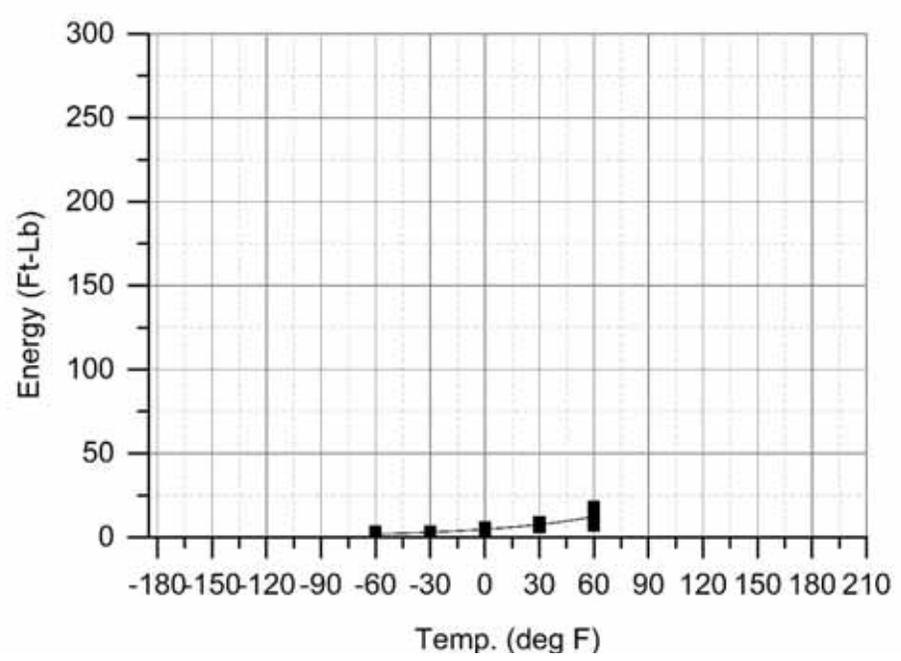
Figure D-21 CVN Data: Specimen 36-4 flange angles

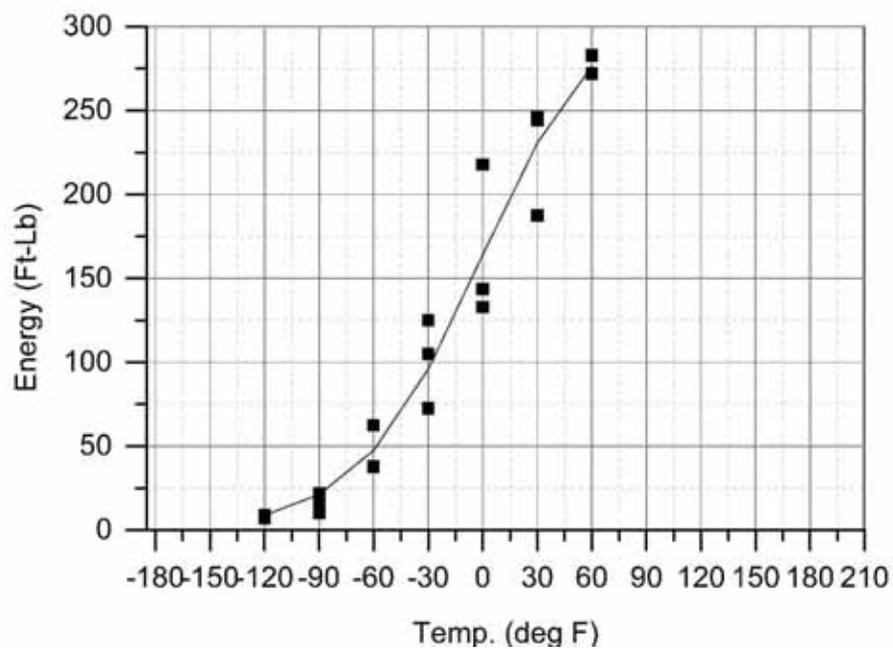
Figure D-22 CVN Data: Specimen 36-4 upper cover plate

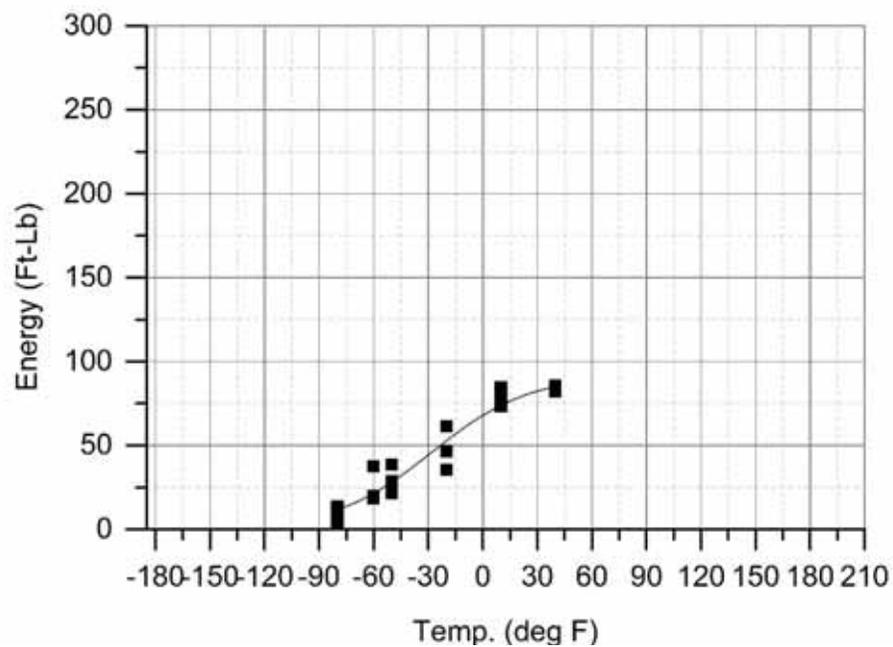
Figure D-23 CVN Data: Specimen 36-4 lower cover plate

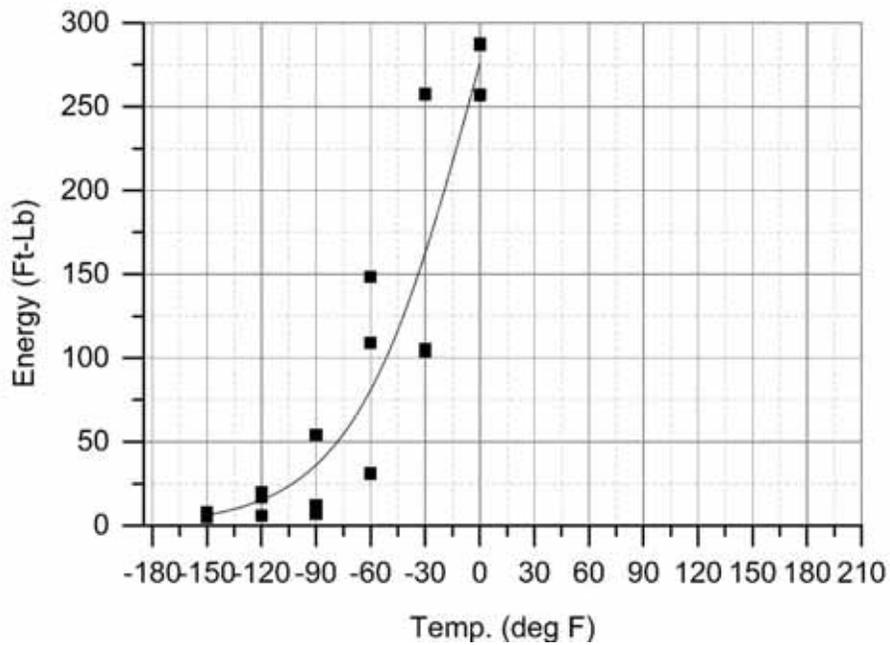
Figure D-24 CVN Data: Specimen 36-5 web plate

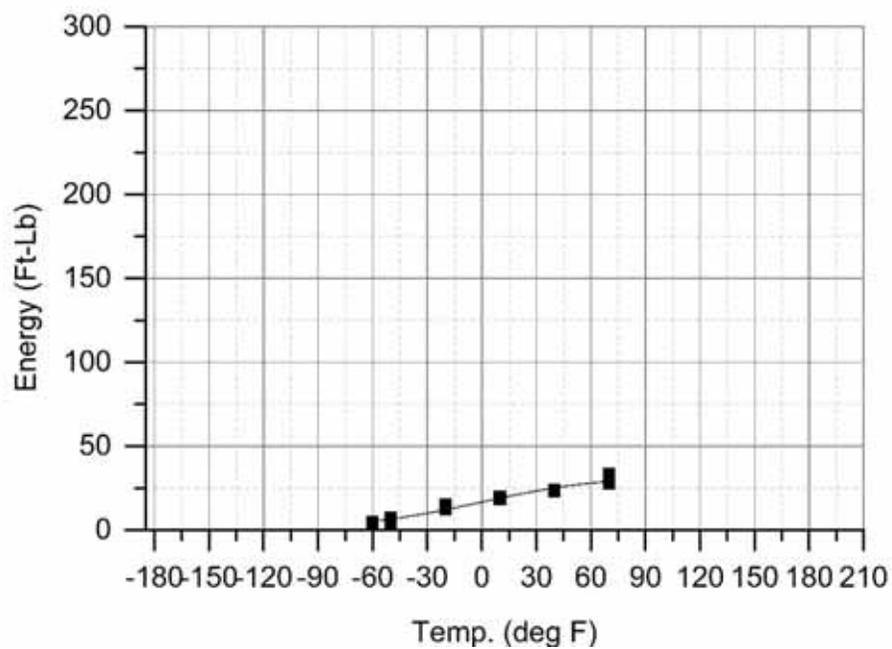
Figure D-25 CVN Data: Specimen 36-5 flange angles

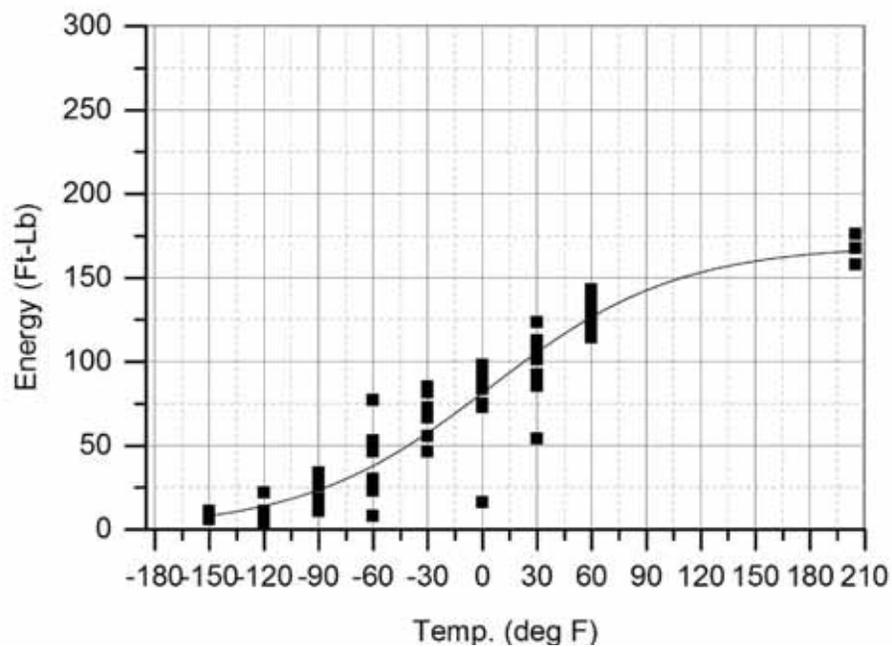
Figure D-26 CVN Data: Specimen 36-5 cover plate

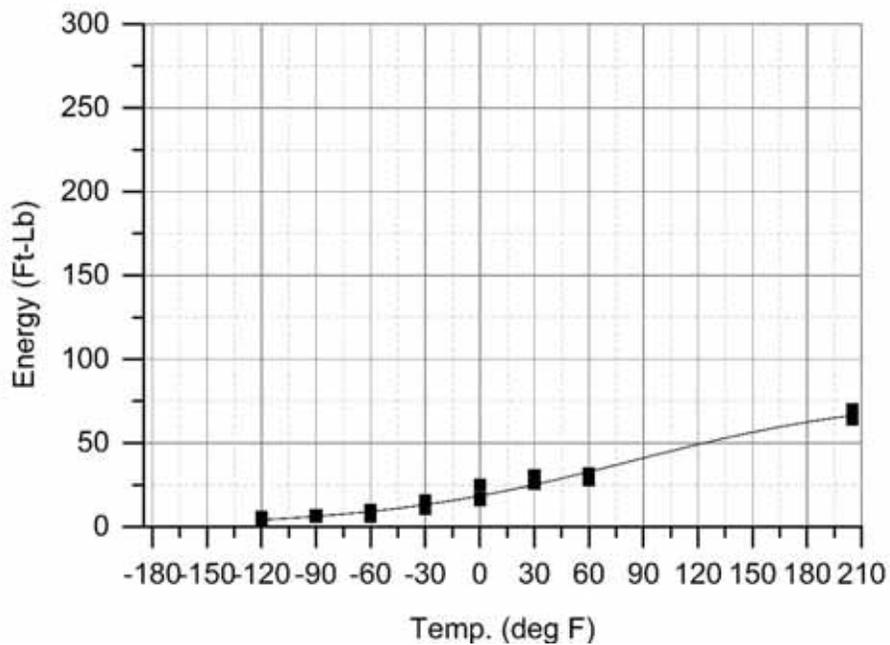
Figure D-27 CVN Data: Specimen 36-6 web plate

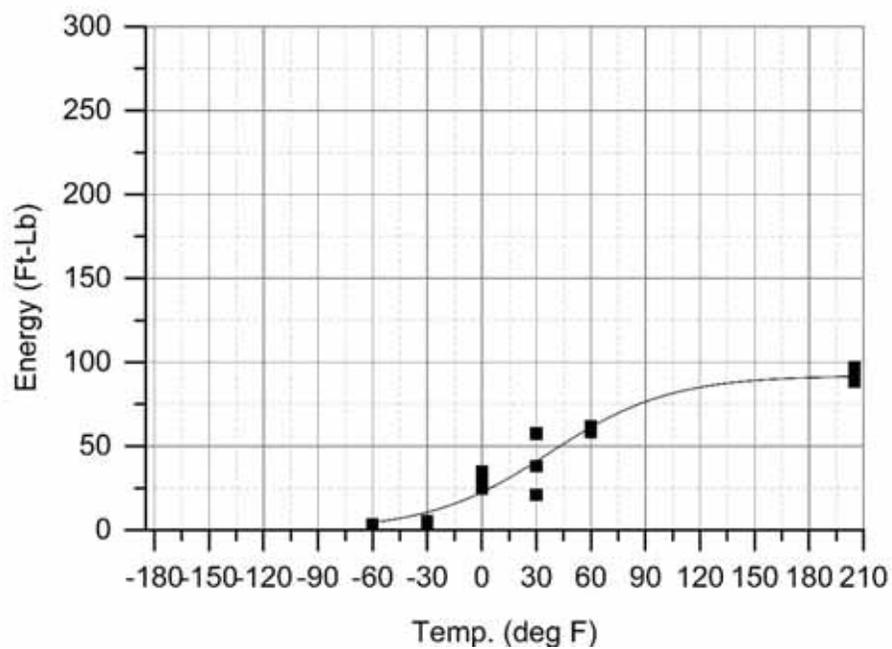
Figure D-28 CVN Data: Specimen 36-6 flange angles

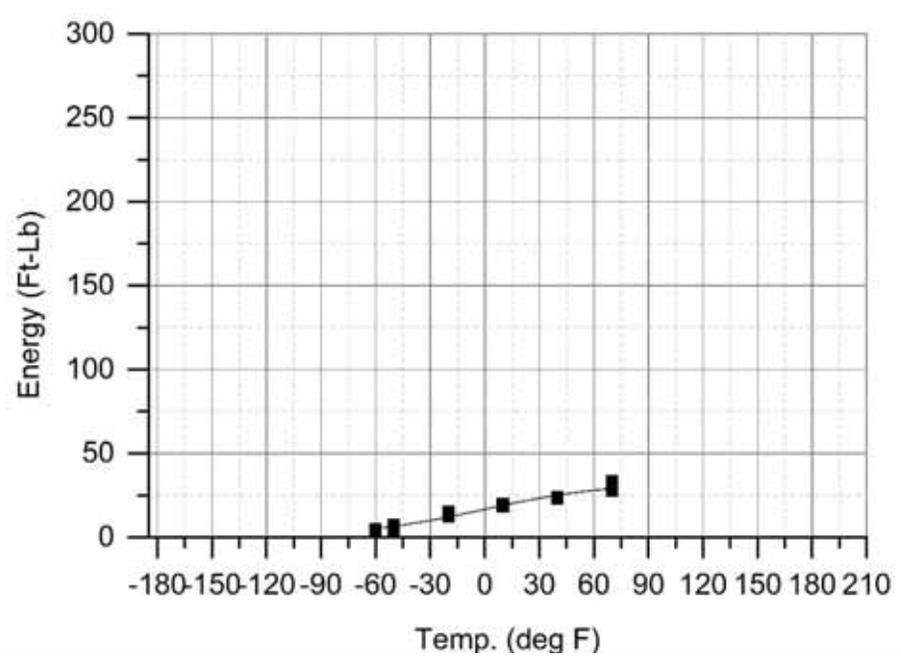
Figure D-31 CVN Data: Specimen 46-1 flange angles

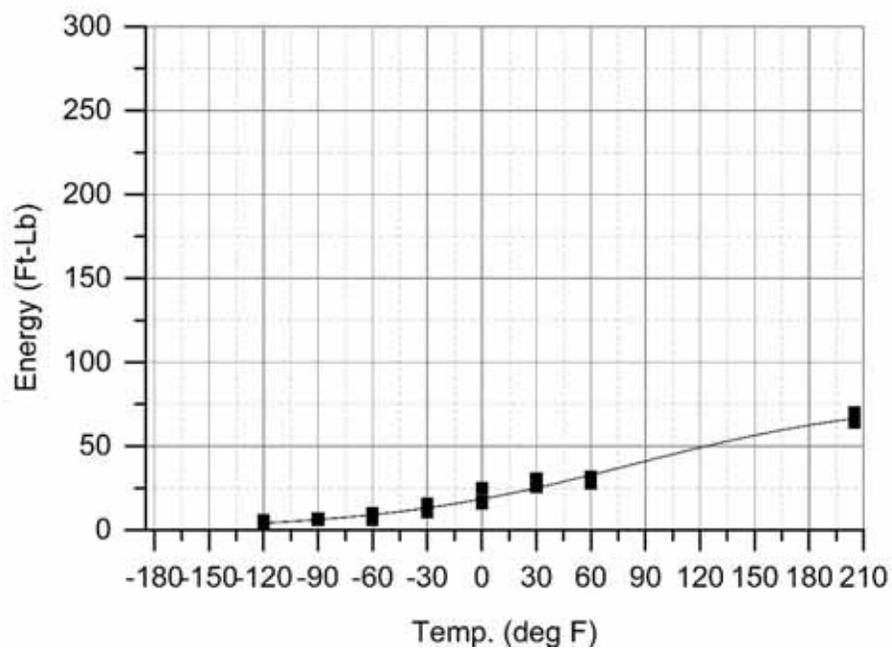
Figure D-33 CVN Data: Specimen 46-2 web plate

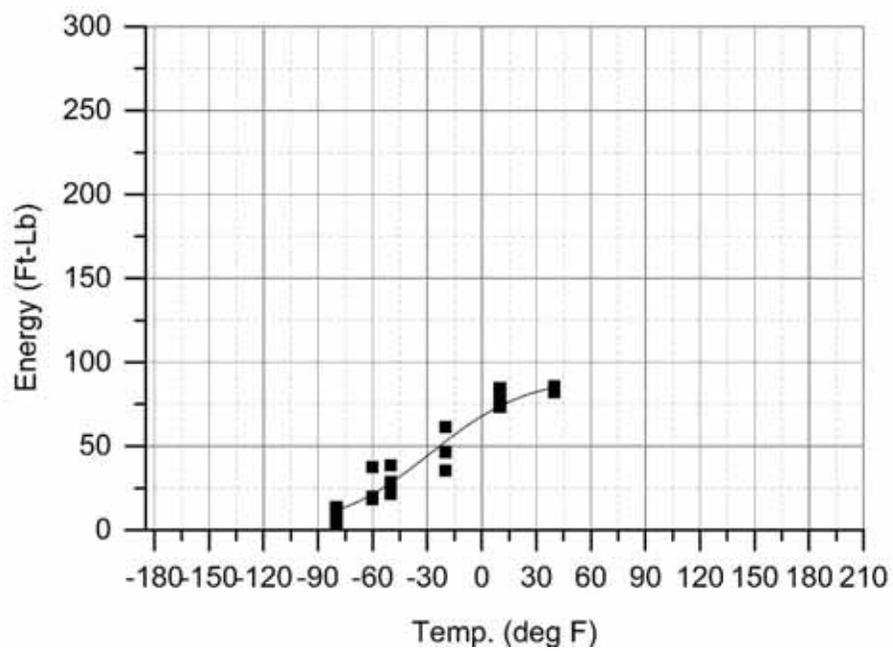
Figure D-35 CVN Data: Specimen 46-2 cover plate

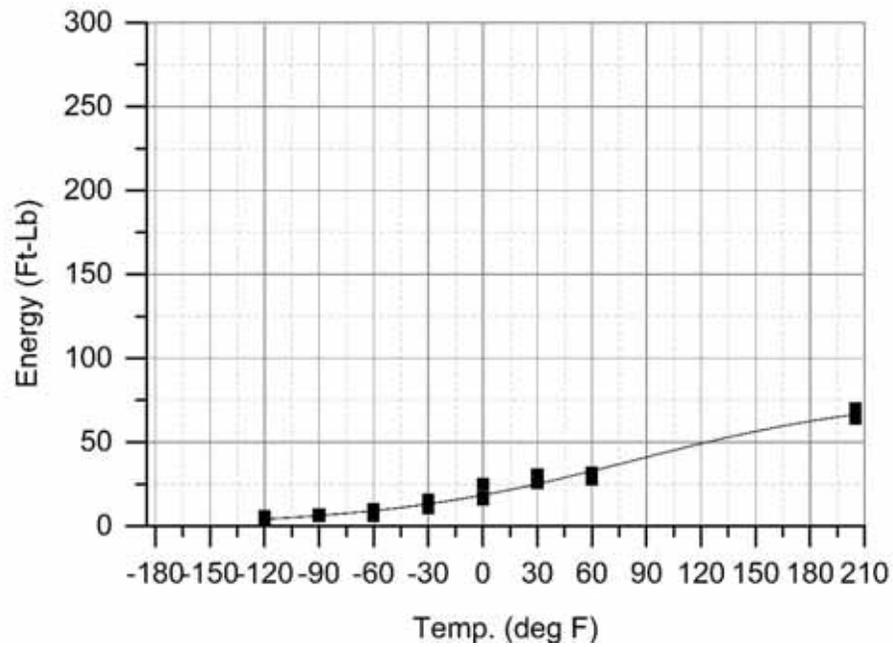
Figure D-36 CVN Data: Specimen 46-3 web plate

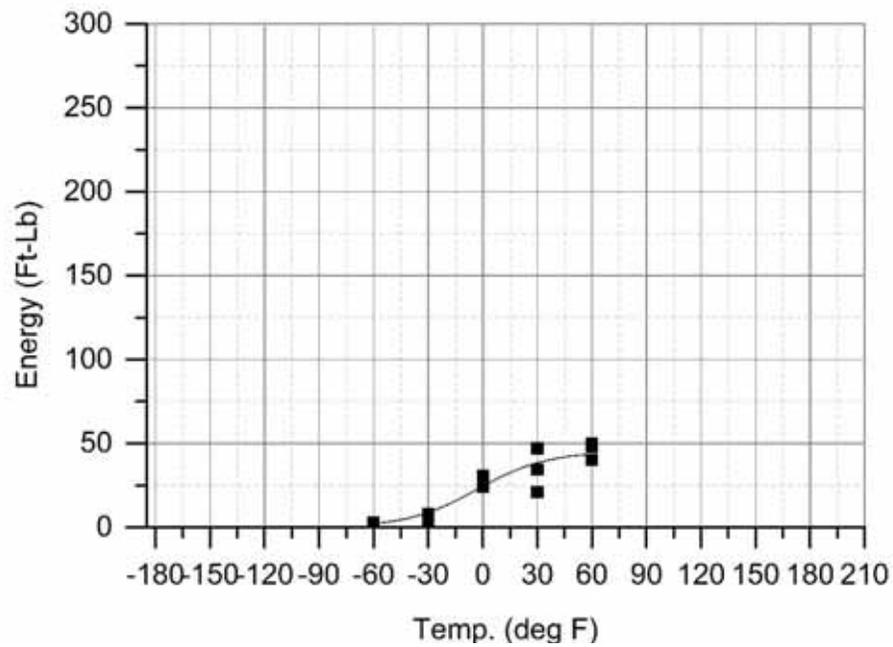
Figure D-37 CVN Data: Specimen 46-3 flange angles

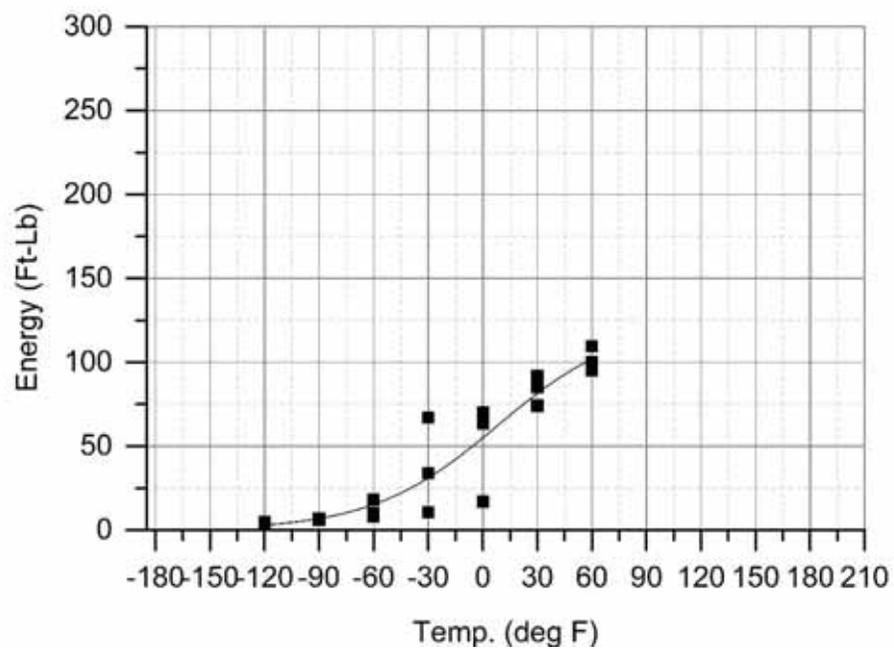
Figure D-38 CVN Data: Specimen 46-3 cover plate
