Purdue University

Steel Bridge Research, Inspection, Training, and Engineering (S-BRITE) Center

Member-level Redundancy of Built-up Steel Girders Subjected to Flexure

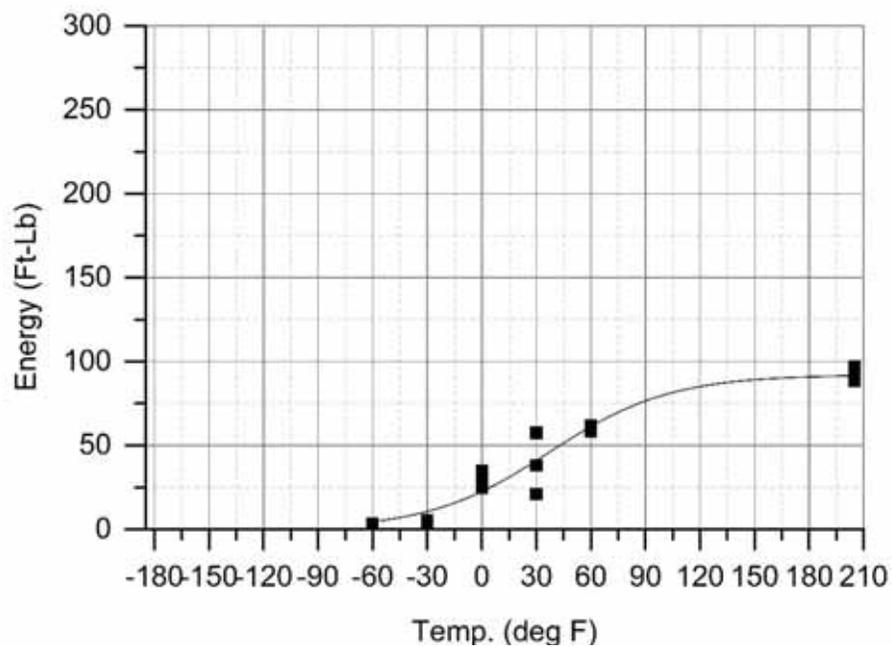
Figure D-40 CVN Data: Specimen 46-4 flange angles

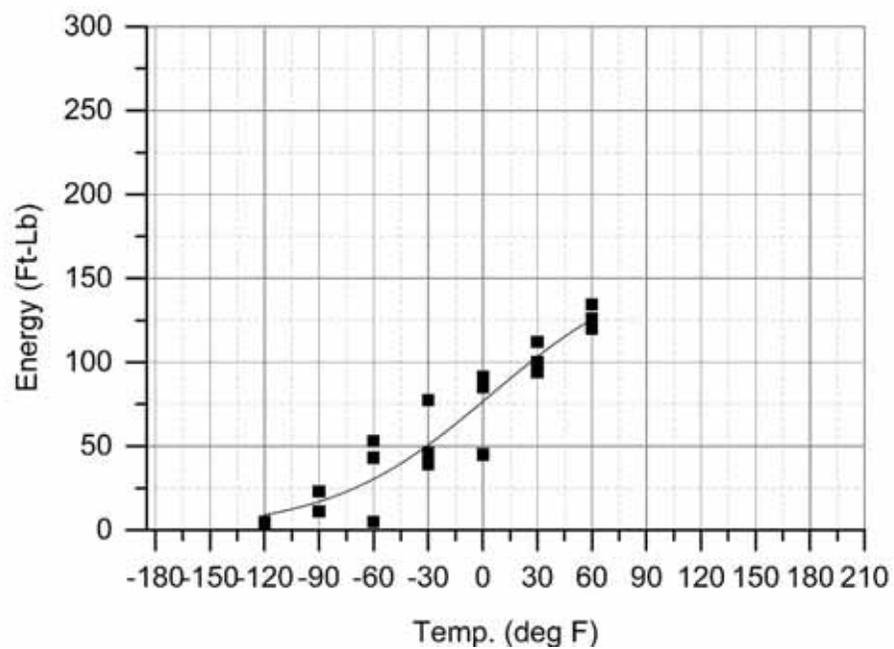
Figure D-41 CVN Data: Specimen 46-4 cover plate

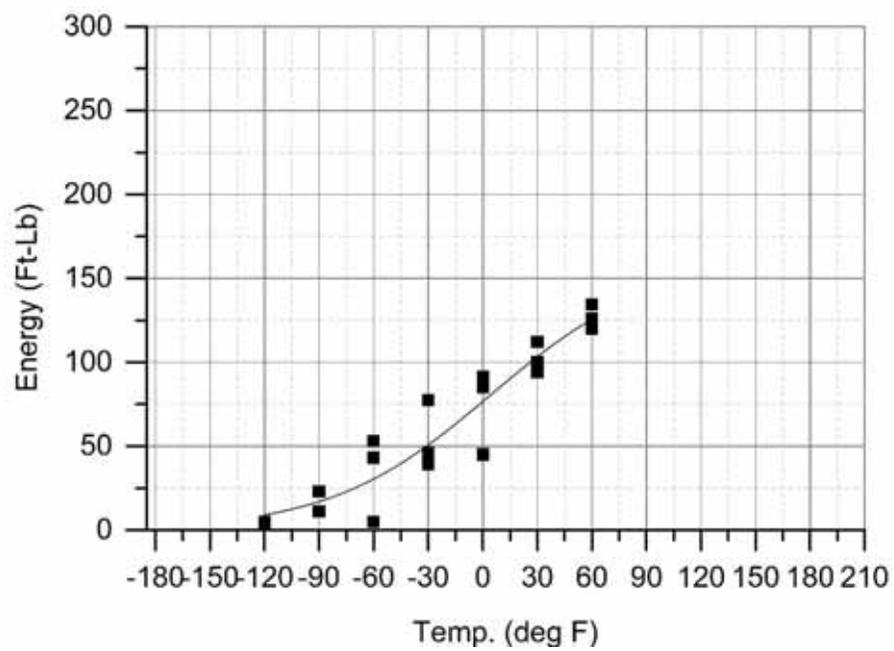
Figure D-44 CVN Data: Specimen 46-5 cover plate

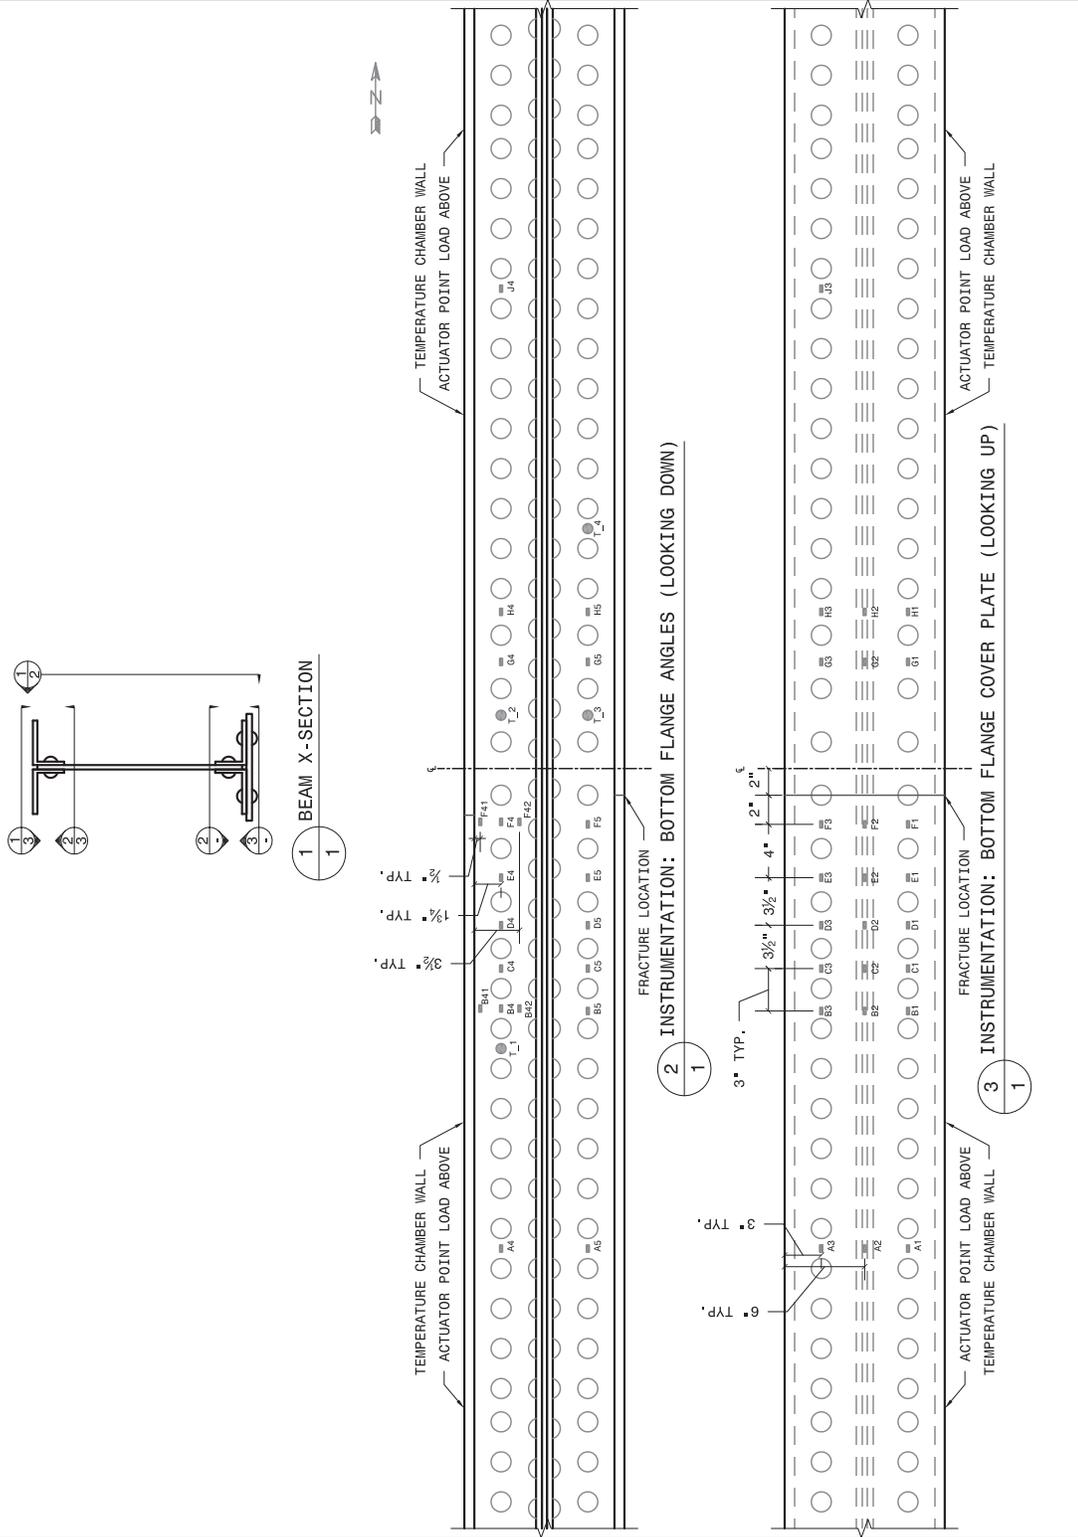
SHEET NO.: **1 of 3**

**SPECIMEN 23-1
INSTRUMENTATION
PLAN**

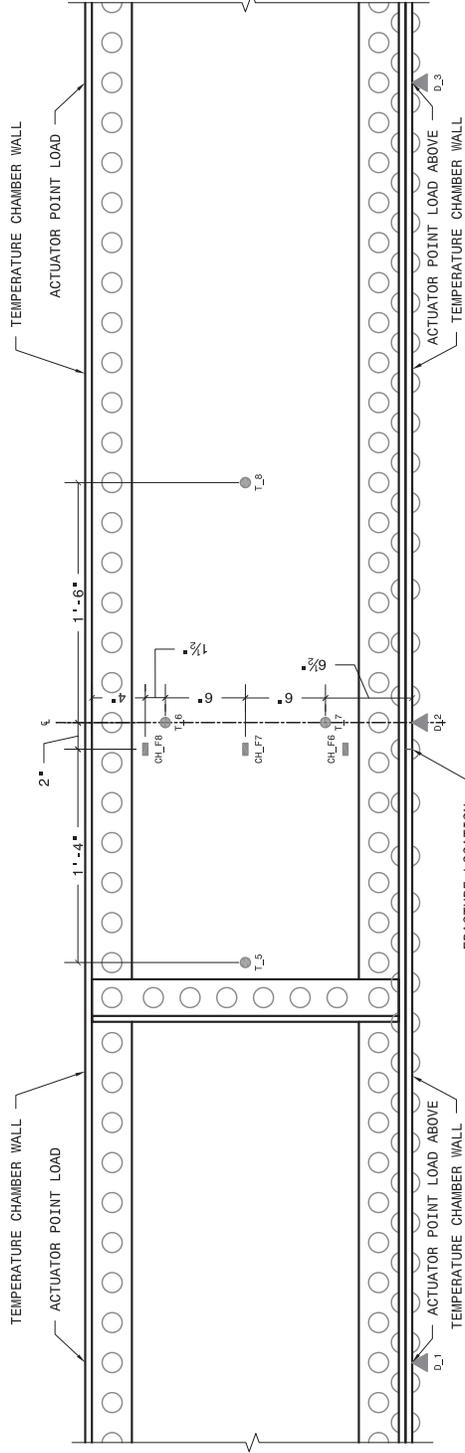
1 INSTRUMENTATION: ELEVATION VIEW

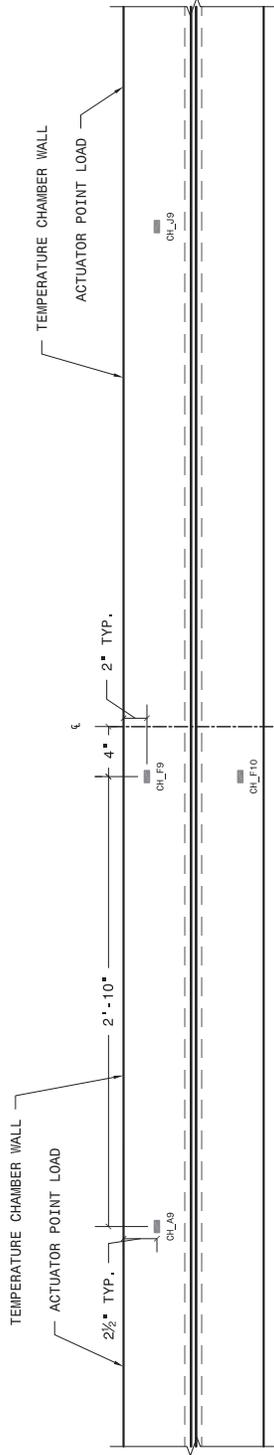
1 INSTRUMENTATION: TOP FLANGE (LOOKING DOWN)

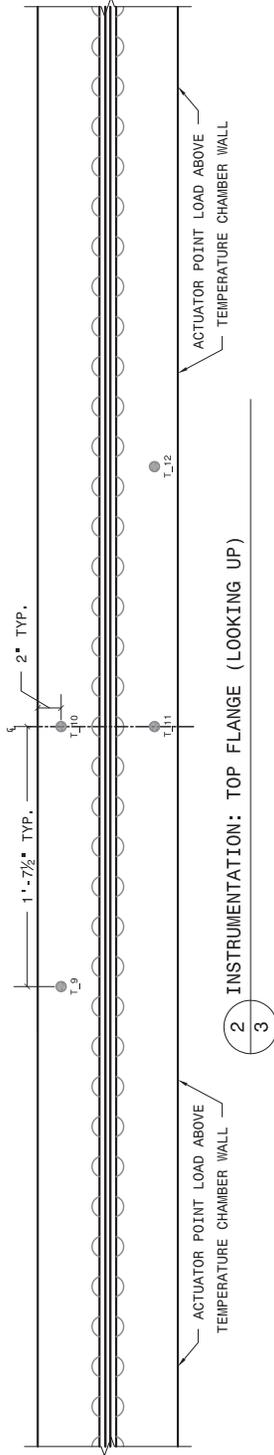
2 INSTRUMENTATION: TOP FLANGE (LOOKING UP)

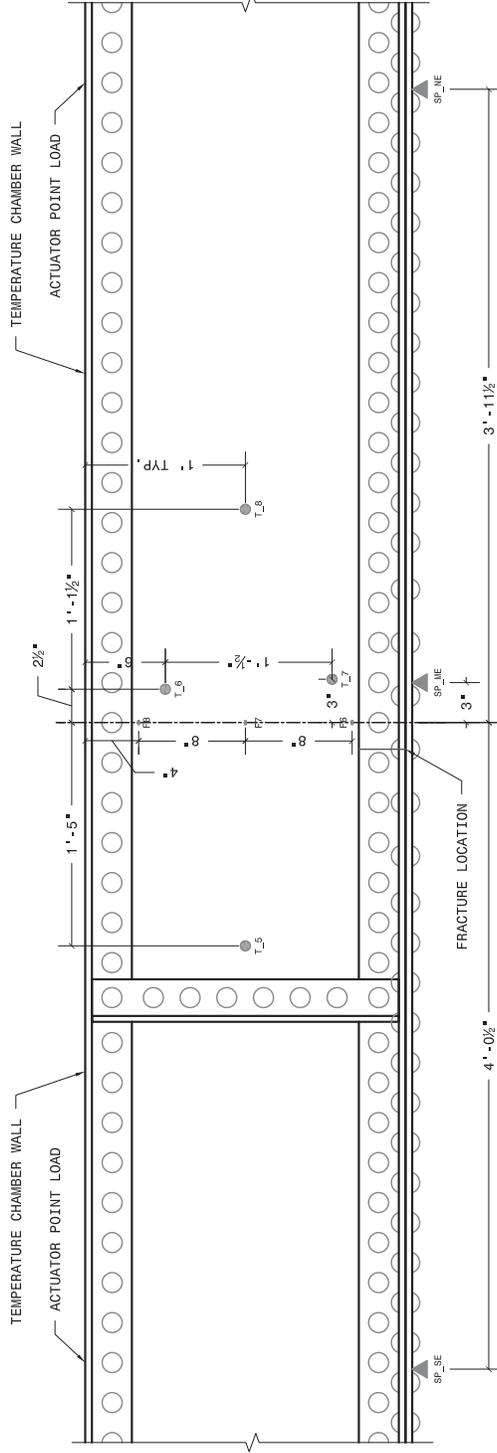
1 INSTRUMENTATION: ELEVATION VIEW

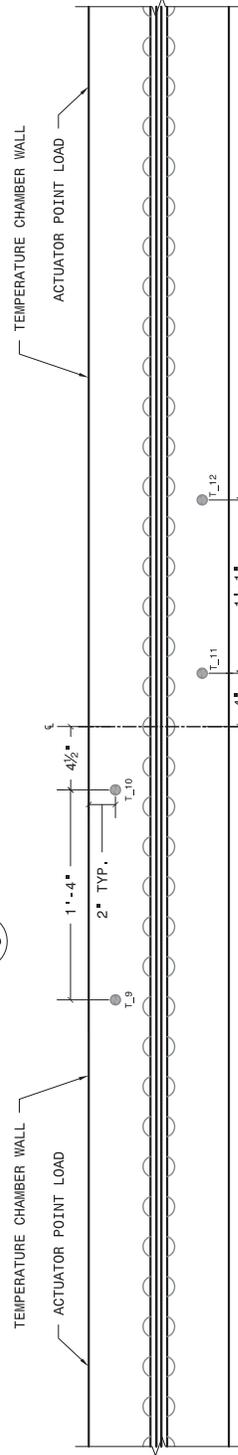
2 INSTRUMENTATION: TOP FLANGE (LOOKING UP)

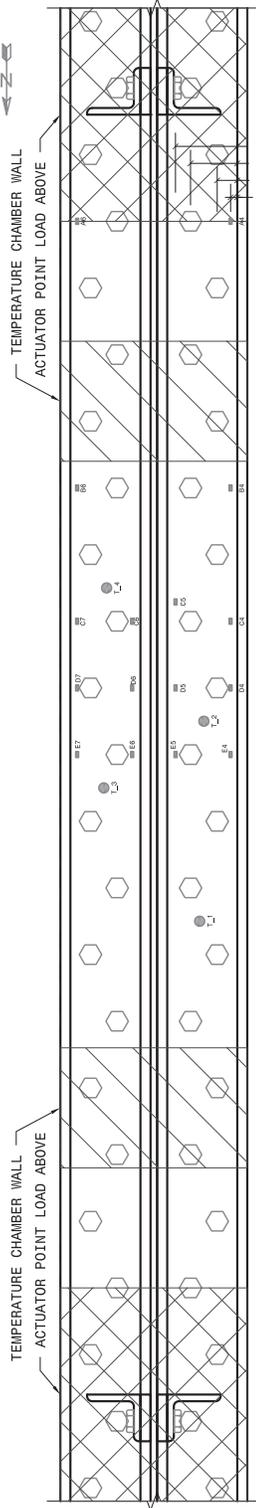
2 INSTRUMENTATION: BOTTOM FLANGE ANGLES (LOOKING DOWN)

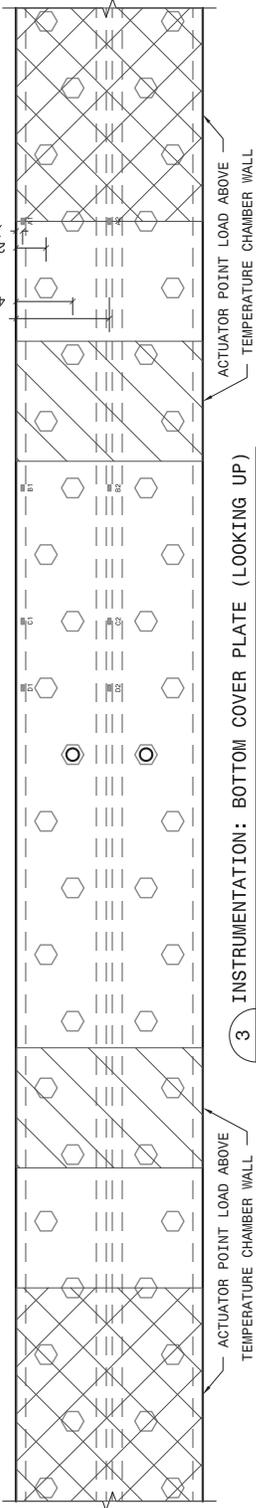
3 INSTRUMENTATION: BOTTOM COVER PLATE (LOOKING UP)

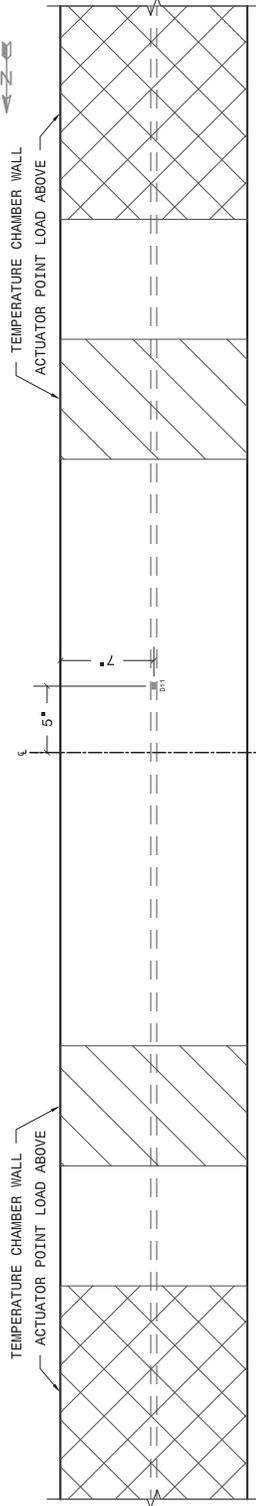
2 INSTRUMENTATION: TOP FLANGE (LOOKING DOWN)

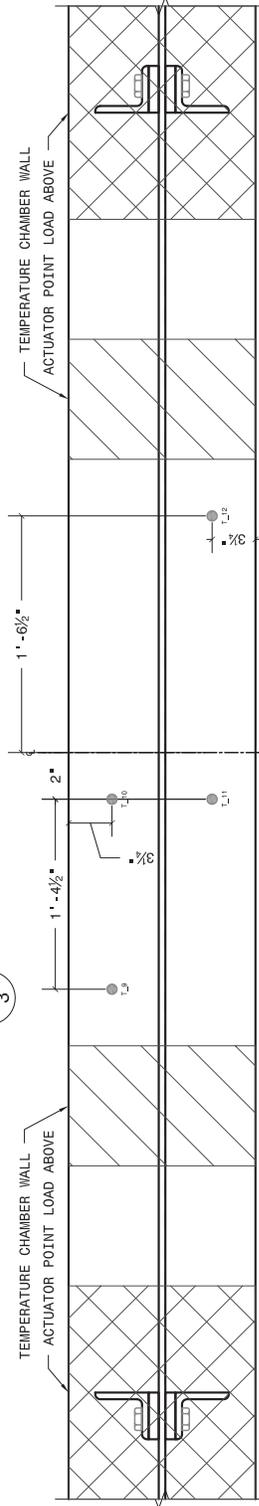
3 INSTRUMENTATION: TOP FLANGE (LOOKING UP)

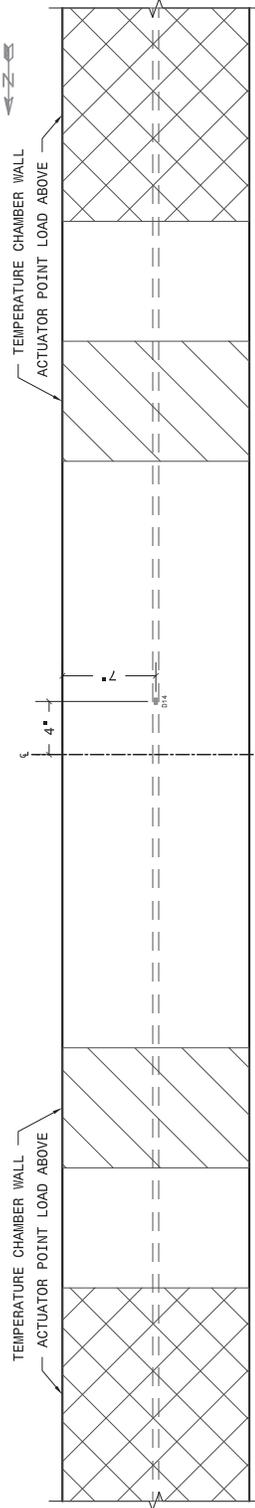
2 INSTRUMENTATION: TOP FLANGE (LOOKING DOWN)

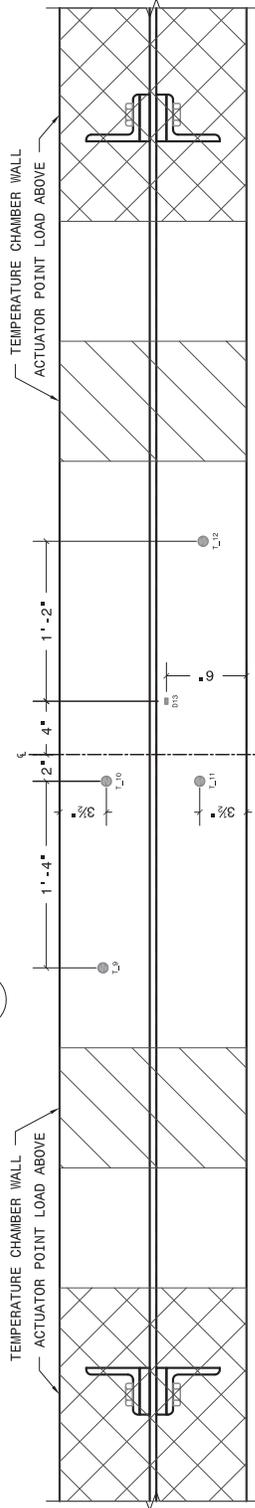
3 INSTRUMENTATION: TOP FLANGE (LOOKING UP)

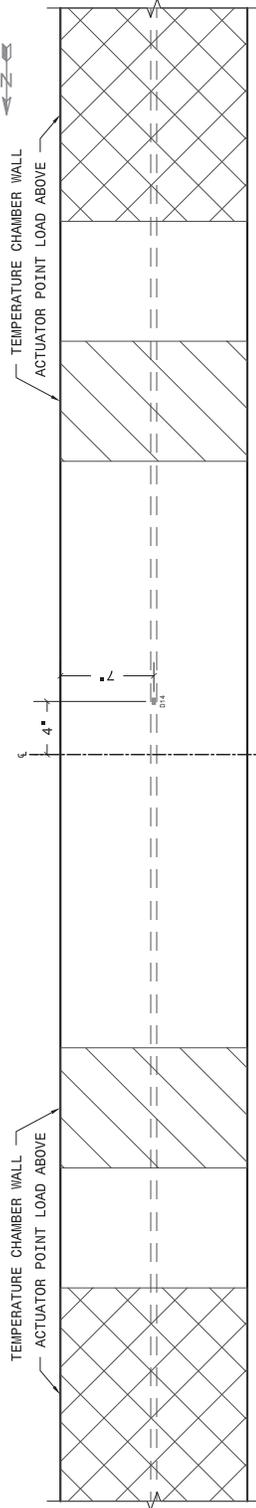
2 INSTRUMENTATION: TOP FLANGE (LOOKING DOWN)

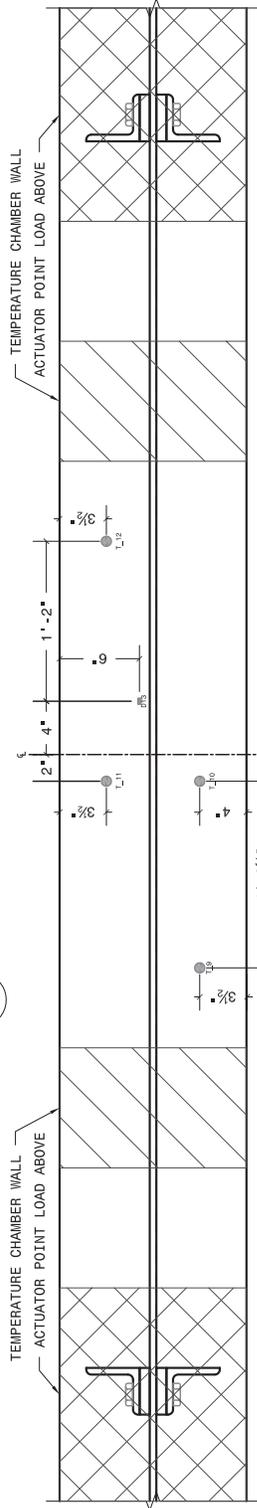
3 INSTRUMENTATION: TOP FLANGE (LOOKING UP)

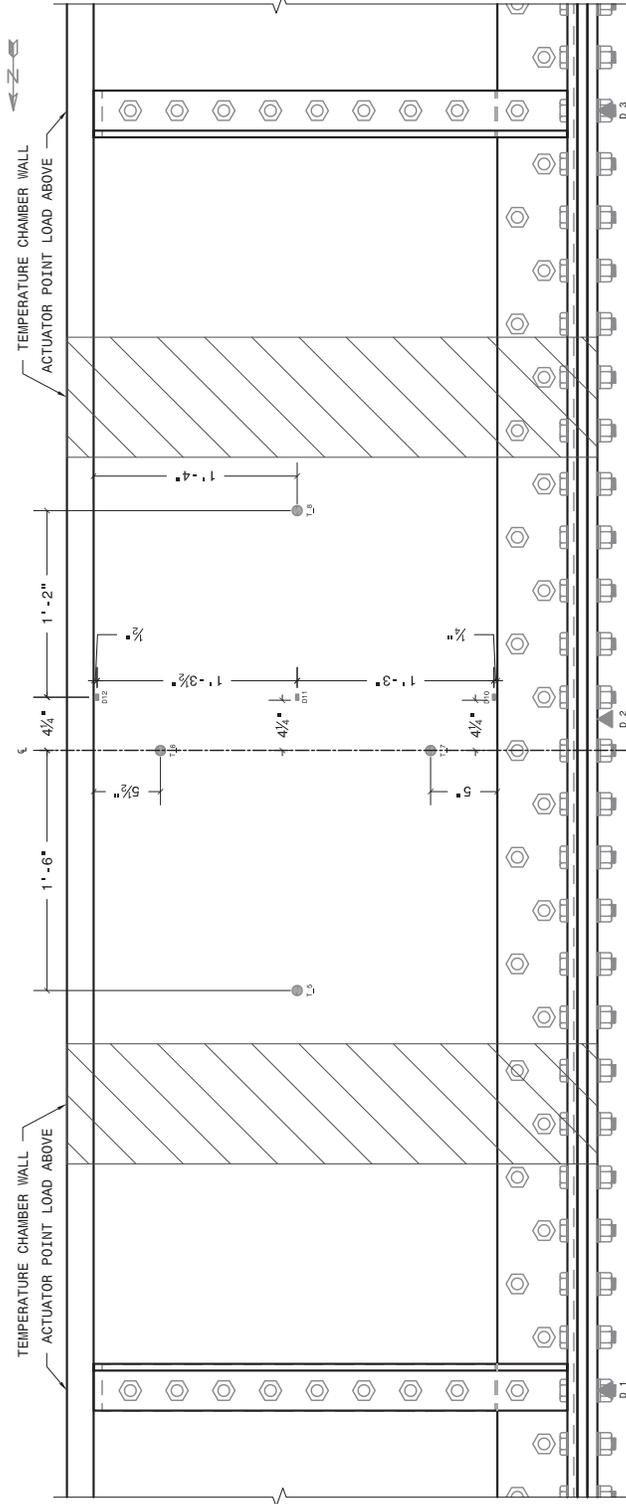
**SPECIMEN 36-3
INSTRUMENTATION**

1 INSTRUMENTATION: WEB (LOOKING EAST)

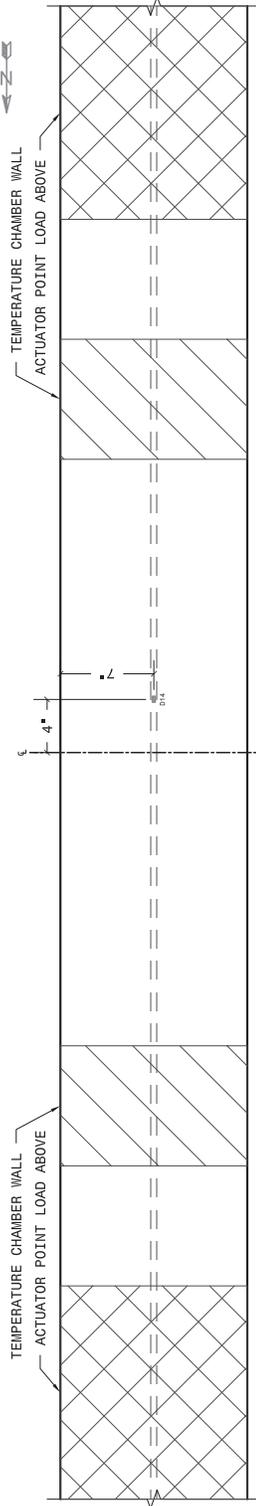
2 INSTRUMENTATION: TOP FLANGE (LOOKING DOWN)

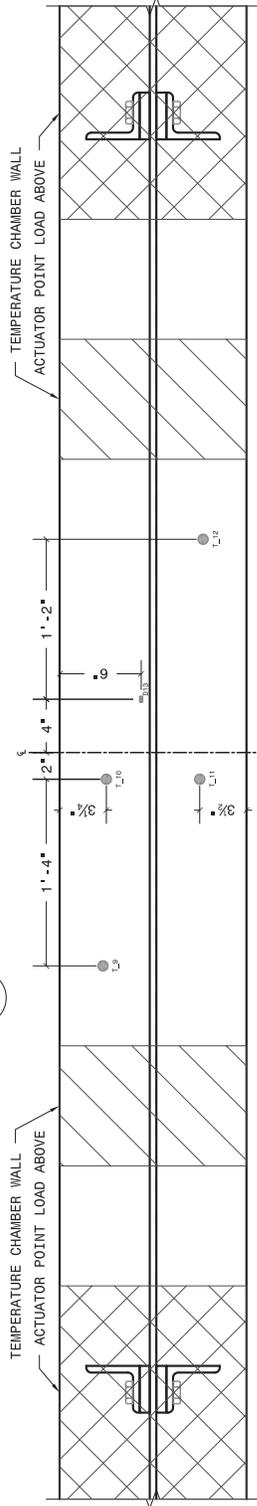
3 INSTRUMENTATION: TOP FLANGE (LOOKING UP)

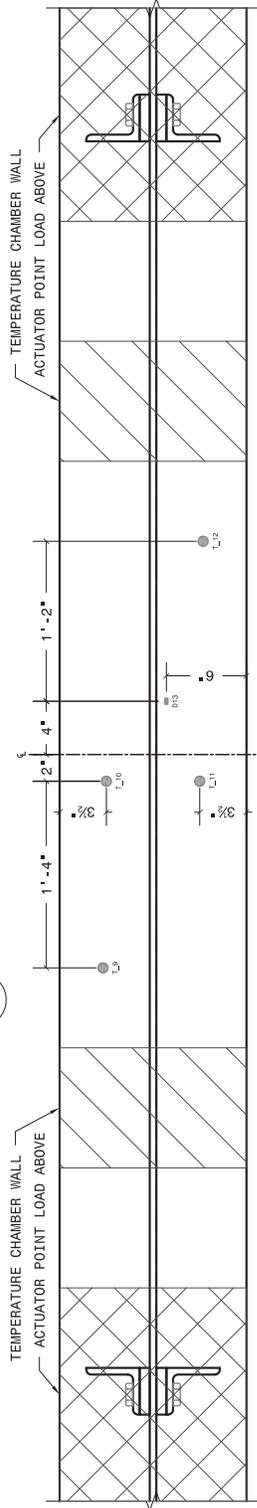
3 INSTRUMENTATION: TOP FLANGE (LOOKING UP)

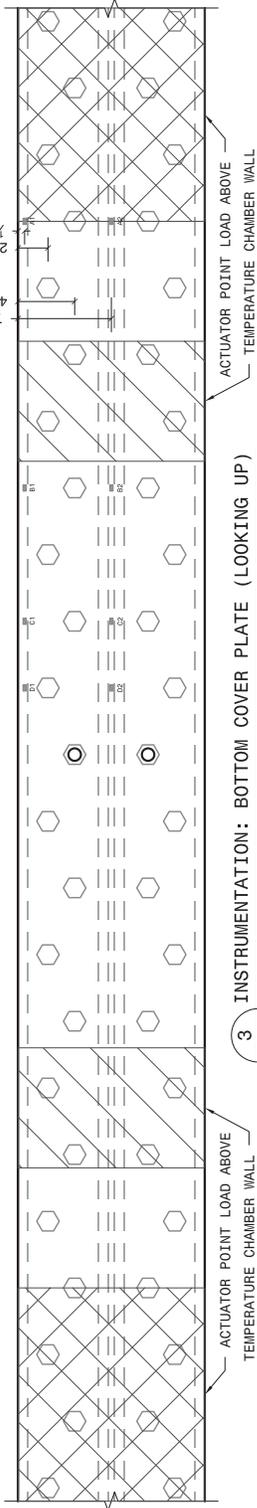
3 INSTRUMENTATION: BOTTOM COVER PLATE (LOOKING UP)

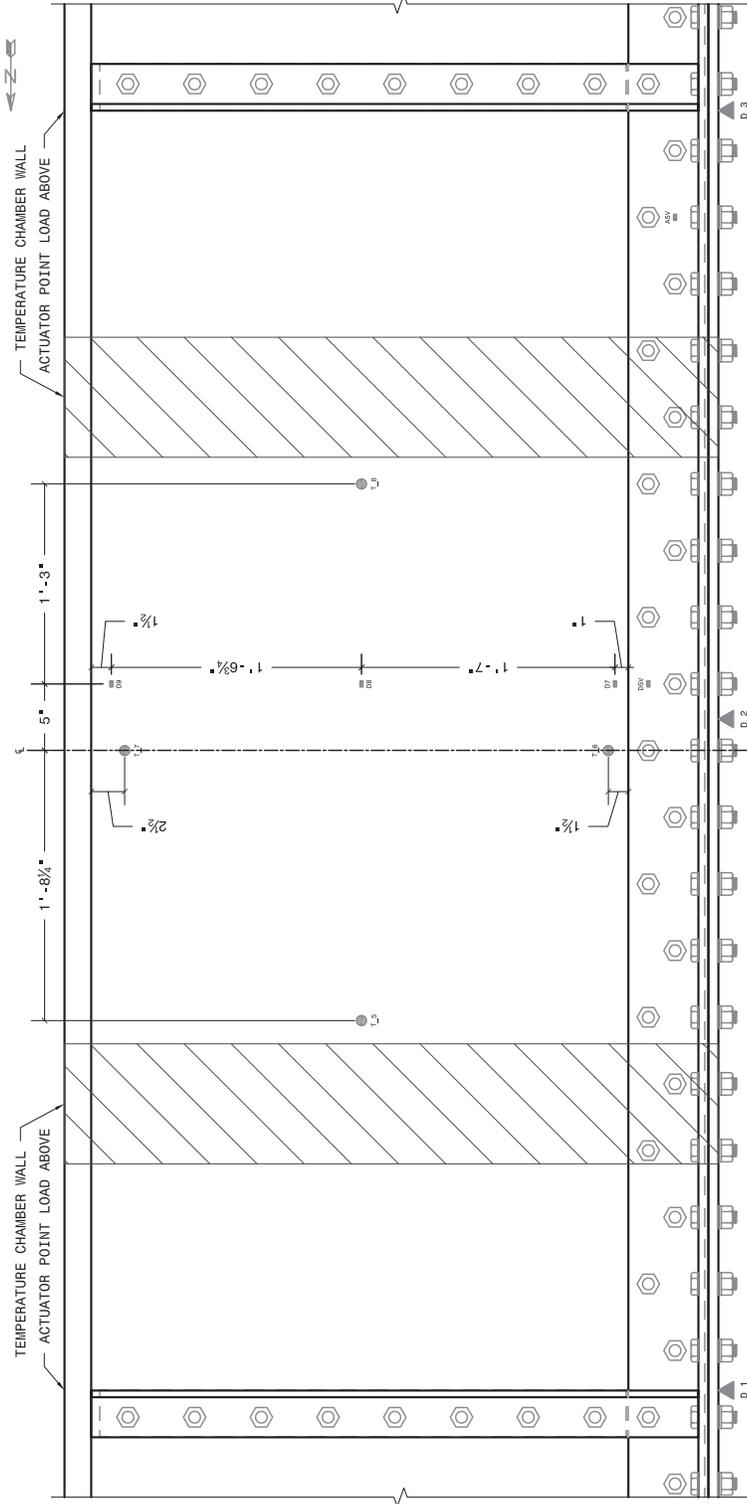
SHEET TITLE:
**SPECIMEN 46-1
INSTRUMENTATION**

1 INSTRUMENTATION: WEB (LOOKING EAST)
2

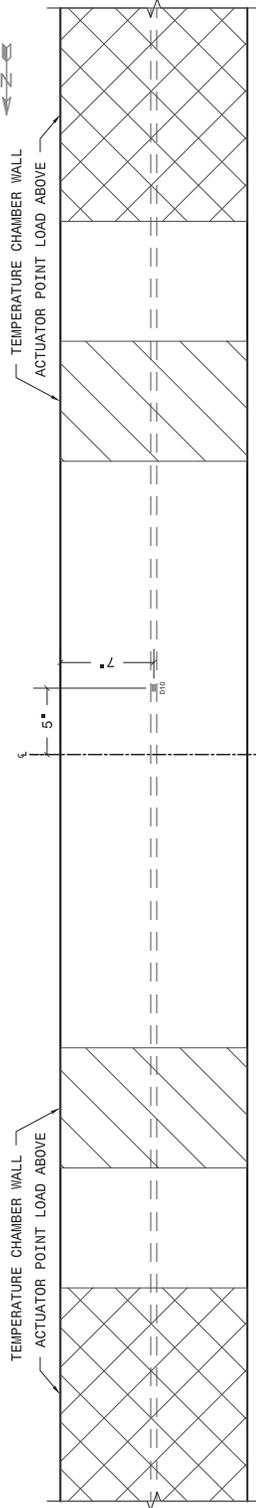
2 INSTRUMENTATION: TOP FLANGE (LOOKING DOWN)

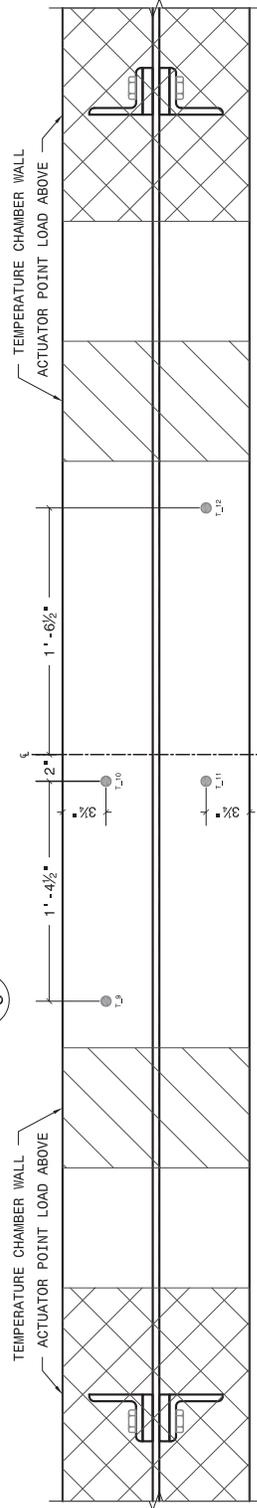
3 INSTRUMENTATION: TOP FLANGE (LOOKING UP)

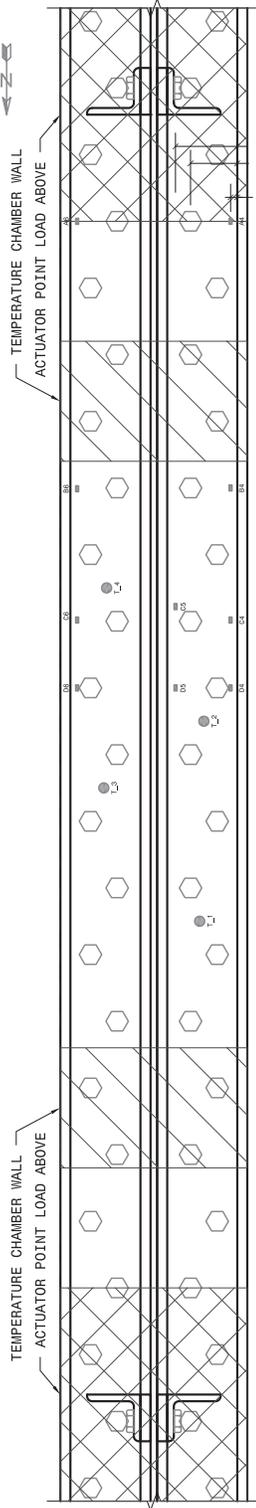
2 INSTRUMENTATION: BOTTOM FLANGE ANGLES (LOOKING DOWN)

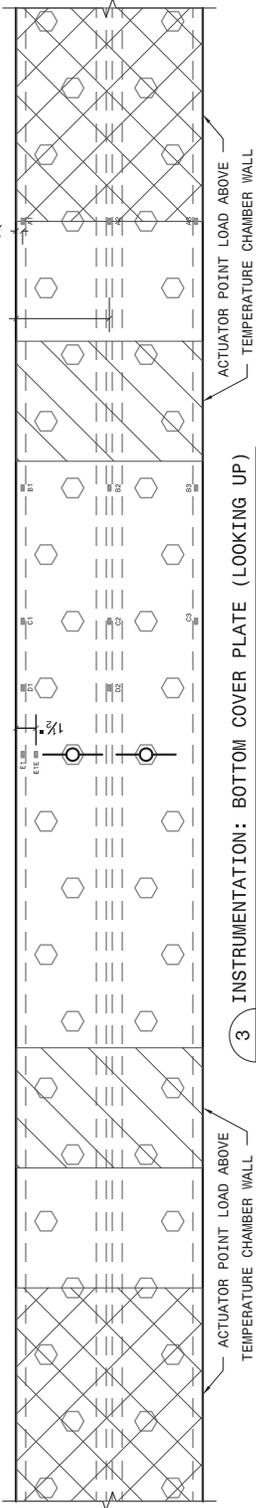
3 INSTRUMENTATION: BOTTOM COVER PLATE (LOOKING UP)

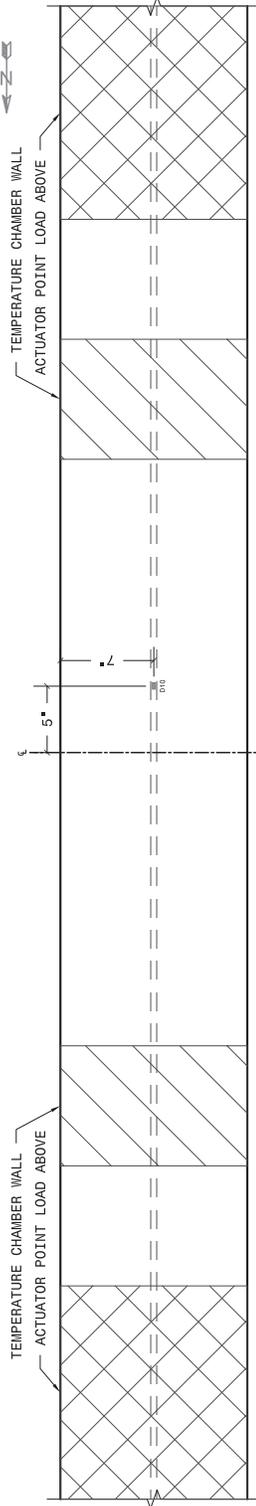
2 INSTRUMENTATION: TOP FLANGE (LOOKING DOWN)

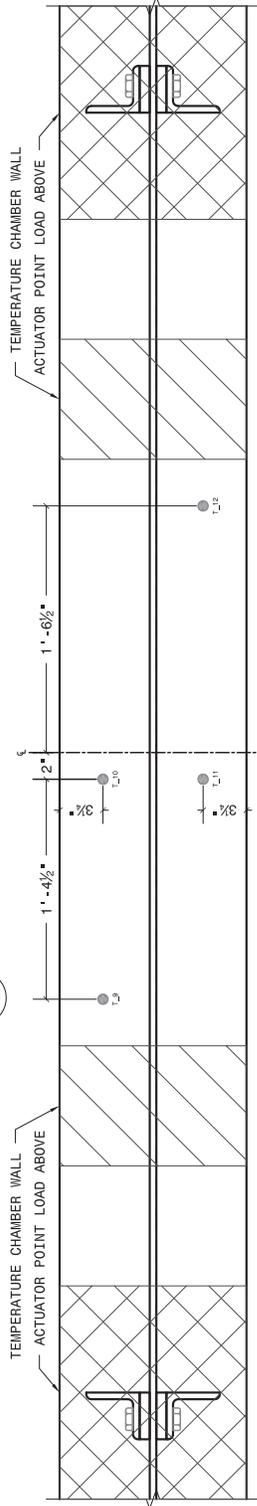
3 INSTRUMENTATION: TOP FLANGE (LOOKING UP)

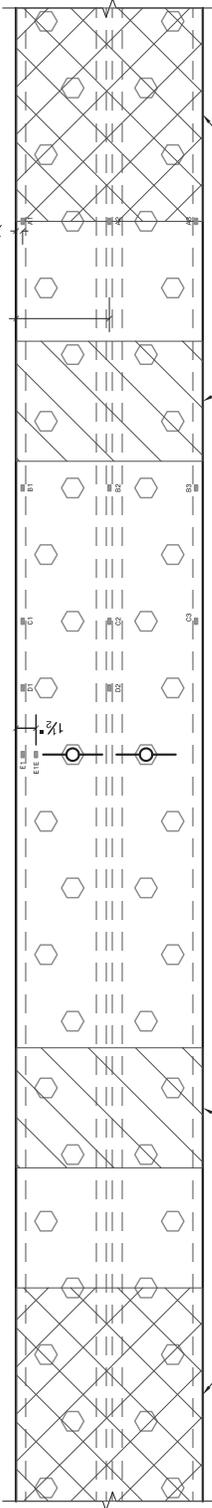
3 INSTRUMENTATION: BOTTOM COVER PLATE (LOOKING UP)

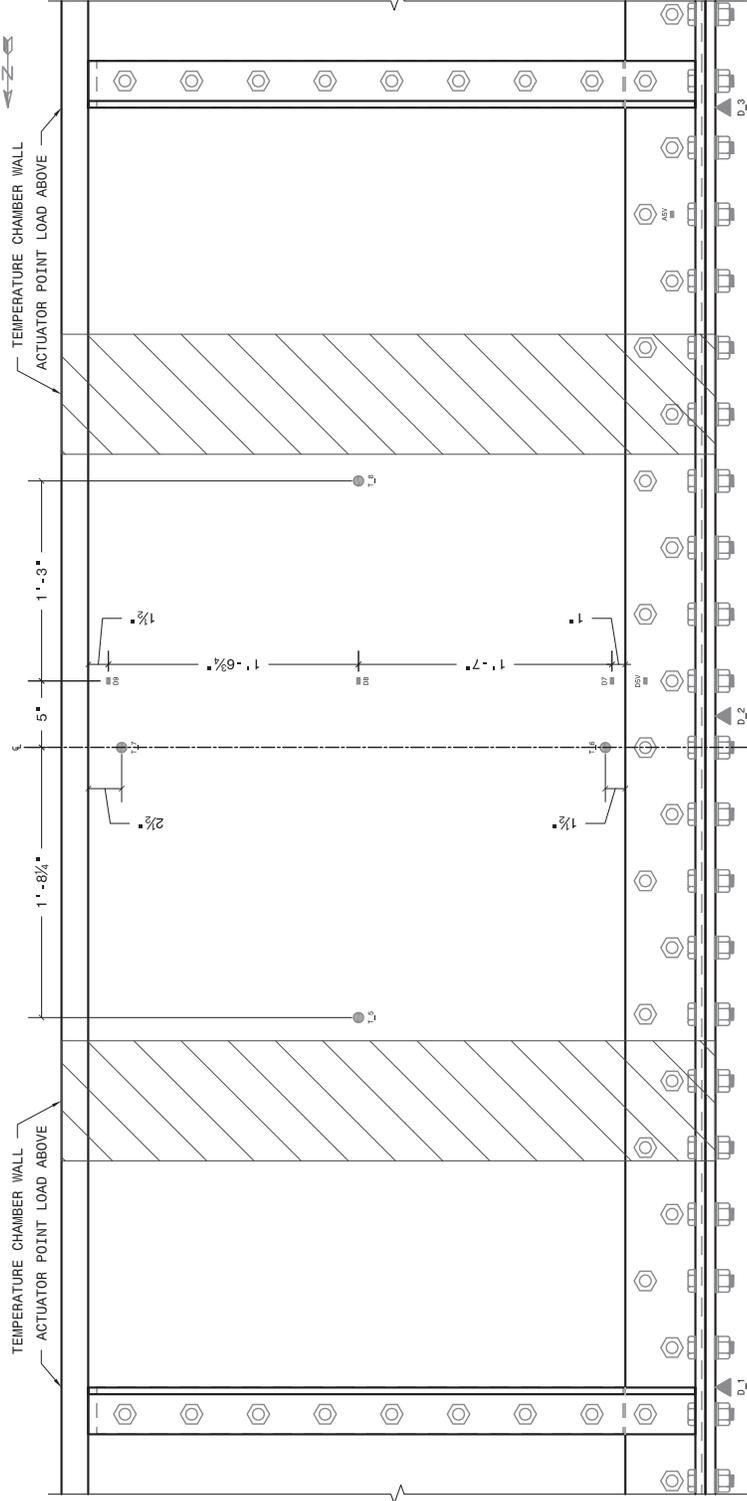
SHEET TITLE:
**SPECIMEN 46-3
INSTRUMENTATION**

1 INSTRUMENTATION: WEB (LOOKING EAST)
2

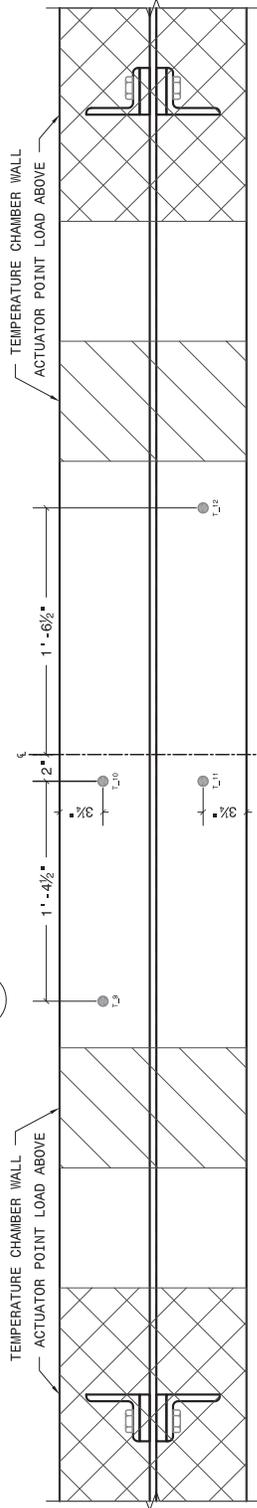
3 INSTRUMENTATION: TOP FLANGE (LOOKING UP)

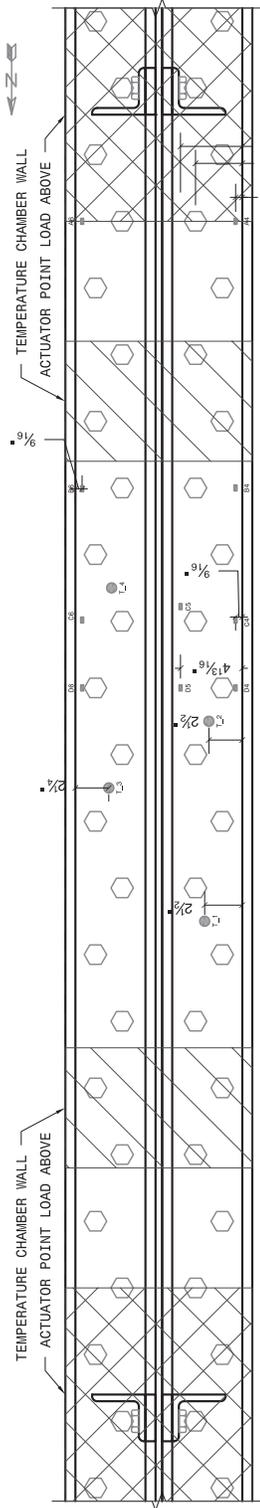
2 INSTRUMENTATION: BOTTOM FLANGE ANGLES (LOOKING DOWN)

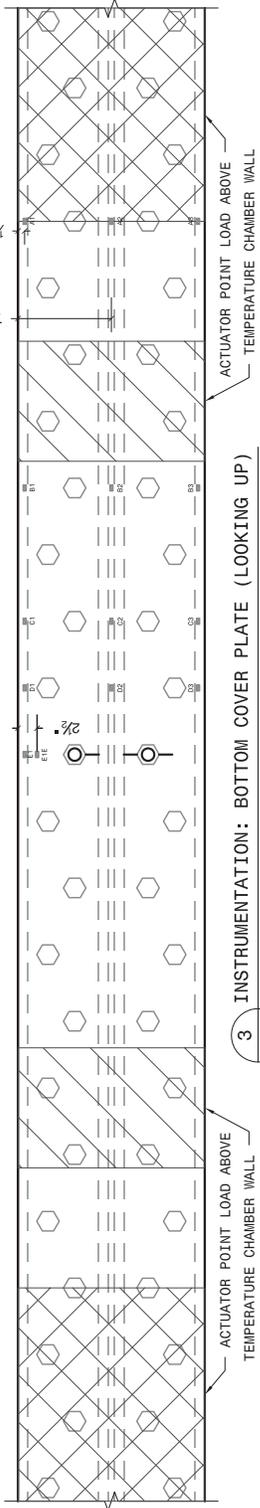
3 INSTRUMENTATION: BOTTOM COVER PLATE (LOOKING UP)

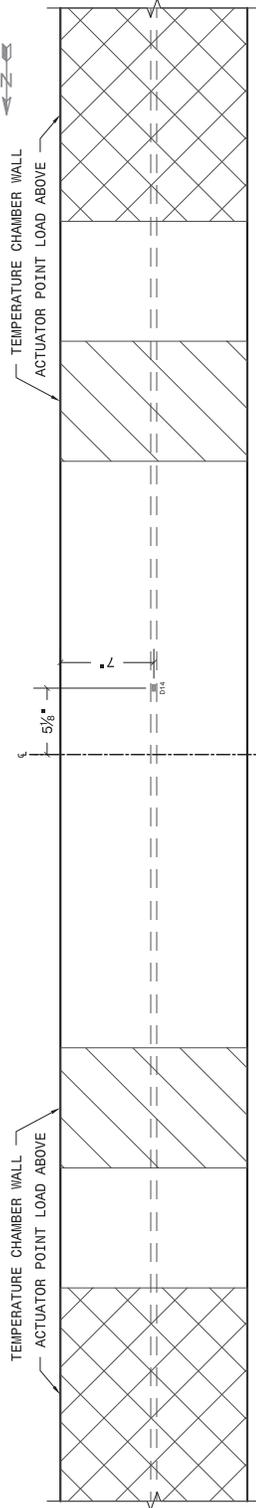
2 INSTRUMENTATION: TOP FLANGE (LOOKING DOWN)

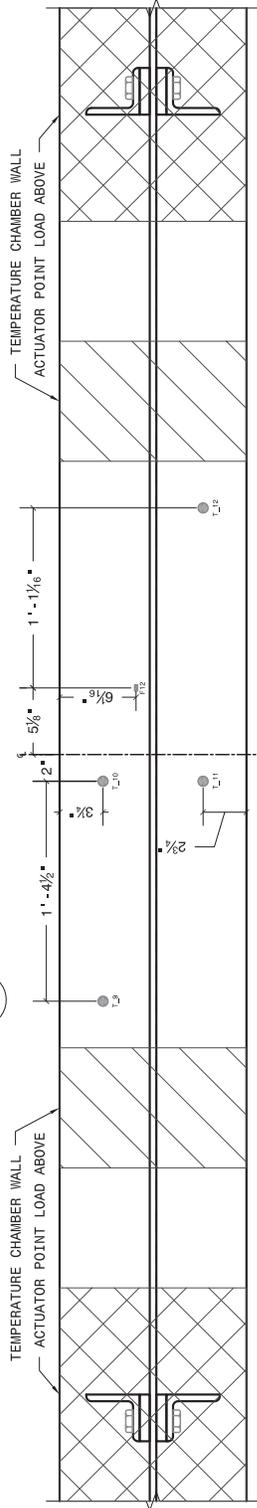
3 INSTRUMENTATION: TOP FLANGE (LOOKING UP)

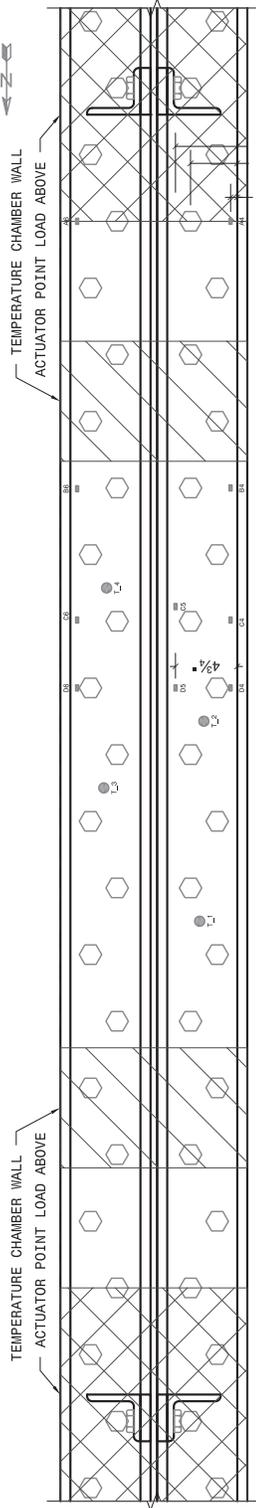
2 INSTRUMENTATION: BOTTOM FLANGE ANGLES (LOOKING DOWN)

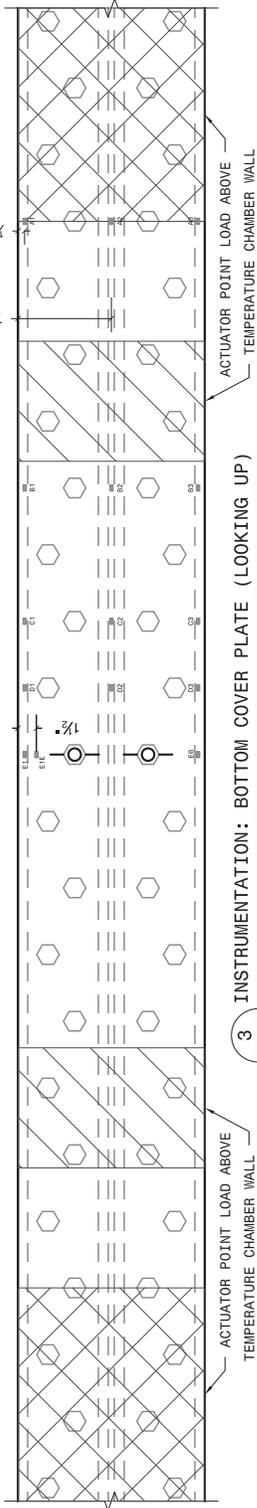
3 INSTRUMENTATION: BOTTOM COVER PLATE (LOOKING UP)
