**SUGGESTED GUIDELINES
FOR RESOLUTION OF
FABRICATION ERRORS**

FIXS - Fabrication error Indexed eXamples and Solutions

AASHTO/NSBA Steel Bridge Collaboration

University of Kansas

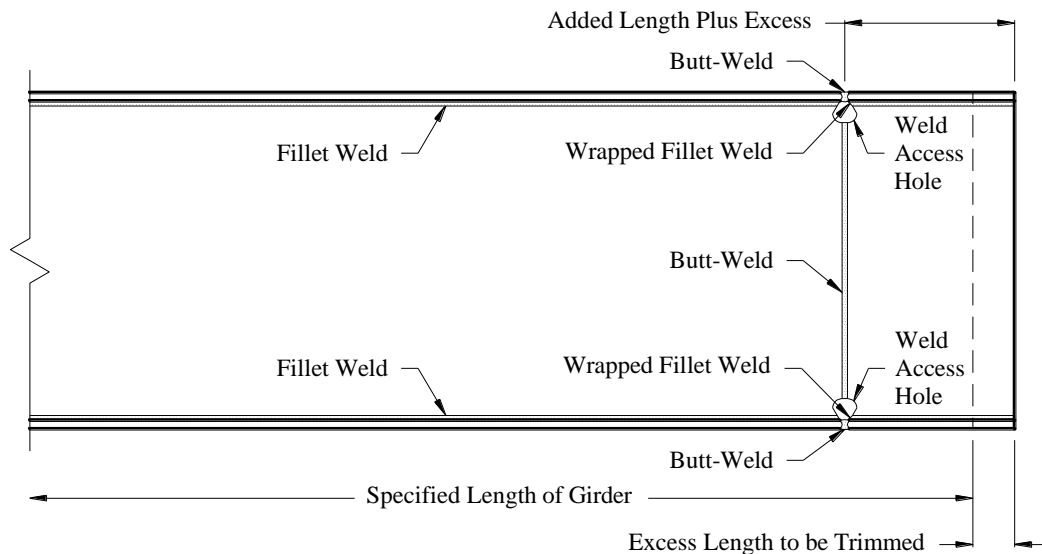
Figure 11: Non-Staggered Butt-Weld Repair

If a rolled beam was cut short and must be weld-spliced (i.e., a bolted splice is not a viable alternative) or if a plate girder near (i.e., within 10% of the span) a simple support and primarily carrying shear with very low moment-induced stresses is miscut, then consider adding a complete section to the cut end (see Figure 11). Make weld joint preparations on flanges and webs and cut weld access holes per Figure 5.2 details in D1.1 (also see Figure 7.1 in S2.1). Note that AASHTO has not adopted a fatigue category for weld access holes, but Table 2.4 in D1.1 does provide this criterion. The Contractor's engineer must evaluate the situation at the proposed full-depth joint and provide calculations and a proposal including welding and NDE procedures for the Owner's review and approval. Access holes are not to be welded to reduce their size, but may be covered for aesthetic reasons if approved by the Owner. After all butt-welds are completed, NDE each per governing specifications. For plate girders, make the flange-to-web fillet welds, including wrapping the welds at the access hole locations, after the butt-welds are accepted. 100% MT and trim to the correct length.

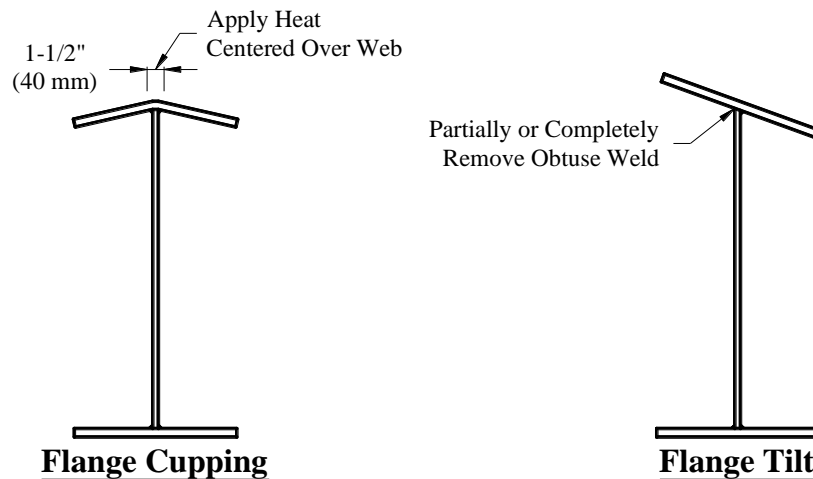
Figure 18: Flange Cupping and Tilt

One type of distortion involves flange edges being pulled toward the web, sometimes referred to as “cupping”, by weld shrinkage. This is most common when attaching light flanges (i.e., up to about 7/8" [22 mm] thick) to webs with 5/16" [8 mm] or larger fillets or by CJP welds. To reduce existing flange cupping, apply a strip heat approximately 1-1/2" [40 mm] wide, centered over the web (see Figure 18). To enhance effects, install jacks or other restraints between flanges to apply restraint before and during heating.

Another type of distortion is flange tilt, leaving the flange non-perpendicular to the web (see Figure 18). This usually occurs with heavy flanges and large fillet or CJP flange-to-

web welds. The flange is stiff enough to resist cupping, and the distortion results from shrinkage of the first side weld rotating the flange. Shrinkage stresses during second side welding are not large enough to overcome the first side's restraint. To correct flange tilt, partial or complete removal of the weld metal between the flange and the web on the obtuse side is normally required. For fillet welds, the obtuse flange-to-web weld is completely removed and enough web material is excavated to permit the flange to rotate back to "square". For CJP welds, excavate the weld and part of the web from the obtuse side. For both fillet and CJP flange-to-web welds, preheat both the remaining weld and the side to be welded to reduce restraint and subsequent residual stresses and apply jacking force to the acute side of the flange. Preheat will typically be higher than normal, but should not exceed about 400° F [200° C] to avoid hot-working (i.e., plastically deforming the metal) the weld fusion and HAZ areas. Jacking alone must not be used to correct the tilt, since that could cause cracking or distort the web, and subsequent welding could over-correct the initial problem.

If tilt is observed or anticipated, problems should be reduced or avoided on subsequent girders by pre-positioning flanges to anticipate rotation and by changing welding procedures and sequences to balance forces.
