Report No. UT-003

**NON-DESTRUCTIVE AND
DESTRUCTIVE INVESTIGATION
OF AGED-IN-THE FIELD CARBON
FRP-WRAPPED COLUMNS**

New York State Department of
Transportation &
Utah Department of Transportation

University of Utah
Department of Civil and Environmental
Engineering

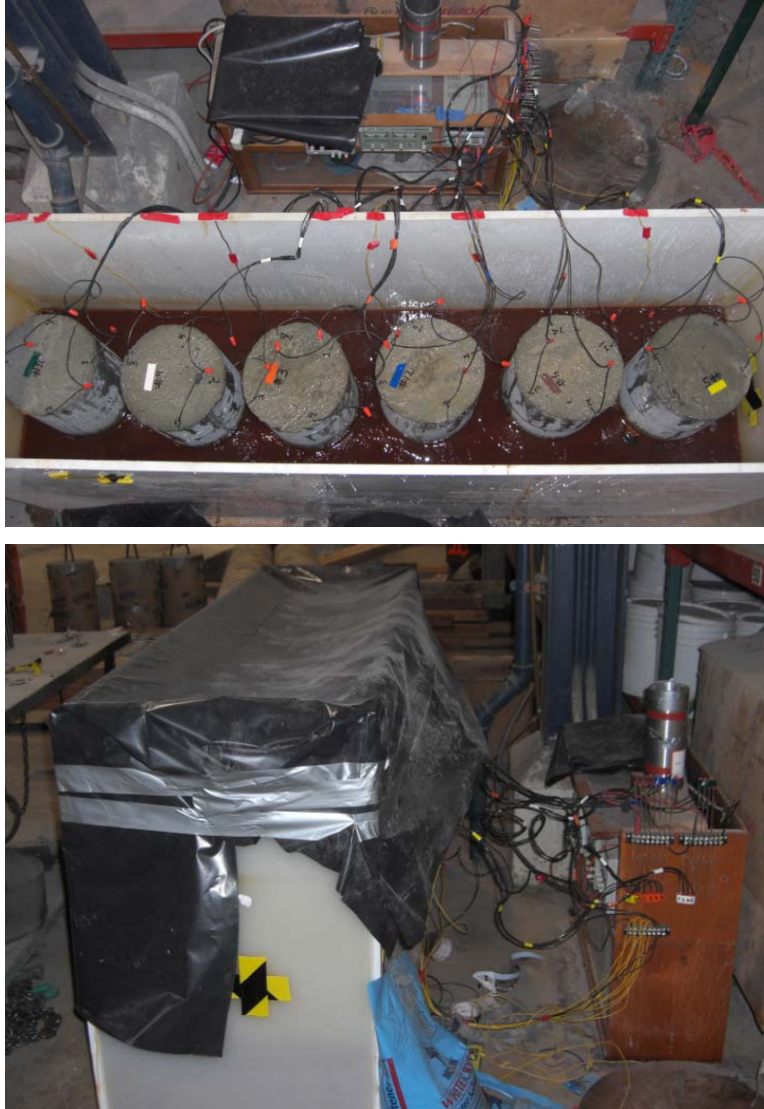
Figure 2. Corrosion system for small-scale steel reinforced columns

Corrosion of the remaining six small-scale columns was initiated in March of 2010. Four of the six columns have all steel reinforcing and two have steel vertical bars with glass fiber reinforced polymer (GFRP) spirals. The columns were placed in the corrosion tank with 5% salt water solution, and were left to soak in the solution for one week to allow the water to penetrate to the rebar - before the 5.0 volt potential was applied on March 24, 2010 (see Figure 2). Initial readings were taken right after the 5.0 volt potential was applied. Readings were taken frequently at the start, on March 25, 26, 29, 30, 31, and April 1, 2, and 7 to ensure the corrosion process was running correctly. From this time onwards readings were taken weekly.

Three DC power supplies were required to implement corrosion of the six columns. Each power supply is connected to two columns and supplies a constant 5.0 volt potential across each vertical rebar. This 5.0 volt potential is checked with a voltmeter every time readings are taken to ensure it stays constant. This was done at initial set up and the potential has remained at a level of 5.0 volts.

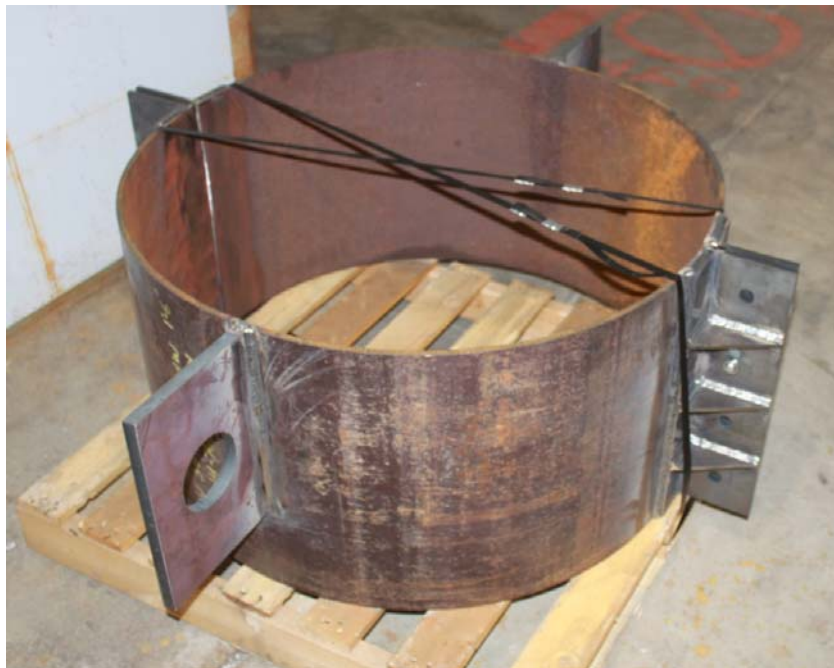
Figure 3. Steel collar

Intermountain Rigging Company was contracted to transport the full scale columns inside the laboratory and stand the columns in the loading frame in December of 2009. A steel collar had to be designed to lift the columns vertically into the frame, and maneuver them afterward. The steel collar had a length of 1 ft.-6 in. and was constructed out of a 36 in. diameter steel pipe as shown in Figures 3 and 4. The steel pipe was cut in half with two $\frac{3}{4}$ in. thick steel lifting tabs attached and $\frac{3}{8}$ in. thick bolt plates that were stiffened with $\frac{1}{4}$ in. stiffener plates as shown in Figure 5. The bolt plates allowed for a total of eight $\frac{3}{4}$ in. bolts to tighten the collar onto the column as shown in Figure 5. Once inside the frame, the column had to be adjusted to stand in the vertical position and in the center of the frame. To achieve this, the column was suspended and square metal tubing was welded into the frame to hold the bottom centered; then the top was adjusted until the column was vertical. Once the column was vertical it was braced and a form was built around the base; Hydrostone, a high strength plaster, was poured in to fill the small gap between the column and the bottom steel plate. Hydrostone was placed to provide a uniform bearing area beneath the column and on top of the column so that there would be no unintended loading concentrations that could affect the test results.

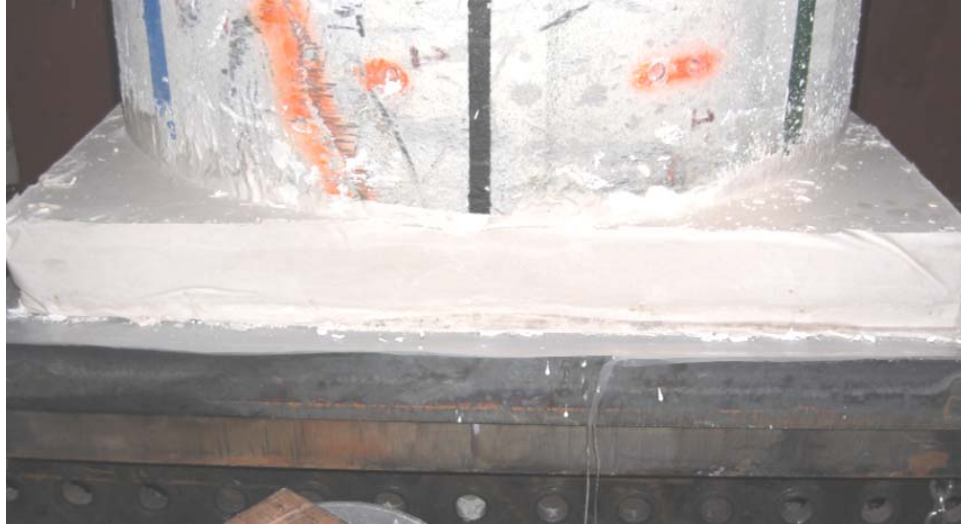
Figure 6. Bottom column cap (thickness between bottom of column and steel plate 2in.)

A small batch of 25% water to plaster ratio was used to fill in the bottom of the column where there was a large piece of concrete missing from the center due to the cutting off of the top and bottom of the columns to achieve the exact height of the 12 ft high columns. This was done to avoid an air pocket forming when the base was poured and the column was in the vertical position. Once the plaster hardened, the top bracing was removed and the column stood vertical on its own base as shown in Figure 6. The steel collar used to lift and hold the column was then loosened and raised to make a form to cast the top cap. All gaps around the steel collar were filled with silicon and the top cap was subsequently cast. The thickness of the top and bottom caps was limited 2 in.

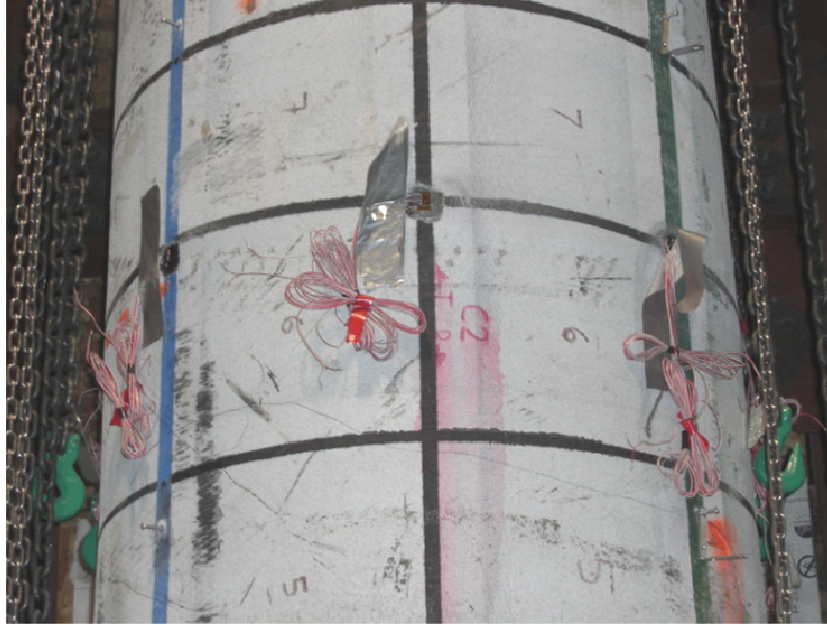
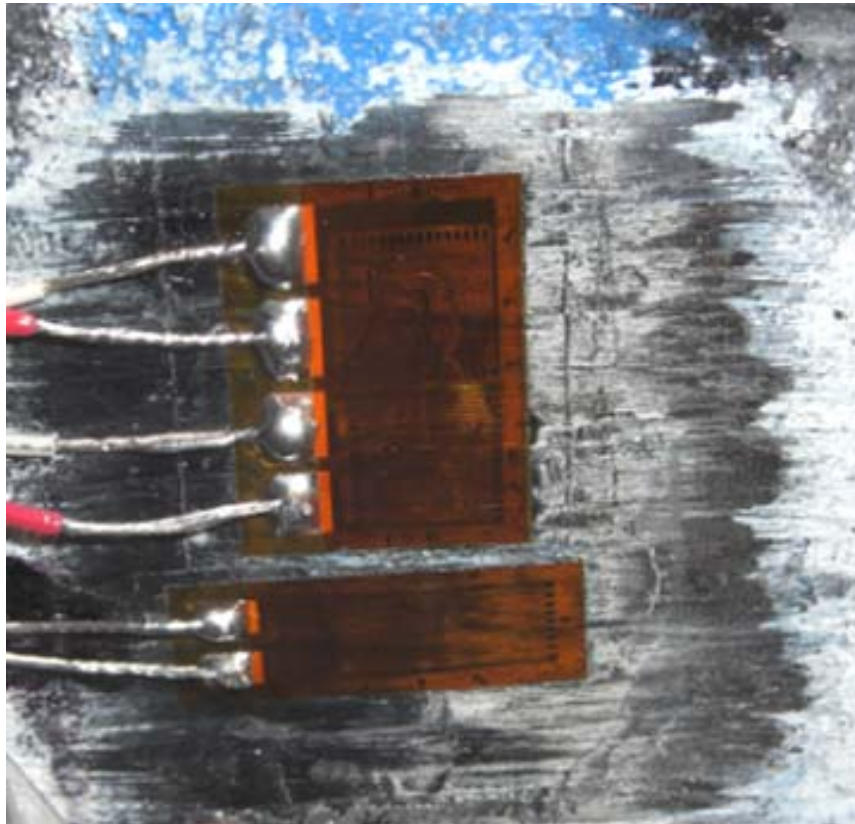
Figures 7. Strain gauge arrangement and close up of strain gauges

After the plaster caps were cast, a total of 24 electrical strain gauges were placed around the column perimeter in the hoop direction at mid height and at eight locations (every 45 degrees). At each 45 degree location, two strain gauges were placed to measure radial strain while one gauge was attached to measure vertical strain as shown in Figure 7. Four Linear Variable Differential Transducers (LVDTs) will also be placed every 90 degrees around the column perimeter and span a vertical distance of 2 ft, centered around the column mid height, to measure axial strains. A diagram showing the arrangement of the electrical strain gauges that will be used to measure hoop strain and the four LVDTs that will be used to measure axial strain is provided in Figure 8.

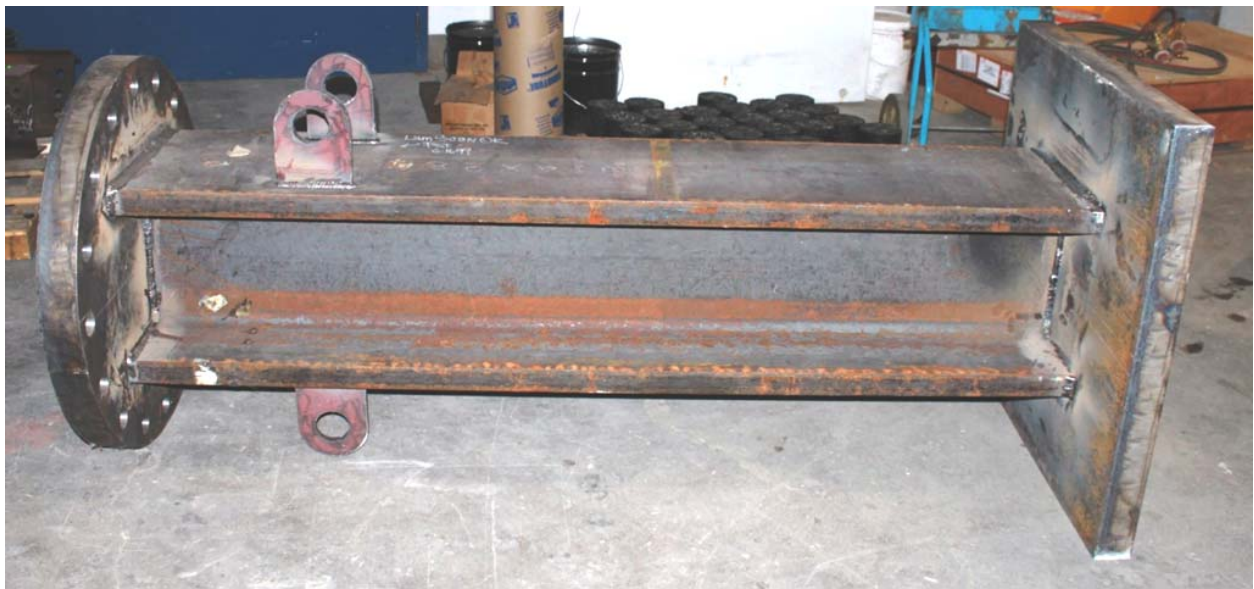
Figure 9. Column connector to actuator (W 14 x 283 steel column)

A W 14 x 283 steel column was cut to length and designed to connect to the actuator to apply the force to the top of the columns as shown in Figure 9. This W 14 x 283 steel column was 6 ft- 6 in. long, and it was restrained in the frame with 6 in. square tubing to avoid the possibility of bending the actuator rod during the eccentric load test as shown in Figure 10. Steel plates measuring 1 in. thick, will be used to achieve various eccentricities; two of the steel plates are 6in. wide and the other two 12 in. wide. The plates will be placed in-between the two 40 in. by 40 in. by 3 in. thick plates that are located at the base of the load frame, shown in Figure 6. All plates will remain in during the centric load test, but for eccentric loading the plates on one side can be slid out. Having multiple plates will make it possible to test different eccentricities one right after the other. It is anticipated that the two full-scale columns, 3 ft diameter and 12 ft high, will be tested in May 2010 in the configuration shown in Figure 11.

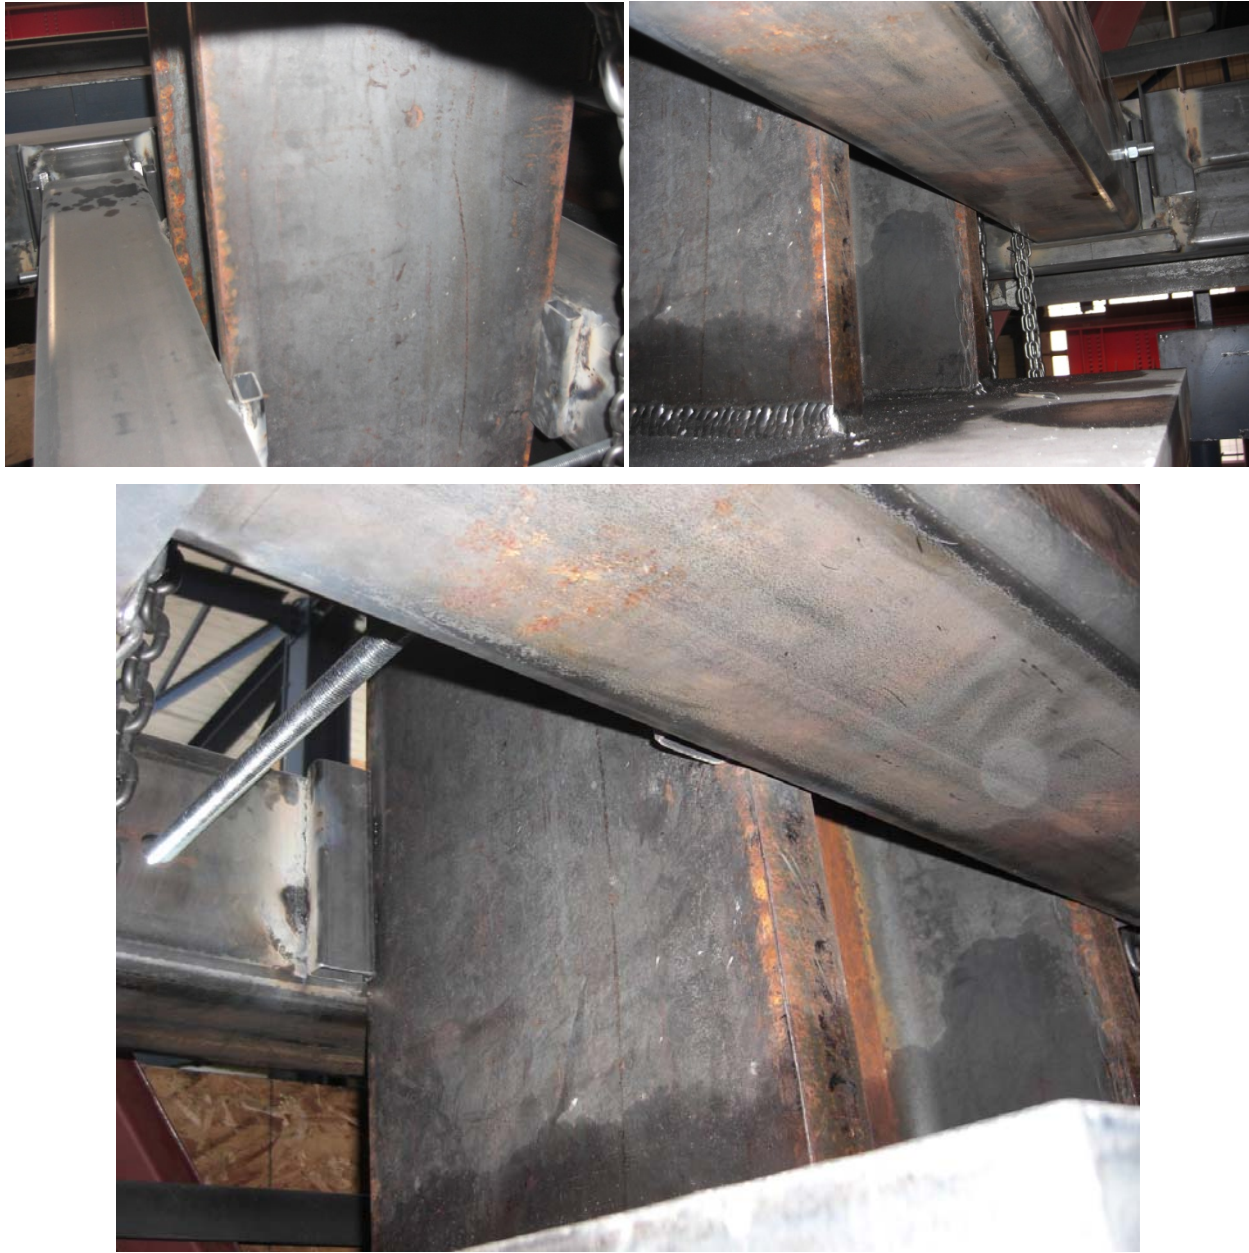
Figure 10. Restraining system for column connector to actuator

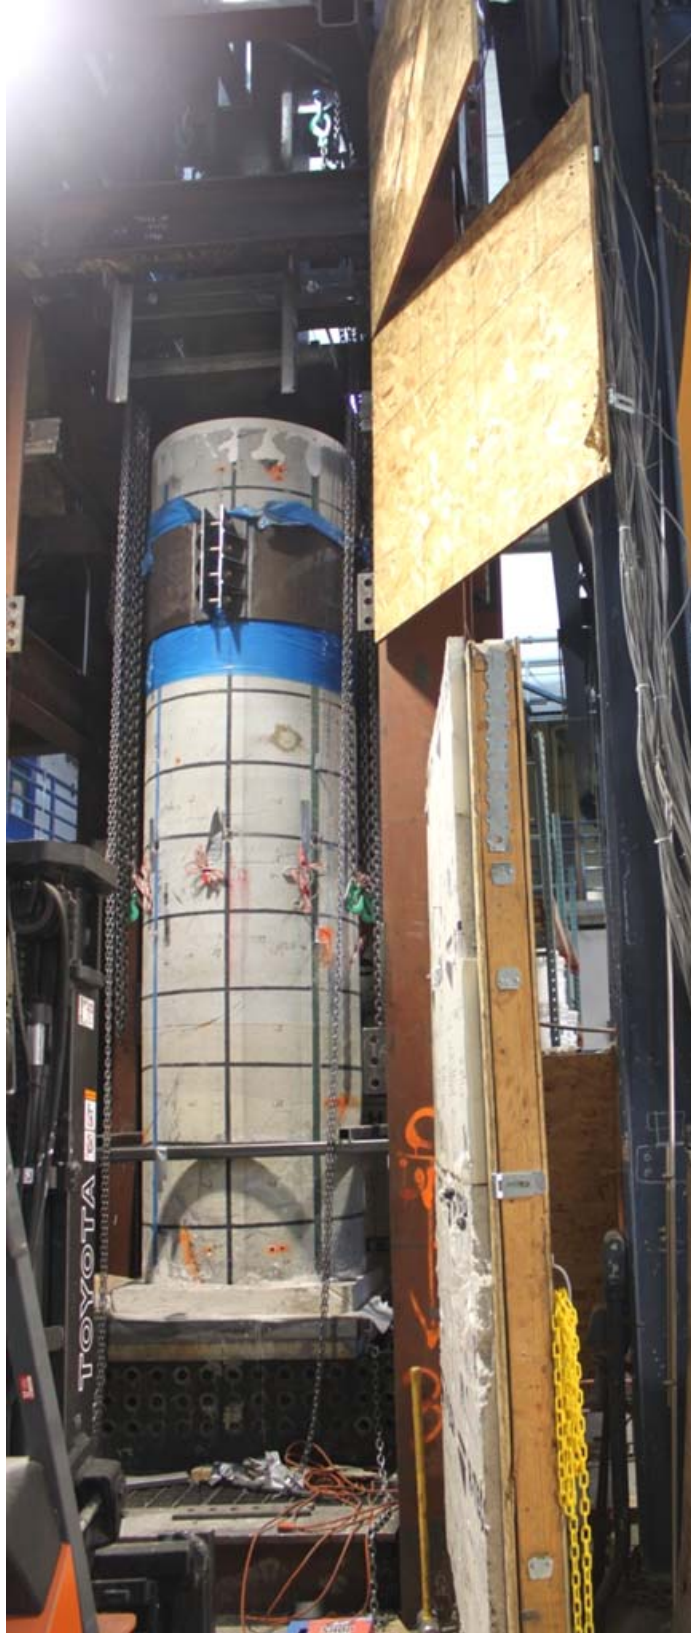
Figure 11. Test setup for the 12 ft high – 3 ft diameter columns
