Project Description:

The main objective of this proposed research is to *provide state DOTs a practical and cost-effective long-term fatigue crack monitoring methodology using a **wireless elastomeric skin sensor network***. This research is intended to demonstrate the value-added of fatigue crack monitoring of steel bridges using wireless skin sensors over the traditional bridge inspection.

Part 1: Crack detection using the SEC sensor

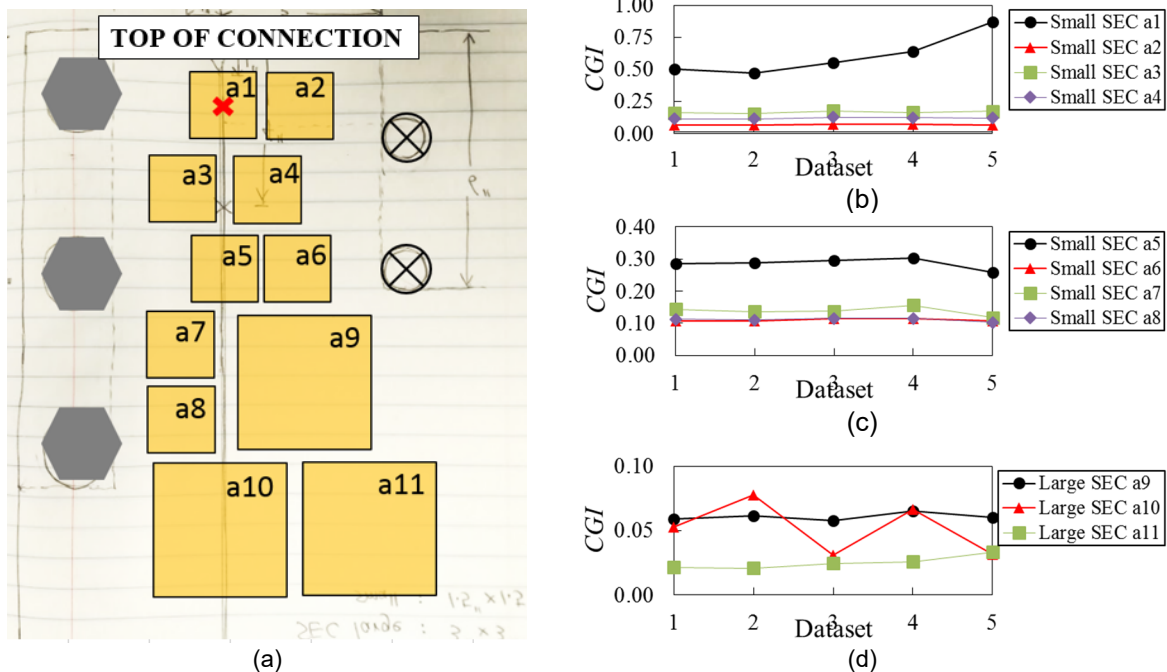
After taking all five dataset in table 1, the crack monitoring algorithm was applied to compute the CGI. Fig. 6 shows CGIs of all SEC's measurement at the top of the connection under varying load ranges. Several observations can be obtained from the figure:

- SEC a1 has the largest response which leads to the highest CGI (about 0.5) than any other SECs. This indicates that the small SEC at the very top of the connection can capture the fatigue crack. CGIs on other SECs show a decreasing trend when the sensor was deployed lower (i.e. far away) from the tip of the fatigue crack.

Fig. 6 CGIs from the SECs at the top of the connection

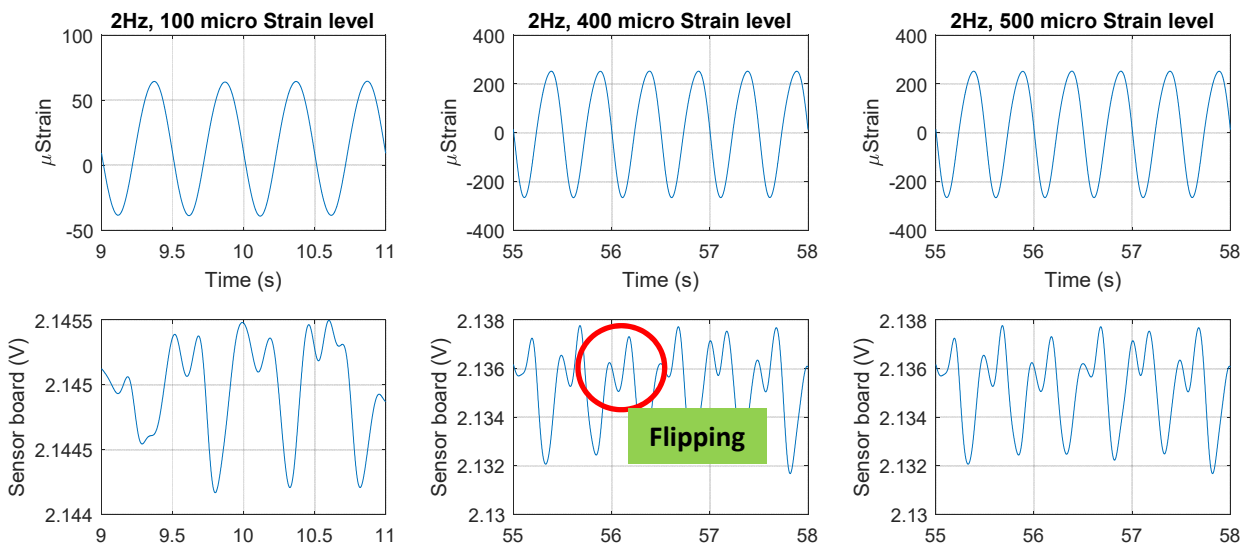
Unintended signal flipping has been observed under sinusoidal load during tests as shown in Fig. 7.

Fig. 7. Test result showing unintended flipping

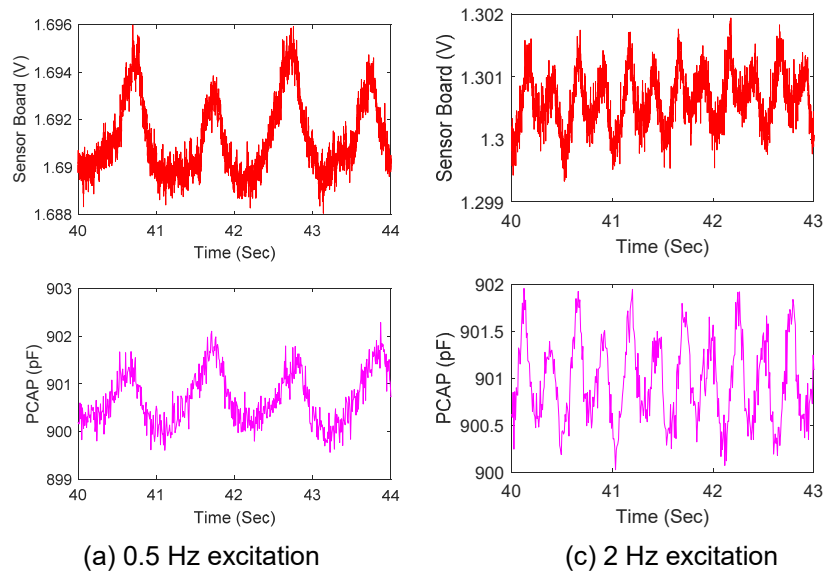
Fig. 9 Comparison test result: Sensor board measurement (top row) vs. PCAP measurement (bottom row)

Fig. 3 shows the comparison test results under 0.5Hz and 2Hz sine excitations. Results show similar signal shapes from both the sensor board and PCAP. Both signals include another unintended frequency components leading to twice of the original excitation frequency. Comparison test results confirmed that flipping is not from the sensor board but reflects actual capacitance variation. Further investigation may be required, but possible sources of such flipping signal may be due to bending buckling of the plate under the test setup.

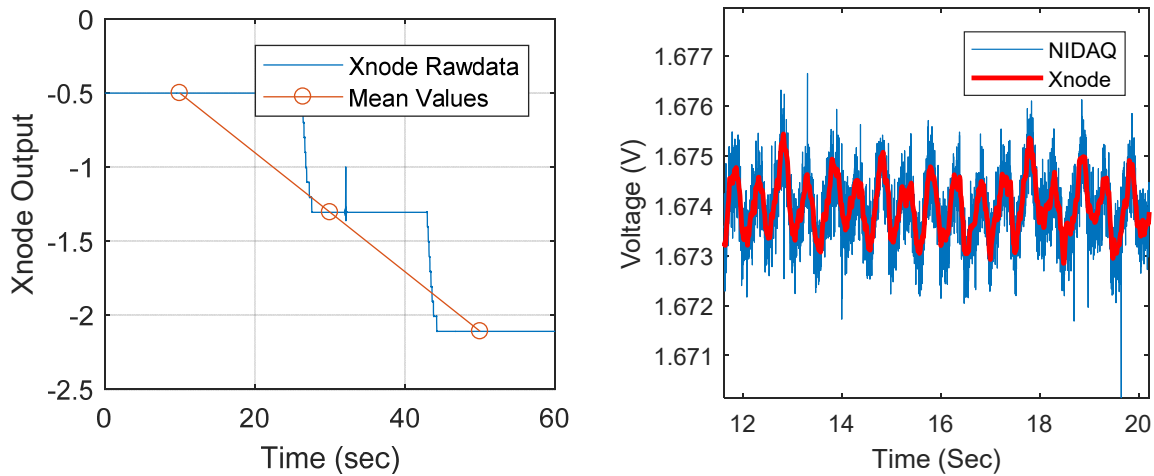
(a) Calibration test result; (b) Comparison with NIDAQ measurement
 Fig. 10 Xnode Calibration and comparison test result

Fig. 10(a) shows the calibration test done by changing the voltage supply as 0.5V-1.3V-2.1V for each 20 sec. The calculated calibration factor was -1 using averaged values of each steps and a linear relationship is observed. Fig. 10(b) shows the comparison test result between NIDAQ and Xnode. They show good agreement. The noise content from NIDAQ is due to the high sampling frequency. Sampling frequency of NIDAQ was 1kHz but, while Xnode was sampling at 100Hz.
