TRANSPORTATION POOLED FUND PROGRAM QUARTERLY PROGRESS REPORT

Transportation Pooled Fund Program Project # TPF-5(189)			XQuarter 1 (Januar □ Quarter 2 (April 1	<mark>y 1 – March 3</mark> – June 30)	
			□Quarter 3 (July 1 -		,
Project Title:					
"Enhancement of Wel	ded Steel Bridge Girder	s Suscepti	ible to Distortion-Induced	Fatigue"	
Project Manager:		Phone: E-mail			
John Jones, KDOT		785-368-7175		iones@ksdot.org	
Project Investigator:	Caroline Bennett Adolfo Matamoros Stan Rolfe Ron Barrett-Gonzalez	Phone:	785-864-3235 785-864-3761 785-864-3767 785-864-2226	E-mail:	crb@ku.edu abm@ku.edu srolfe@ku.edu barrettr@ku.edu
Lead Agency Project ID:		Other Project ID (i.e., contract #): KAN00063732		08/31/2008	
Original Project End Date: 08/31/2011		Current Project End Date: 08/31/2013		Number of 1	Extensions:
Project schedule status	~ .				
☐ On schedule	X On revised sched	ule	☐ Ahead of sch	edule	☐ Behind schedule
Overall Project Statistic	os:				
Total Proje	ct Budget	Total (Cost to Date for Project	Total Pe	rcentage of Work

A large number of steel bridges within the national inventory are affected by distortion-induced fatigue cracks. Repairs for this type of failure can be very co

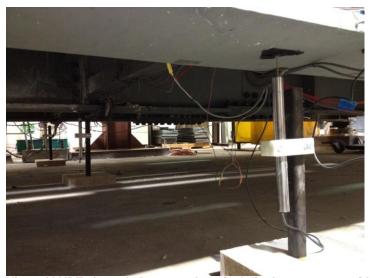
Fig. 3: View of LVDTs intended to record vertical displacements at mid-span

In addition to the instrumentation already described, 9 LVDTs have been placed on the bridge to record displacements. Each exterior girder contains similar LVDT placement as seen in the 9 ft. girder set-up to establish a displacement profile. As the bridge deflects, it is expected that the bottom of the girder will also displace laterally. This displacement will be captured using the three LVDTs placed on the exterior girders, spaced along the depth of the girders. Additionally, vertical girder displacements are of interest; many attempts to quantify distortion-induced fatigue have been correlated to differential displacements between girders. Due to this, vertical girder displacements of the bottom flanges at midspan will be measured and recorded with 3 LVDTs (one for each girder), as shown in Fig. 3.

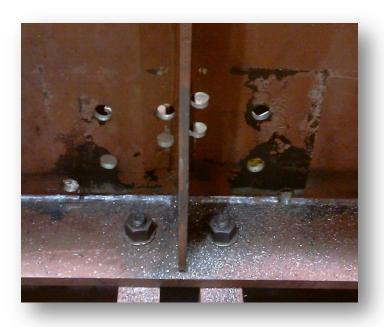
Crack-Arrest Holes

- ³/₄-in. dia. crack-arrest holes drilled at tips of cracks in bottom and top web gaps.
- 4-in. horseshoe-shaped crack grew 2.75 in. over 39,700 cycles after retrofit.

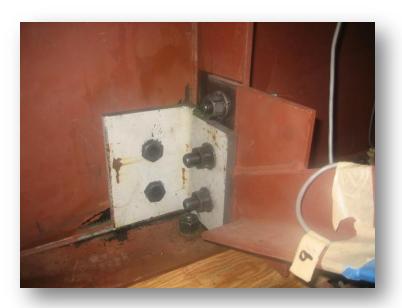
Web-to-Stiffener Angles with Backing Plate

• Retrofit was first applied in bottom web gap_{test} and later applied in the top web gap_{test} .

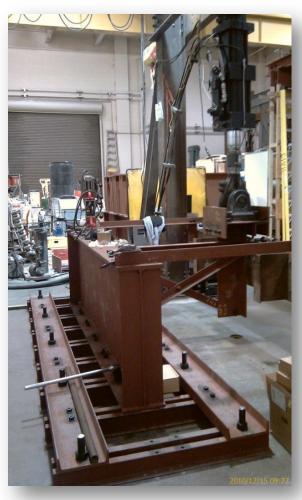
Web-to-Stiffener Angles with Backing Plate

Dimensions

- Fourteen girders
- I 12-in. long
- $34.5 \times 3/8$ in. web
- I in. thick top flange
- 0.625 in. thick bottom flange

- Max Load = 4.6 K
- Min Load = 0.8 K

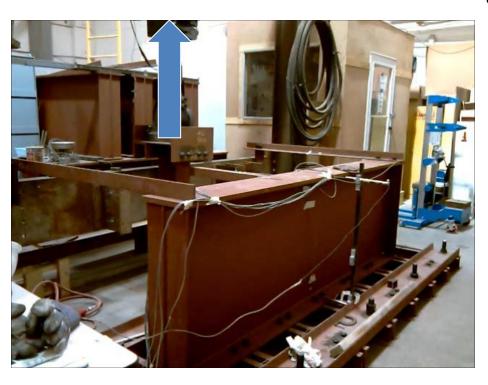
Web-to-Stiffener Angles with Backing Plate

- Test set-up considerations:
 - Lab concrete strong floor acting as the "concrete bridge deck"
 - Loading is applied vertically upward at the cross-frame to simulate differential deflection between adjacent girders

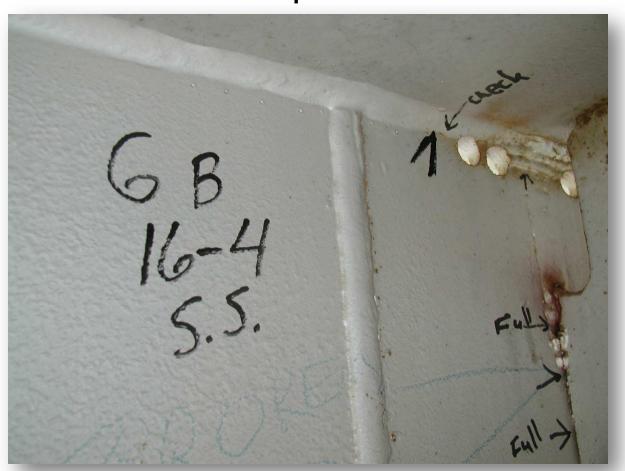
- PICK Tool
 - The need for crack-stop hole treatment

Problem:

Crack-stop holes are often not effective in halting crack propagation between inspection cycles
