# TRANSPORTATION POOLED FUND PROGRAM QUARTERLY PROGRESS REPORT

The objective of this research project is to quantify the redundancy possessed by built-up members. For example, a riveted built-up member will not typically "fail" if one of the components fractures. However, there is very little experimental data which is available to quantify the remaining fatigue life or strength of a member in which one of the components has failed. Furthermore, if built-up members are located in bridges classified as fracture critical, when significant member redundancy can be shown the bridge may not need to be classified as FC. However, doing so would release these members from the more rigorous arms-length inspection currently required. As a result, should a component fail, it may go undetected for an extended interval. Thus, a portion of the project is devoted to setting rational inspection intervals for these members. Lastly, the advantages of using built-up members fabricated with HPS components fastened using HS bolts in new construction will also be explored.

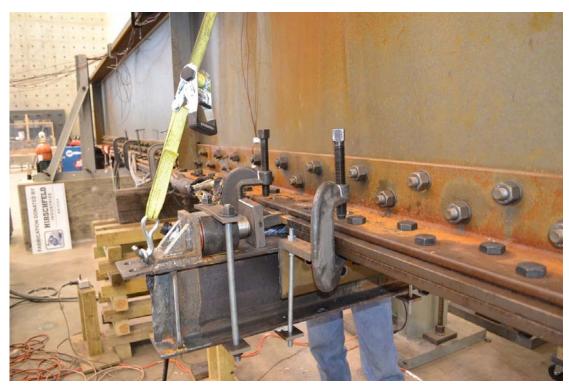
Figure 1: Specimen 36-2 with wedge driven into fractured upper cover plate

- After attempted fracture of bottom cover plate of Specimen 36-2 and subsequent fatigue test (with run-out value of 20,000,000 cycles at a stress range of 6.5ksi in the 'failed' condition, the upper cover plate was partially dismantled, notched, and then fractured (see Figure 1). At this stage of the test both cover plates were completely failed, and the resulting load to the girder was near the remaining net section yield stress. This fracture of the upper cover plate did not propagate into the flange angles or the web.
- In-house fabrication of new 36 inch deep girder specimen.
- In-house fabrication of new 30 inch deep girder specimen (see Figure 2).
- In-house fabrication of new flange angles, and cover plates for 3 new specimens.

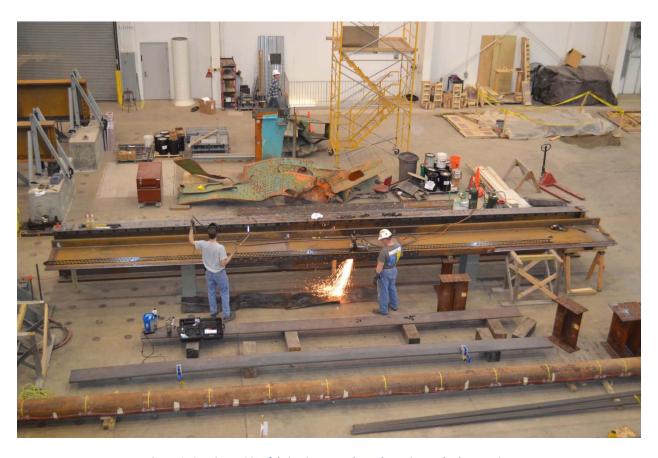
Figure 2: Specimen 30-1 fabrication – track torch cutting web plate to size

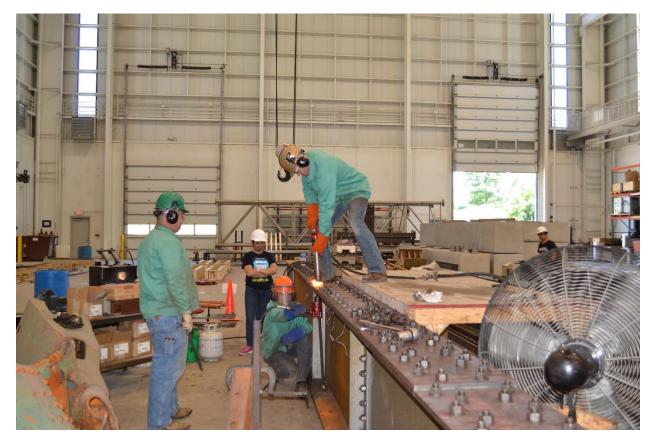
Figure 3: Specimen 36-3 fabriction - riveting cover plates to flange angles

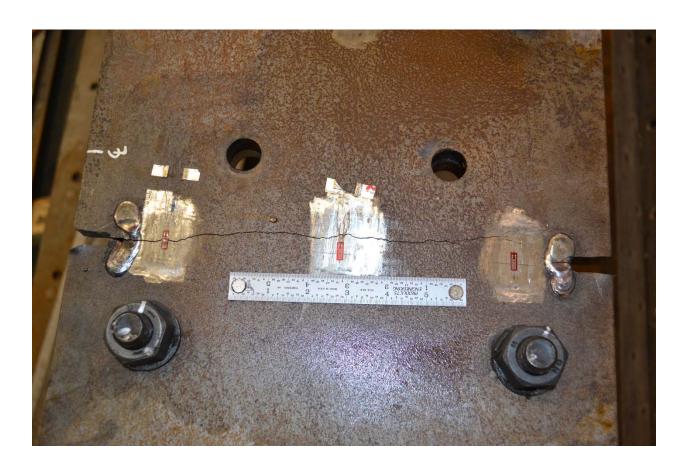
Figure 4: Fractured cover plate of specimen 46-4

Continued fatigue cycles on specimen 46-4 at stress range of 6.5ksi in the 'failed' state (with bottom cover plate fractured). Specimen reached runout value of 20,000,000 cycles with no cracks found in any other components (both flange angles, and web plate). See
