TRANSPORTATION POOLED FUND PROGRAM **QUARTERLY PROGRESS REPORT**

Project Description:

- 1) To develop AASHTO ready specifications for the evaluation of the effects of pack-out corrosion in built-up steel tension, compression, and flexural members.
- 2) Provide guidance on the need for repairs and corrosion rates that can be expected in various environments in order to assist owners in programming when repairs may need to be made.
- 3) Identify the most effective methods of repairs and provide suggesting verbiage that could be used when preparing special provisions for repairs.
- 4) Develop several case-study examples, including calculations that will be used for training users on the methodologies to be developed. It is anticipated that the research team will host a number of webinars or on-site training sessions to ensure technology transfer and implementation.

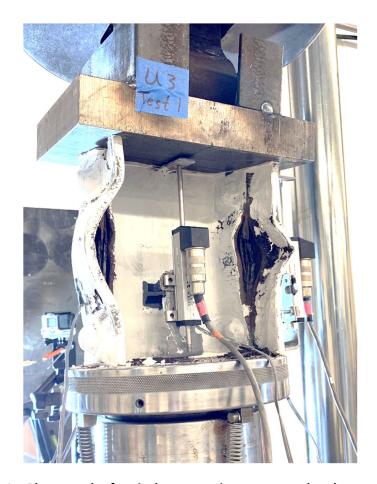
Figure 1 – Photograph of typical compression test on stub-column section.

Note light shining through the areas where the corrosion has completely eaten away the cover plate and presence of loose pack-out corrosion product.

- The tests on small portions of members with real pack out corrosion is completed and data are being reviewed and used to calibrated FEA simulations. These specimens were subjected to compression loading to evaluate the effect of section loss and distortion on local buckling. A typical specimen with severe section loss is shown in Figure 1. These data will be used along with the data from the compression flange girder tests to begin to develop strategies to evaluate the effects of pack-out on the capacity of compression members.

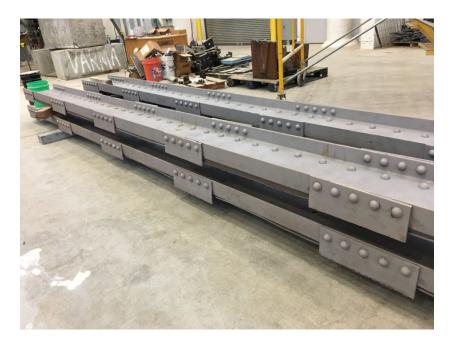
Figure 2 - Members ready for shipping to fabricator after sandblasting.

A web and top flange will be added so these former lower chords can be loaded in flexure.

- Obtained quotes for fabrication of four girders built from truss members with real pack-out. The lowest bidder was
 selected and the girders should be available for testing in mid-February. The specimens were sandblasted per
 the request of the fabricators (See figure 2), however care was taken to ensure the pack-out corrosion produce
 was not removed.
