## **Dynamic Passive Pressure on Abutments and Pile Caps**

### **Quarterly Report May 2007 - July 2007**

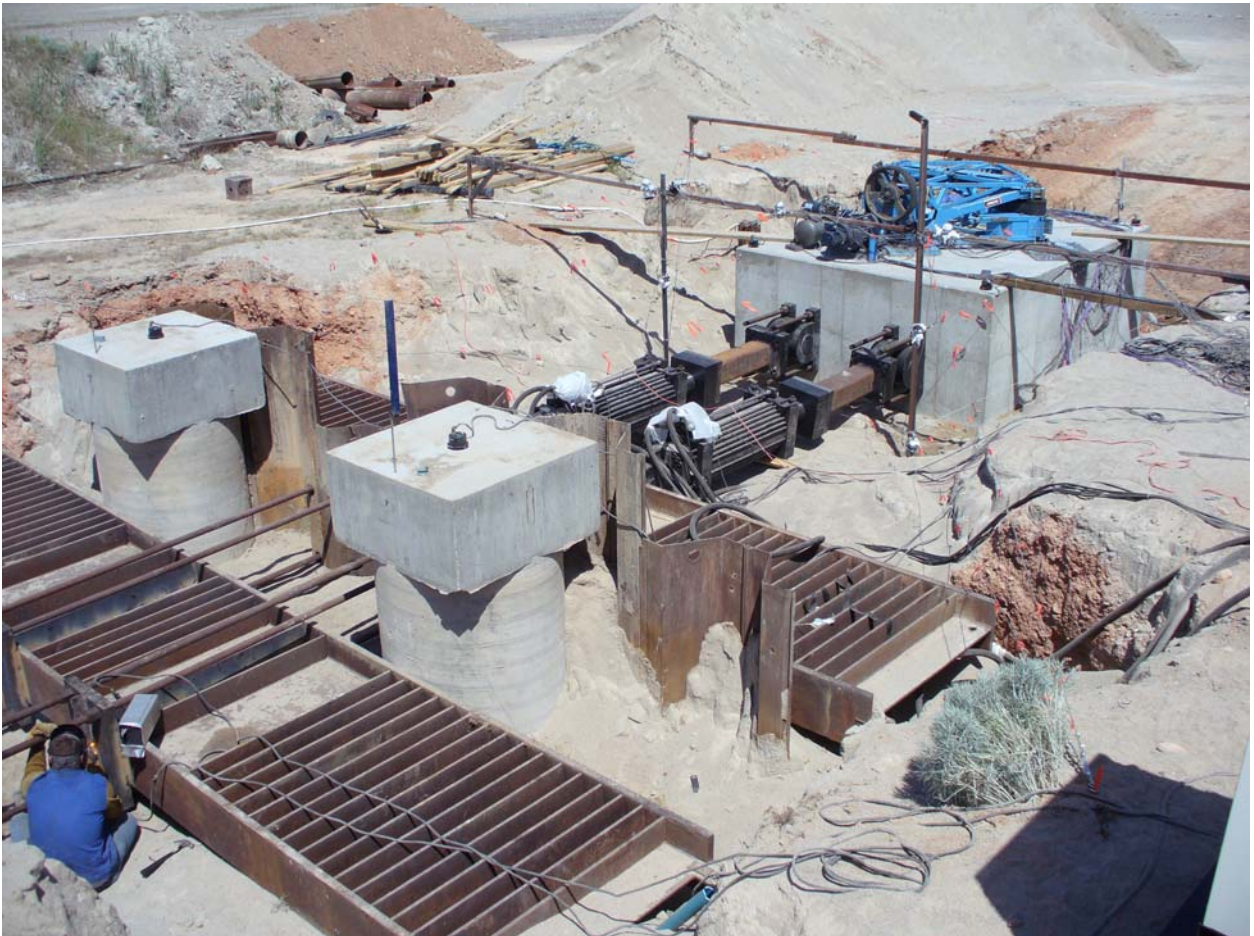
Fig. 1. Looking northwest at test site with reaction foundation (foreground), two 600 kip hydraulic actuators, and eccentric-mass shaker (blue device in background) mounted to test pile cap

The test pile cap with dimensions of 4.57m x 3.35m x 1.68m (length x width x height) was constructed and a sheet pile wall was installed to increase the reaction capacity of the two existing 1.22 m diameter drilled shafts. Test equipment from BYU and the NEES@ucla equipment site were mobilized and installed at the field test site. Static cyclic and dynamic load tests were completed for the four following backfill configurations: (1) no backfill against pile cap, (2) 0.9m of granular roadbase against cap with remaining backfill consisting of loose sand, (3) 1.8m of granular roadbase against cap with remaining backfill consisting of loose sand, and (4) an MSE wall section in place of a full-width sand backfill. These tests are complemented by other tests completed as part of a NSF/NEES project which included tests with the following backfill configuration: (1) full-width dense sand backfill, (2) full-width loose sand backfill, (3) full-width dense road-base backfill, (4) full-width loose road-base backfill, (5) full-width dense gravel backfill and (6) full-width loose gravel backfill. Photos of the test pile cap and loading system are provided in Figures 1 through 3.

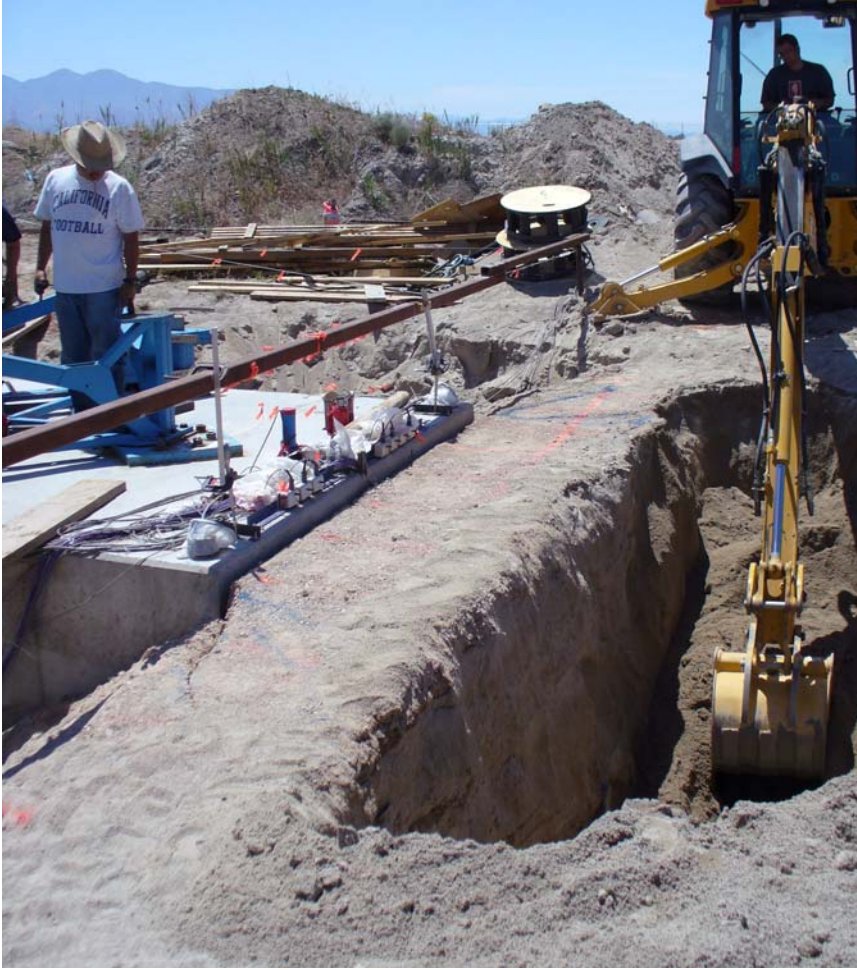
Fig. 2. 0.9m wide granular backfill zone adjacent to test cap during removal of loose sand backfill

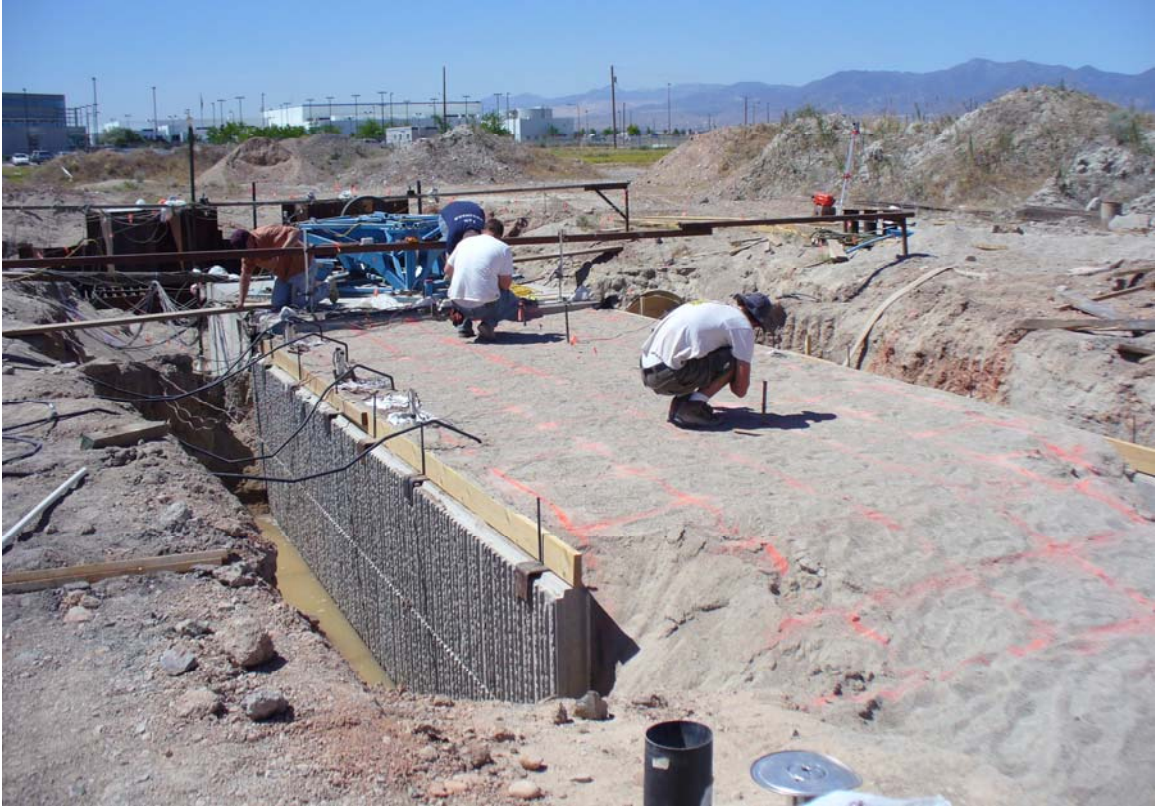
Fig 3. Looking south at MSE wall section with test pile cap and eccentric-mass shaker in background
