The Tire-Noise Performance of Montana Highway Pavements: On-Board Sound Intensity (OBSI) Measurements

The Montana Department of Transportation,
Helena, MT

ILLINGWORTH & RODKIN, INC.
/// Acoustics • Air Quality ///

505 Petaluma Boulevard South
Petaluma, California 94952
July 30, 2010

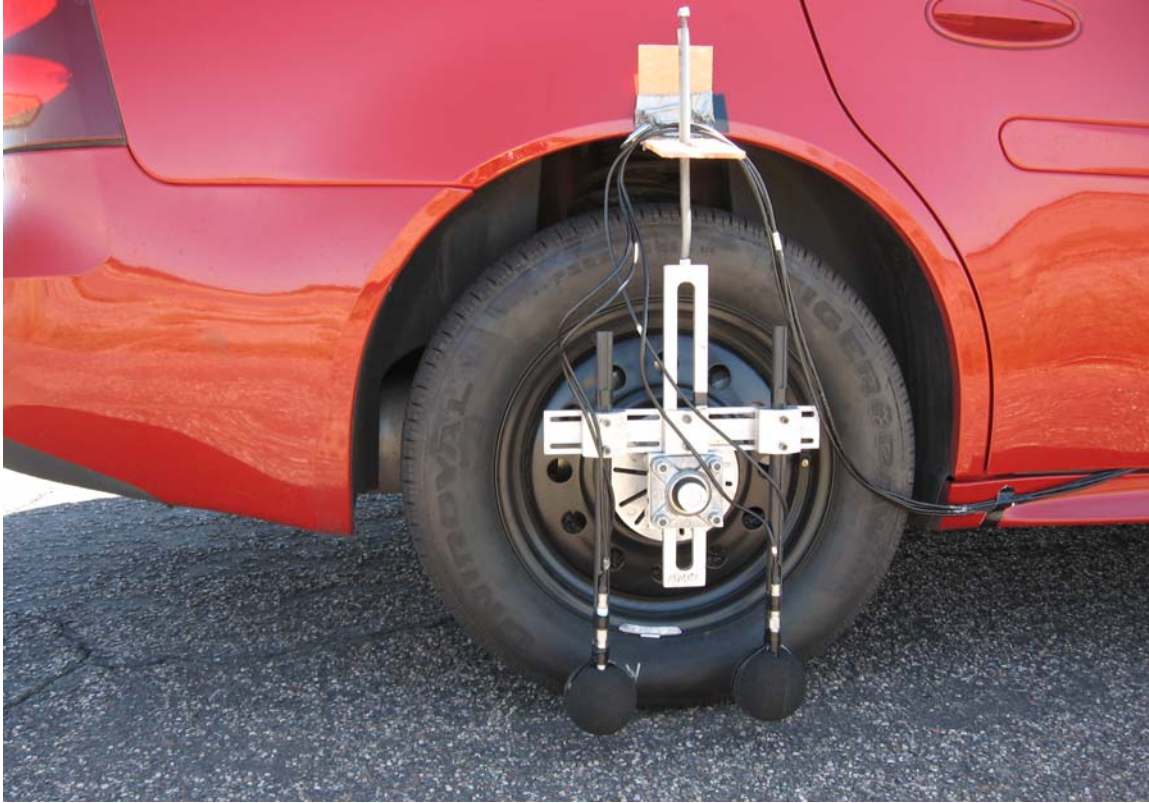
Figure 1. OBSI Equipment Installed on a Test Vehicle

On-vehicle OBSI testing is conducted following the provisional American Association of State Highway and Transportation Officials (AASHTO) Standard Method of Test TP 76-10. To accomplish this, a dual-probe sound intensity fixture with attached microphones is used. This fixture assembly is connected to and supported by the test vehicle in free space, allowing for measurement positions close to the leading and trailing edges of the tire contact patch. The dual-probe sound intensity fixture allows the leading and trailing edge positions to be measured simultaneously. Each probe consists of two ½" G.R.A.S phased-matched condenser microphones, installed on ½" G.R.A.S 26AK microphone preamplifiers, attached to a plastic probe holder at a spacing of 0.63 inches (16 mm) in a side-by-side configuration, and fitted with spherical windscreens. The probe is positioned 3 inches (75 mm) from the pavement surface and 4 inches (100 mm) from the face of the tire, at locations opposite the leading and trailing contact patch of the tire. The orientation is such that the sensitive axis is directed toward the tire. See Figure 1 for a picture of the setup as installed on the vehicle. Data from the leading and trailing edge positions are acquired separately for the same section of pavement and averaged together during post-analysis. Three or more passes are made for each test section, which are averaged together during post-analysis. Multiple sections on a site are selected and measured, assuming the length of the test site allowed for multiple measurements. During post-analysis, all measurements for the same pavement section are averaged together, resulting in an average OBSI level per site. In situations where more than one pavement type is identified along a site, each pavement was measured and documented separately.

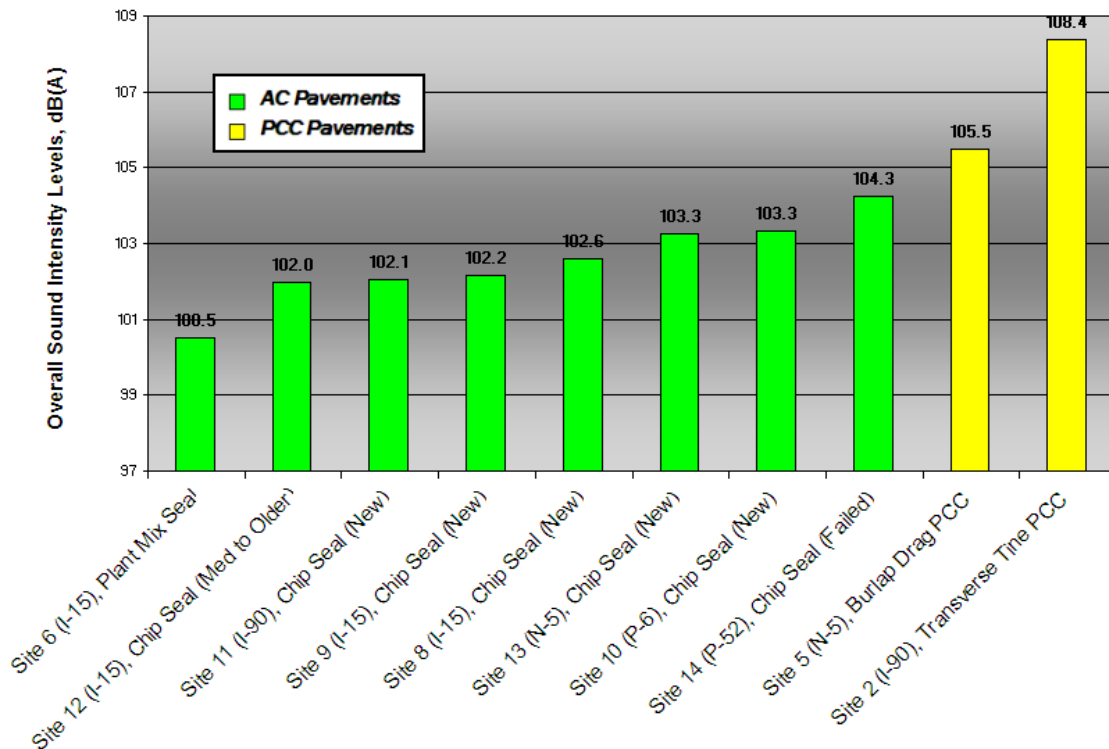
Figure 4. A-Weighted Tire/Pavement Sound Intensity Levels

Table 2 shows a summary of the test sites and the resultant overall A-weighted sound intensity levels for each site. Averages, by pavement type, are also summarized in Table 2. A comparison of the overall A-weighted sound intensity levels for each test site is shown in Figure 4.

As indicated in Table 2 and Figure 4, the PCC sections were, on average, 6.4 dBA higher than the Plant Mix section and 4.1 dBA higher than the Chip Seal sections. The transverse tine PCC segment along Site 2 (I-90) resulted in the highest overall level of 108.4 dBA. The highest AC pavement was the Failed Chip Seal measured at Site 14 (P-52), which had an overall noise level of 104.3 dBA; however, this level was only 1 dBA greater than the overall noise level measured on the New Chip Seal pavement at Site 10 (P-6).

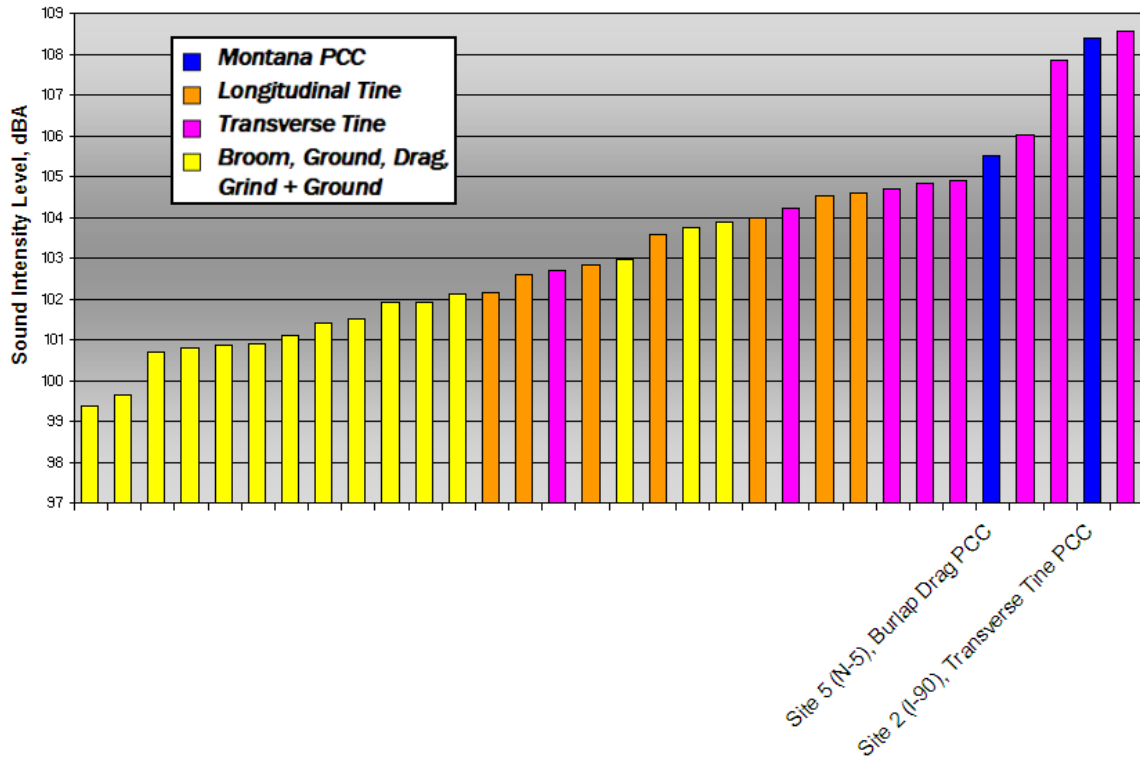
Figure 5. Overall A-Weighted OBSI Levels for PCC Pavements, 60 mph

Figures 5 and 6 show comparisons of the resulting overall A-Weighted sound intensity noise levels of the Montana sites compared with other PCC and AC pavements in California, Arizona, Ohio, Iowa, Kansas, Minnesota, and Alabama. All data shown was measured at 60 mph using the SRTT test tire. The Montana test sites are indicated in blue.

From Figure 5, the broom, ground, and drag PCC pavements from each state shown result in the lower overall noise levels. Longitudinal tine PCC make up the mid-range of the pavements, and transverse tine PCC pavements produce the upper-range shown in Figure 5. The transverse tine PCC pavement from Montana test Site 2 (I-90) produced one of the highest levels and was virtually identical to the transverse tine PCC located along I-70 in Ohio. As shown above, Site 2 (I-90) and Site 5 (N-5) have overall levels of 108.4 dBA and 105.5 dBA, respectively. According to the state of Montana Department of Transportation (MDT) specifications, concrete pavement textures are to be random spaced transverse tine followed by a burlap drag finish. The Site 5 (N-5) segment, which was laid in 2000, would be consistent with this specification; however, the older Site 2 (I-90), which was laid in 1976, was laid prior to the specification update and follows the guidelines for the original specification of regular transverse tine PCC. However, given the state-wide usage of studded snow tires in Montana, the original texturing has likely little bearing on the current pavement texture. Experience in Washington State, which also allows the use of studded snow tires, is that applied texture is typically lost within 2 to 4 years². This is further evidenced by the photograph in Figure A-1d of the Appendix that displays no evidence of the original transverse tining. Although not photographically documented, it is suspected that the Site 5 (N-5) surface has also lost its original burlap drag texture based on the WSDOT experience. Burlap drag textured PCC surface are typically more in the range of 100 to 102 dBA, with a highest level of 103.7 dBA measured on an older section of the roadway in California. The levels at Site 5 (N-5) are actually more in the range of those that have been measured on SR 520 in Seattle that

was also a stud-damaged surface devoid of its original texture. This surface produced levels in the range from 106.1 to 106.9 dBA. In considering the performance of the PCC at Site 2 (I-90) and Site 5 (N-5), these probably should not be considered to be representative of the texturing by which they are identified, but rather as unique to them.

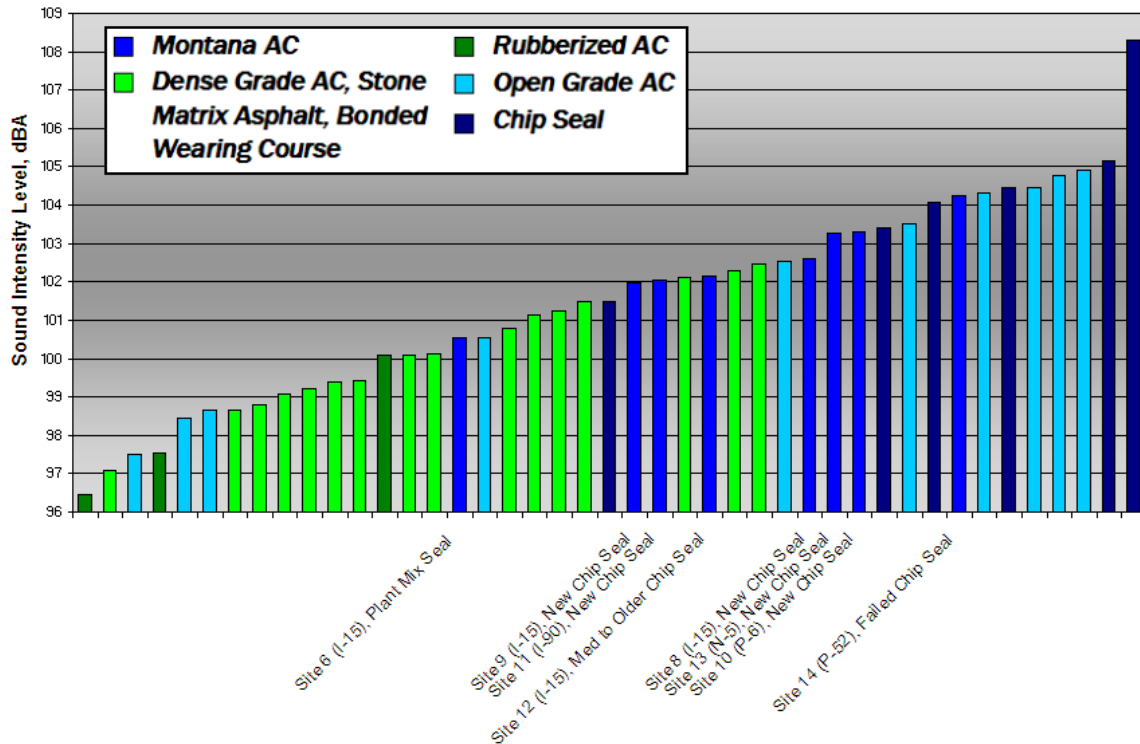
Figure 6. Overall A-Weighted OBSI Levels for AC Pavements, 60 mph

In general, the RAC and DGAC pavements yield overall noise levels in the lower range of all AC pavements shown in Figure 6. The mid- to upper range of overall noise levels consists of Chip Seal pavements. The New Chip Seal and Medium to Older Chip Seal pavement segments in Montana fell into the lower range of Chip Seals shown in Figure 6. The overall noise levels range from 102.0 to 103.3 dBA, which was about the same as the Chip Seal pavement measured at the General Motors Mesa Proving Ground in Arizona. The Failed Chip Seal pavement at Site 14 (P-52) measured an overall noise level of 104.3 dBA. This measurement was louder than the Chip Seal pavement at the Hyundai-Kia Test Track in California, which was 104.1 dBA, and quieter than the Chip Seal pavement along SR 521 in Ohio, which was 104.4 dBA. The Plant Mix Seal falls approximately in the middle of the DGAC pavements and is about 2.0 dBA lower in level than the average of the Chip Seal pavements.

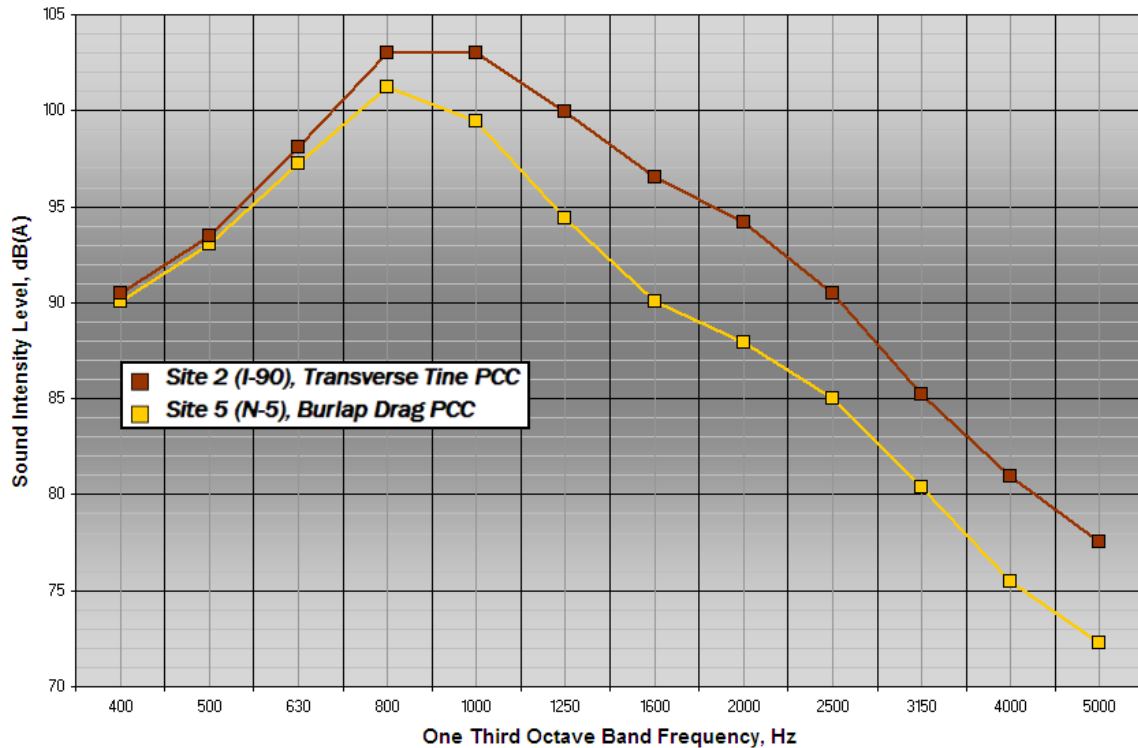
Figure 7. One-Third Octave Band Levels for Concrete Pavements

Figure 7 shows the spectra for both of the PCC pavements measured at sites Site 5 (N-5) and Site 2 (I-90). As shown by the overall levels above, the PCC pavements were, on average, higher than the Chip Seal pavements by approximately 4.1 dBA. The segment for Site 5 (N-5) shows similarities to Site 2 (I-90) in the lower frequency range but has significantly lower levels at frequencies above 800 Hz. In these frequencies, both pavements are about 10 dB higher in level than typical burlap drag or ground surfaces reinforcing the conclusion that stud/chain damage and the resultant increase in surface roughness is a major factor in the performance of these pavements. Above 800 Hz, the levels for Site 2 (I-90) become 3 to 6 dB higher than Site 5 (N-5). The magnitude and range in the levels between these two pavements is similar to that observed for the range of pavements in the OBSI data base and maybe be due to the aging effects for the much older Site 2 (I-90) pavement.

9. At frequencies below 800 Hz, Site 2 (I-90) is an average 0.6 dBA higher than Site 5 (N-5), but at frequencies above 800 Hz, the average difference is 5 dBA. In comparison to other PCC surfaces, higher levels in the lower frequencies for both pavements is likely due to increased roughness, presumably due to studded snow tire and snow chain usage. The higher frequency differences may be due to the relative age of the two surfaces.

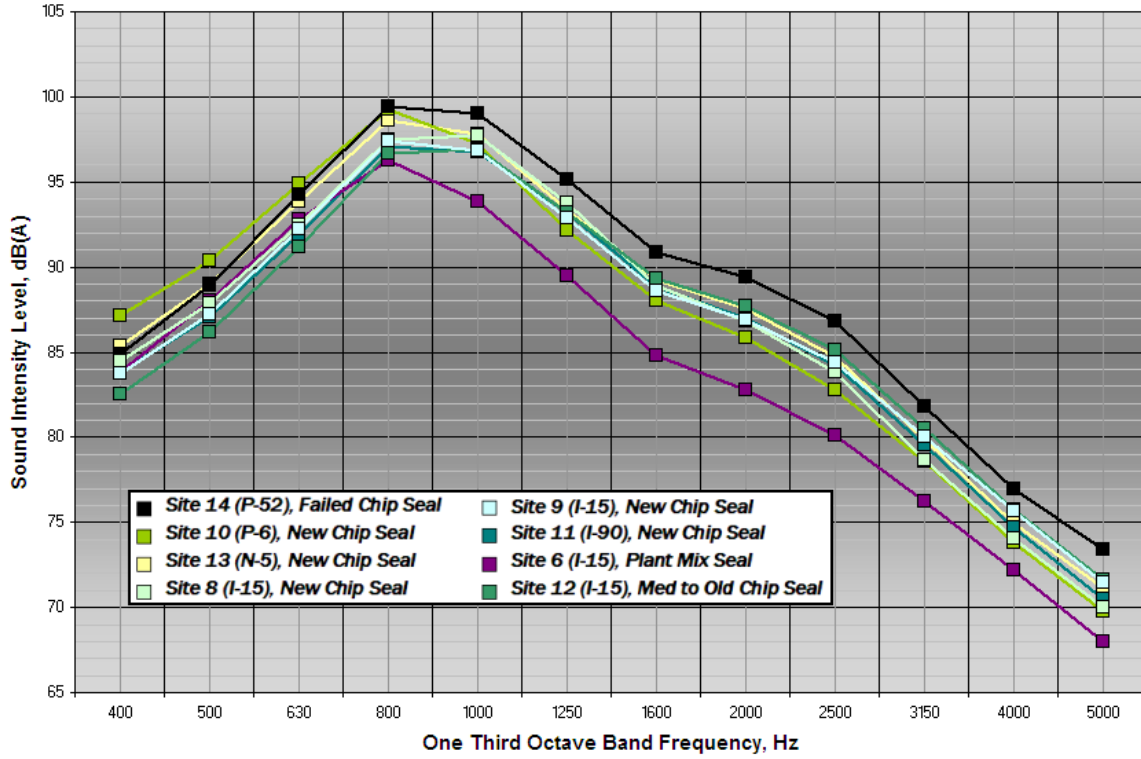
Figure 8. One-Third Octave Band Levels for AC Pavements

The spectra for all the chip seal AC pavements and the plant mix seal pavement are shown in Figure 8. The plant mix seal segment is in the low to mid-range of spectral levels at frequency bands below 800 Hz and is the quietest pavement at frequency bands above 800 Hz, averaging approximately 3.3 dBA quieter than the chip seal pavements. For each test segment with chip seal pavement, raised levels exist in the range from 800 to 1000 Hz. The peak levels are at 800 Hz for the following chip seal segments: Site 9 (I-15), Site 11 (I-90), Site 10 (P-6), and Site 14 (P-52). For the segments along Site 8 (I-15) and Site 12 (I-15), the peak levels are at 1000 Hz. The failed chip seal segment, which is Site 14 (P-52), is in the mid- to high range of spectra for frequency bands below 800 Hz, but above 800 Hz, Site 14 (P-52) shows the highest levels, averaging approximately 2.2 dBA higher than the other chip seal segments. The quietest segment at the lower frequencies is the medium to older chip seal pavement Site 12 (I-15). Site 12 (I-15) averages approximately 1.9 dBA quieter in this frequency range than the new chip seal pavements and is 2.7 dBA quieter than the failed chip seal. At the higher frequencies, however, Site 12 (I-15) is among the segments with the highest spectral levels, being an average 0.7 dBA higher than the new chip seal pavements and 1.6 dBA quieter than Site 14 (P-52). On average, the new chip seal segments fall within the mid-range of spectral levels throughout Figure 8. However, at the lower frequencies, Site 10 (P-6) and Site 13 (N-5) are slightly higher than the other new chip seal pavements, with a standard deviation of 1.2 dBA; at frequencies above 1000 Hz, all the new chip seal segments remain within 0.6 dBA of each other.

5. The plant mix seal, which is denoted as Site 6 (I-15), has spectral levels that fall within the lower to mid-range of AC pavements for frequencies below 800 Hz. Above 800 Hz, however, the plant mix seal averages approximately 3.6 dBA lower than all other AC segments.

6. On average, the new chip seal pavements are within the mid-range of spectral levels throughout the frequency band range. However, the standard deviation of 0.6 dBA at the frequency bands greater than 800 Hz is significantly better than the standard deviation of 1.2 dBA at the frequency bands below 800 Hz.

7. The spectrum for the medium to older chip seal pavement, as compared to the other AC segments, has the lowest levels for frequency bands less than 800 Hz. From 1250 Hz and greater, the medium to older chip seal pavement is among the highest segments.

8. For frequency bands less than 800 Hz, the failed chip seal segment, which is Site 14 (P-52), is in the mid- to upper spectral level range. Above 800 Hz, however, Site 14 (P-52) has the highest spectral levels, averaging approximately 2.2 dBA higher than the other chip seal segments.

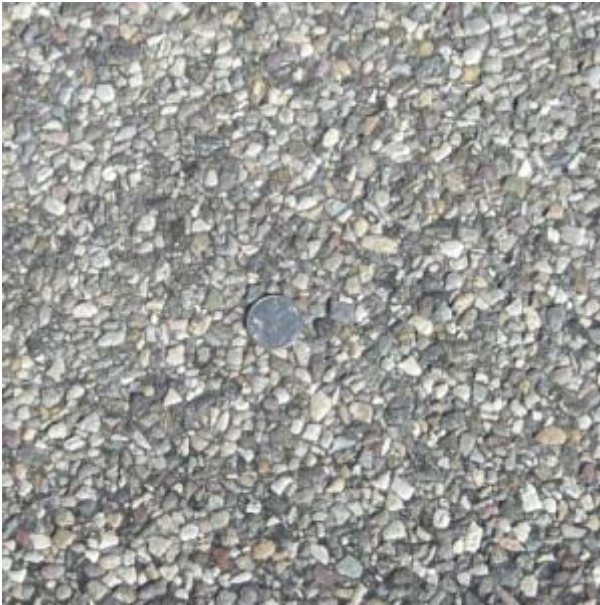
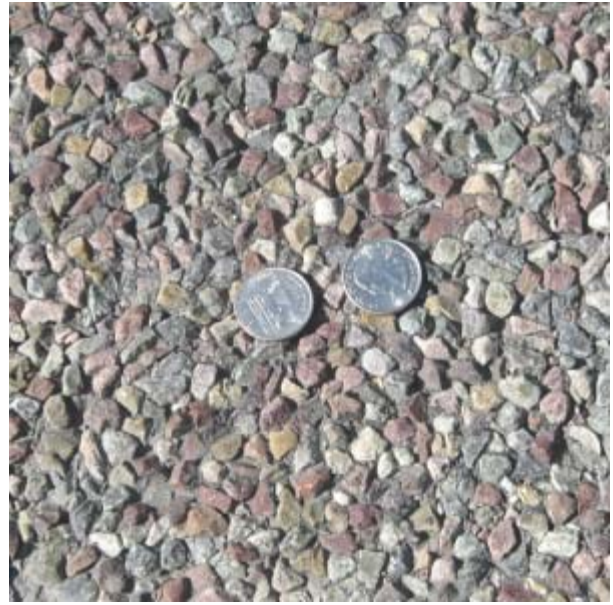
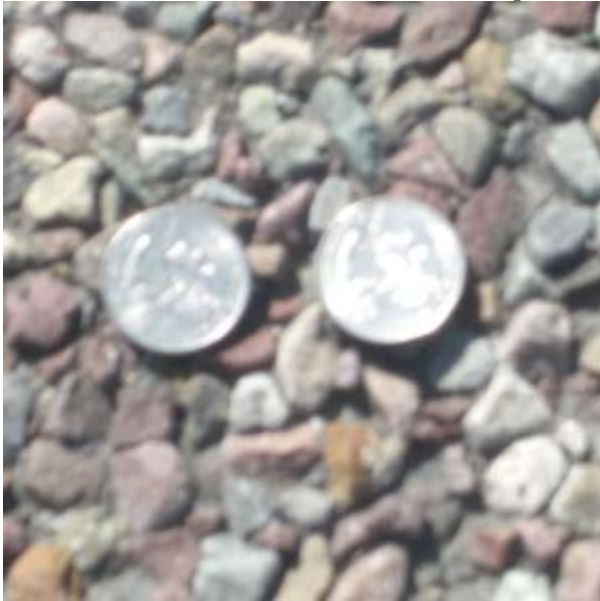
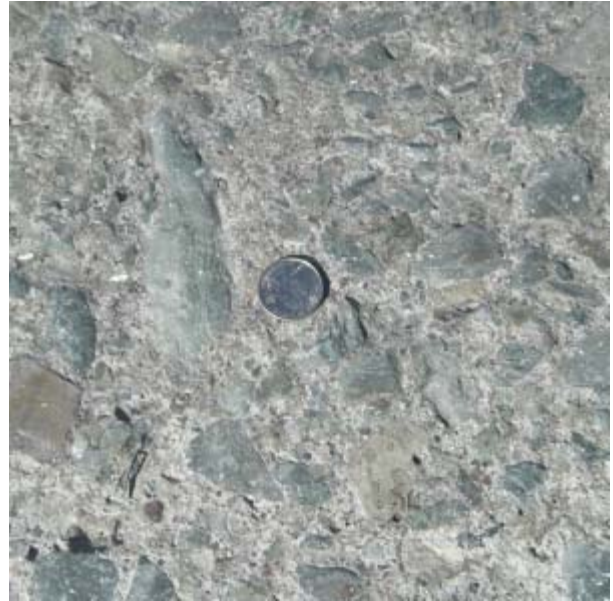
Figure A1. Photos of Test Pavements

(a) Site 12 (I-15), Medium to Older Chip Seal

(b) Site 13 (N-5), New Chip Seal

(c) Site 14 (P-52), Failed Chip Seal

(d) Site 2 (I-90), Transverse Tine PCC

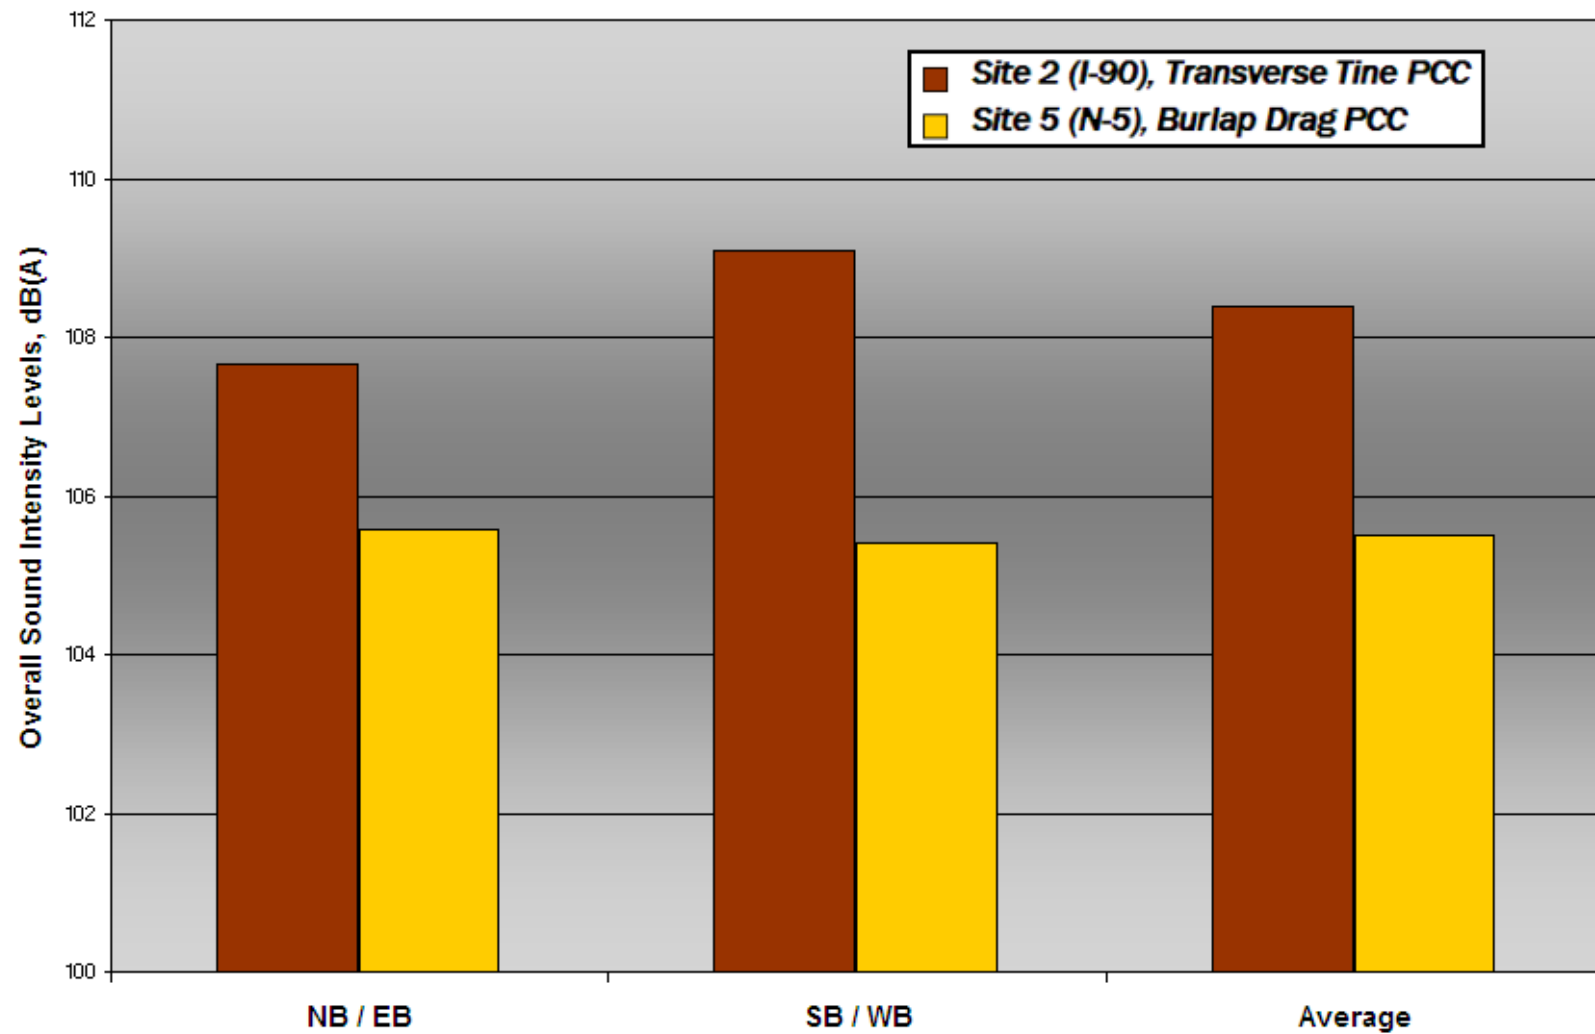
Figure A3. Overall A-Weighted OBSI Levels for PCC Pavements in Each Direction, 60 mph

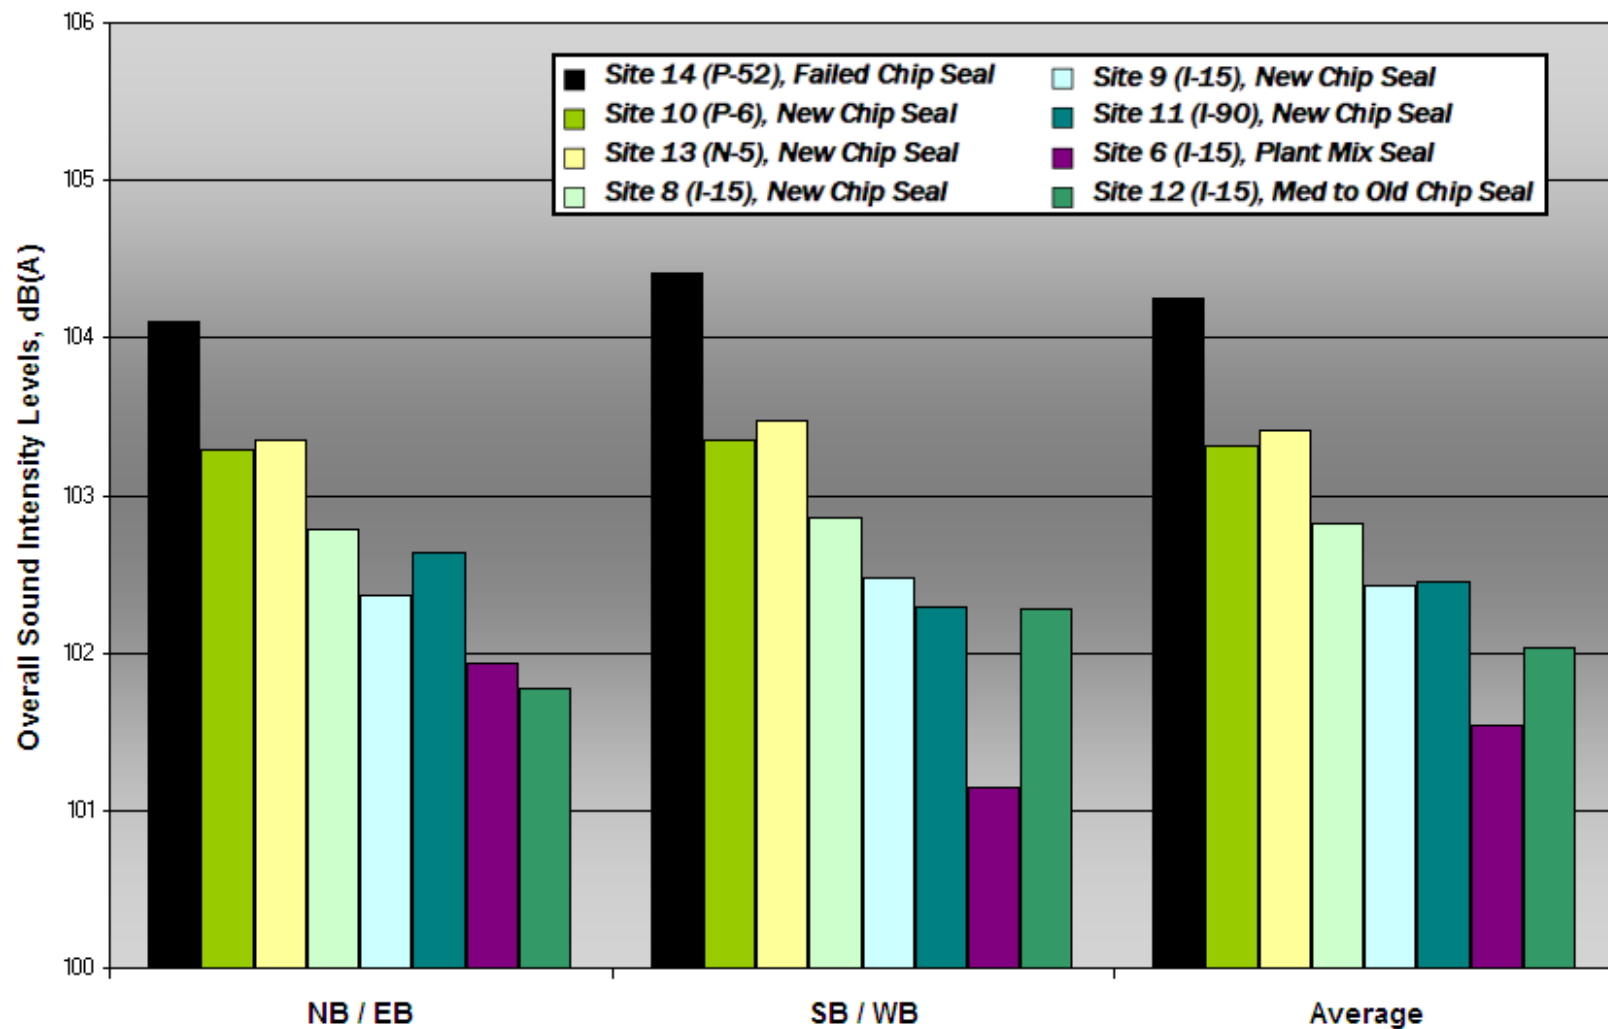
Figure A4. Overall A-Weighted OBSI Levels for AC Pavements in Each Direction, 60 mph

Site Number	Surface Type	OBSI Level, dBA
Site 6 (I-15) – see Figures A4 & A7	AC – Plant Mix Seal	100.5
Site 12 (I-15) – see Figures A4 & A8	AC – Med to Older Chip Seal	102.0
Site 11 (I-90) – see Figures A4 & A8	AC – New Chip Seal	102.1
Site 9 (I-15) – see Figures A4 & A8	AC – New Chip Seal	102.2
Site 8 (I-15) – see Figures A4 & A8	AC – New Chip Seal	102.6
Site 13 (N-5) – see Figures A4 & A8	AC – New Chip Seal	103.3
Site 10 (P-6) – see Figures A4 & A8	AC – New Chip Seal	103.3
Site 14 (P-52) – see Figures A4 & A8	AC – Failed Chip Seal	104.3
Site 5 (N-5) – see Figures A3 & A6	PCC – Burlap Drag	105.5
Site 2 (I-90) – see Figures A3 & A5	PCC – Transverse Tine	108.4
<i>Average AC – New Chip Seal</i>		<i>102.6</i>
<i>Average All Chip Seals</i>		<i>102.8</i>
<i>Average Concrete</i>		<i>106.9</i>

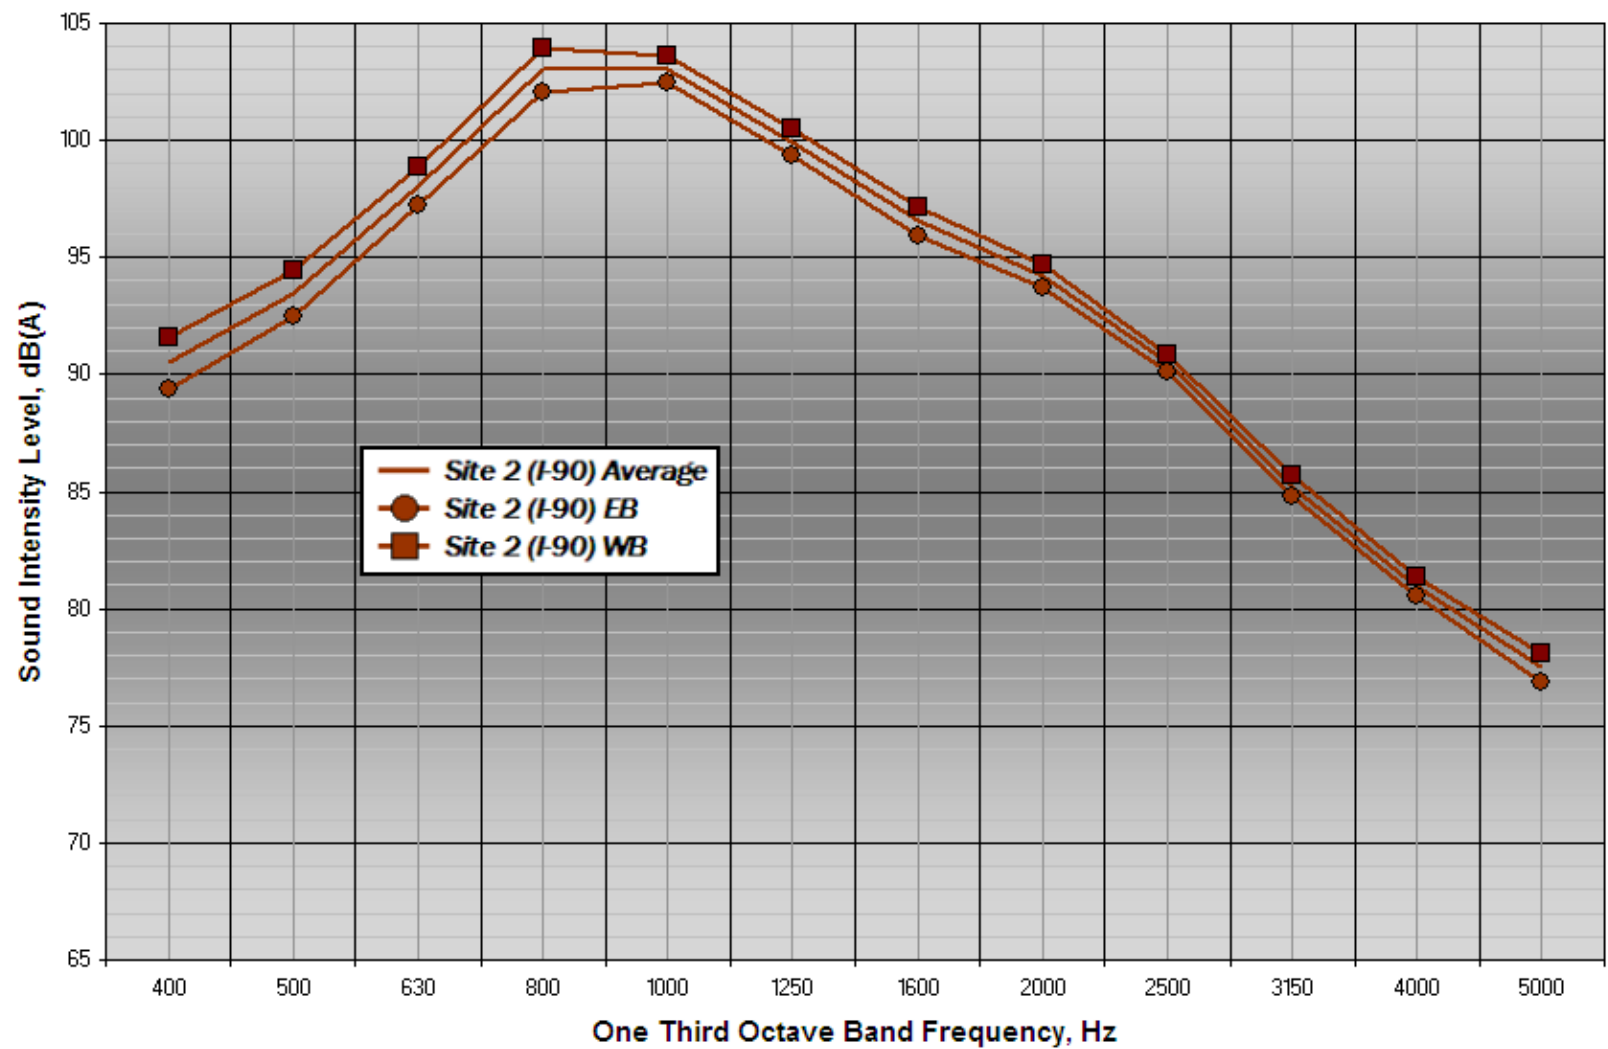
Figure A5. One-Third Octave Band Levels for Site 2 (I-90), Transverse Tine PCC Pavement in EB & WB Directions

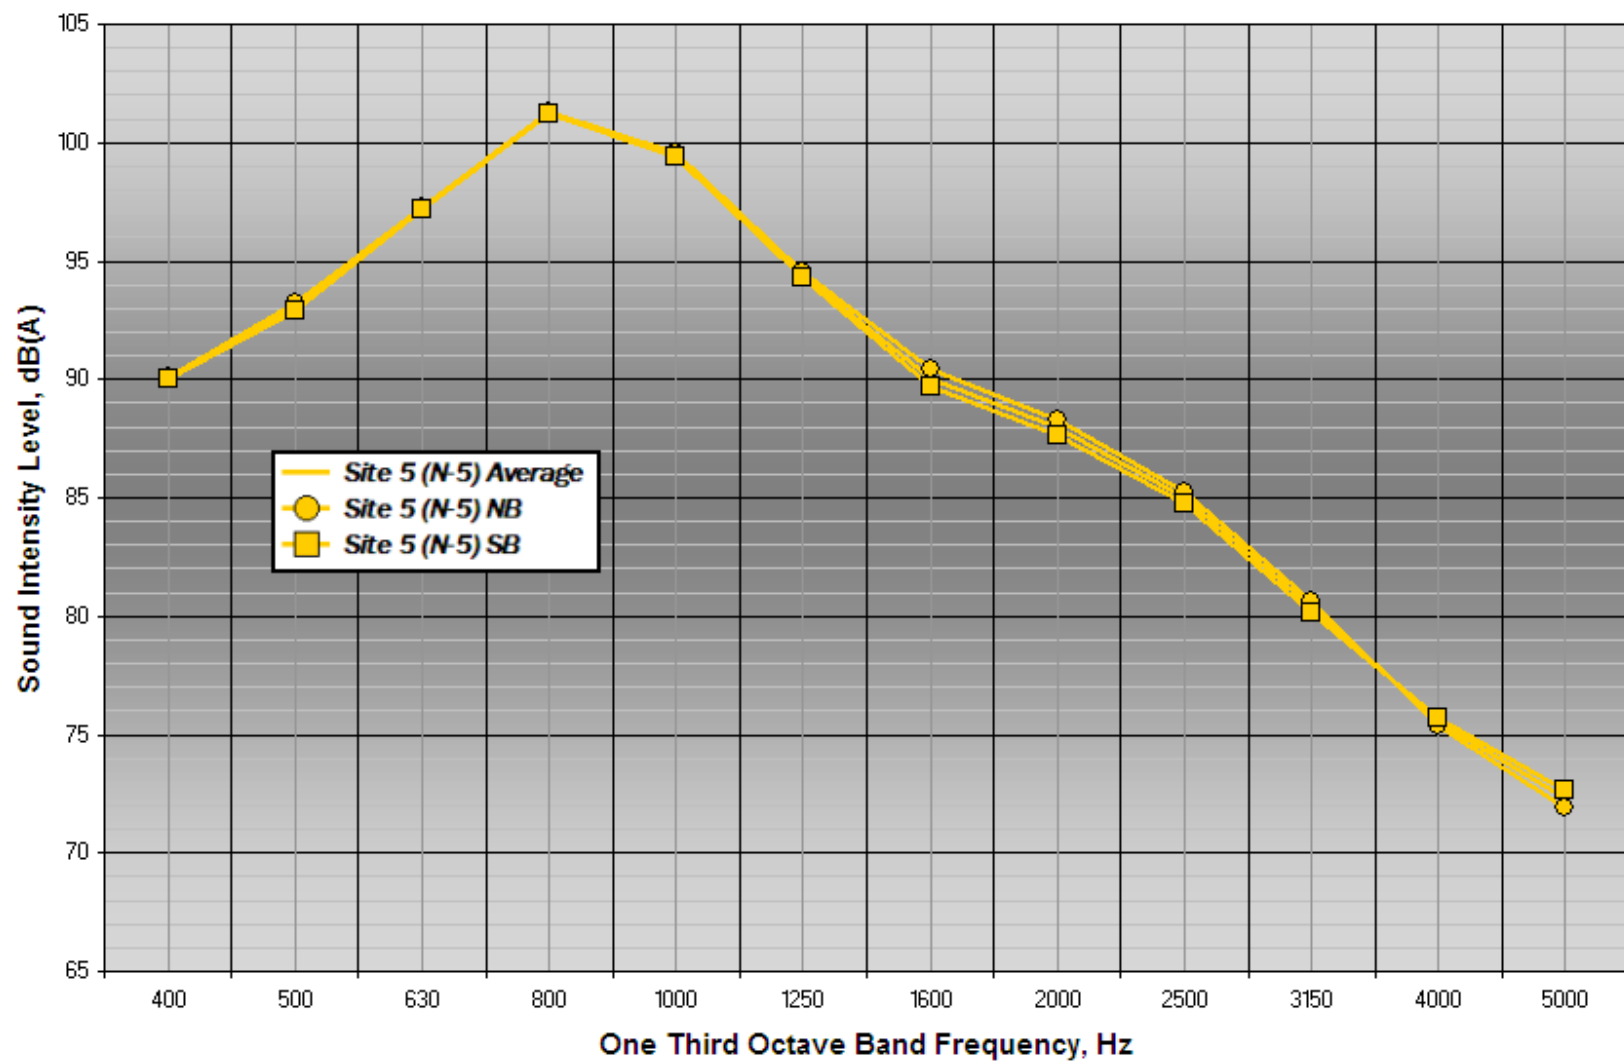
Figure A6. One-Third Octave Band Levels for Site 5 (N-5), Burlap Drage PCC Pavement in NB & SB Directions

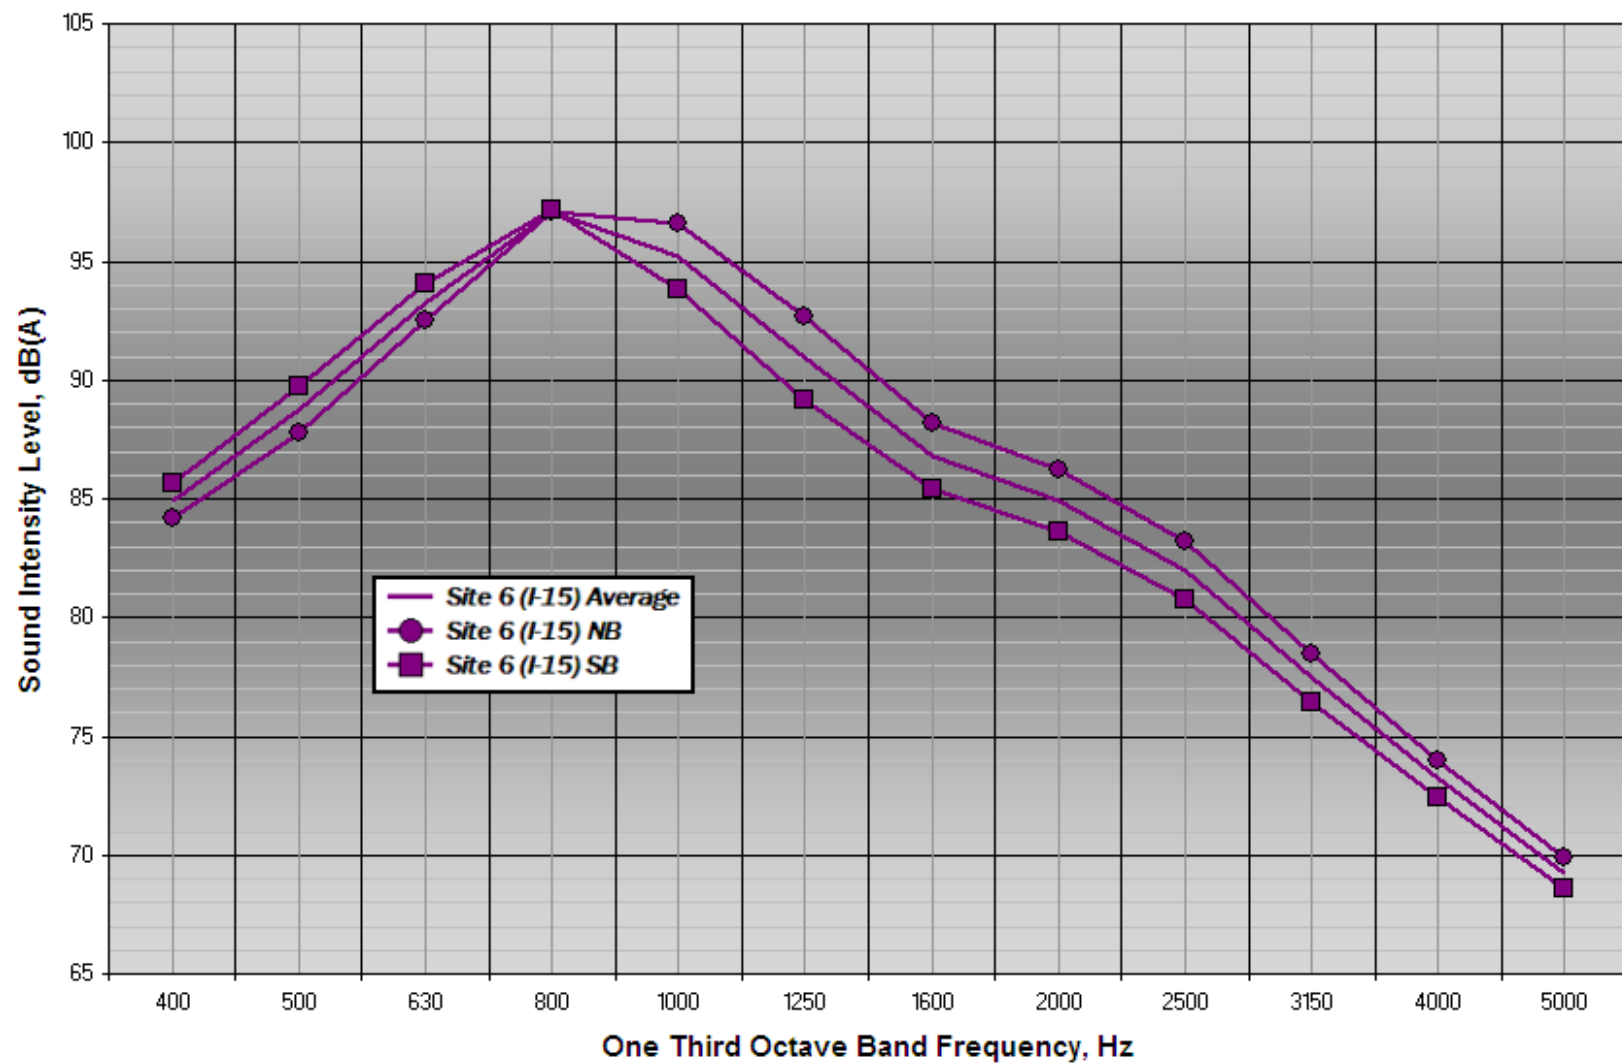
Figure A7. One-Third Octave Band Levels for Site 6 (I-15), Plant Mix Seal AC Pavement in NB & SB Directions

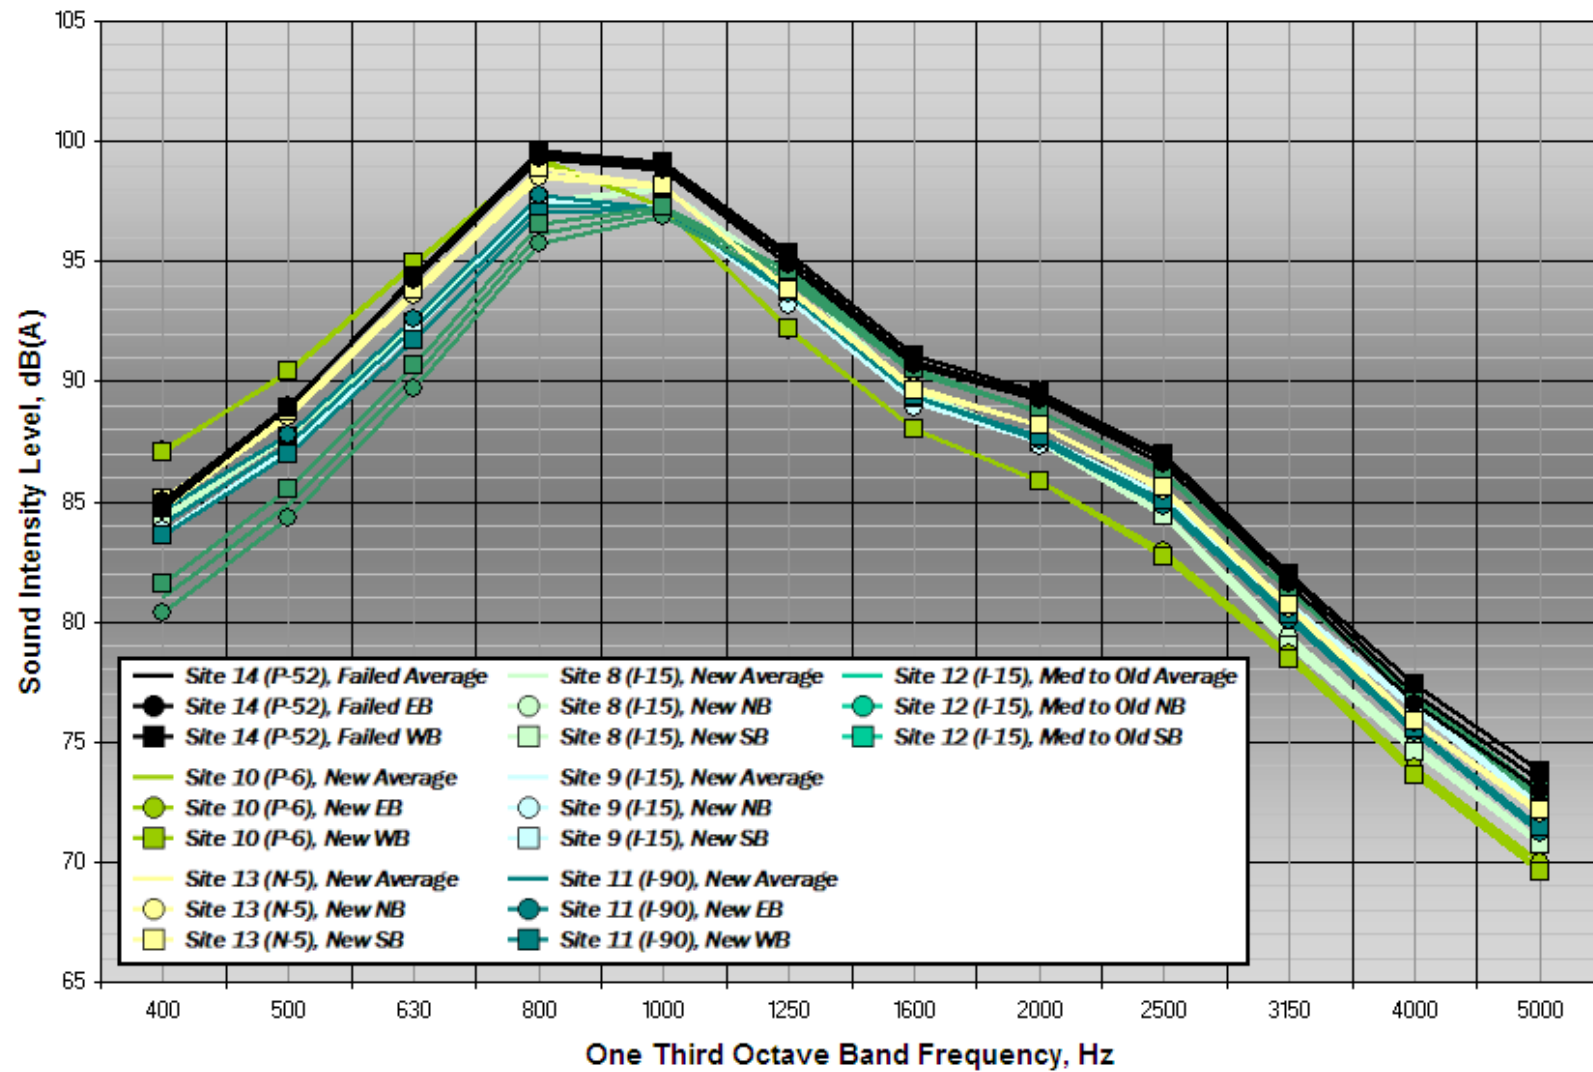
Figure A8. One-Third Octave Band Levels for All Chip Seal AC Pavements in Each Direction
