TRANSPORATION POOLED FUND PROGRAM QUARTERLY PROGRESS REPORT

Project Description:

This pooled fund project will develop and demonstrate new self-de-icing LED signals for highway signalized intersections and railroad signaling applications to solve a well-known problem of the existing LED signal light whose lens is too cool to melt snow and de-ice in wintery conditions. The self-de-icing LED signals will adopt one or both of two novel architectures (Figure 1), including (a) "Heated Lens Lighting Arrangement" that uses a single high-power LED and (b) "Heat Arrangement of LED Arrays in Low Profile" that deploys multiple LEDs. The heat generated by the LED(s) is harvested by the passive heat exchanger and stored to heat the lens for melting snow and de-icing in wintery conditions.

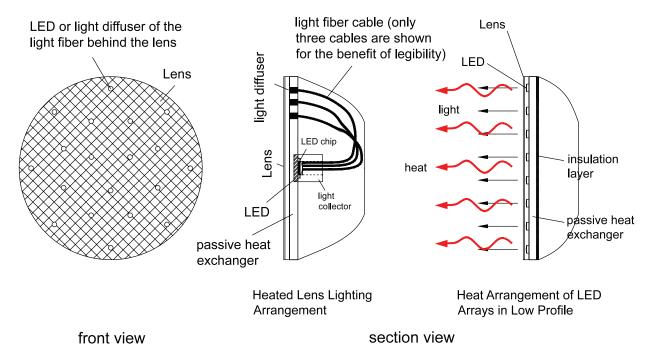
Figure 1 The concept of the self-de-icing LED signal light, which adopts new architecture of "Heated Lens Lighting Arrangement" or "Heat Arrangement of LED Arrays in Low Profile"

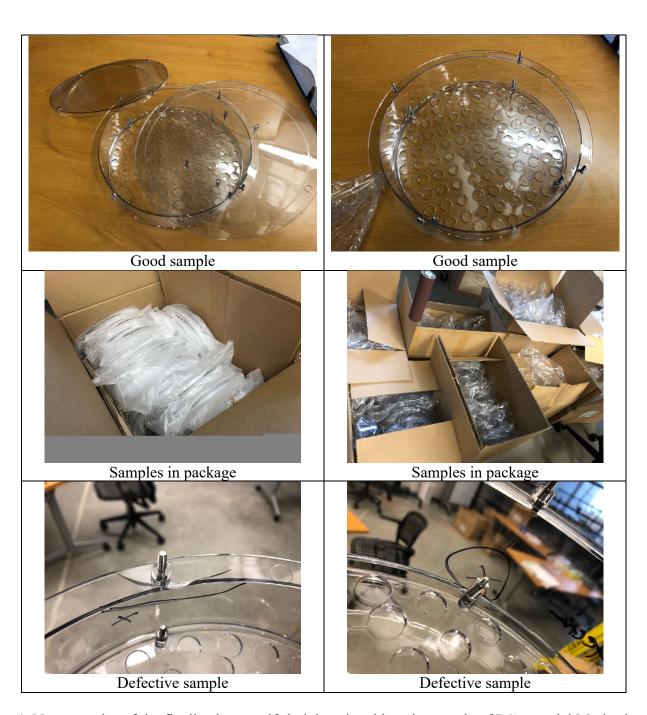
Firstly, we have tested the 100 new samples of the finalized new self-de-icing signal housing, which were made of Markrolon 2807 for UL certificate, using the revised mass production technology to correct the defective concaved lens surface of the plastic housing in mass production, with a maximum tolerance of 1.5 mm. The test results are summarized in Table 1. It was found that the average concaveness of the main signal housing lens is 1.24 mm with standard deviation of 0.64 mm, which is less than the maximum tolerance of 1.5 mm. Among the 100 samples, two samples are defective cannot be used, while the other two have tiny air bubbles that may not affect its use. Therefore, the new samples passed the quality inspection with a yield rate of 96%, meaning future products made with the revised mass production technology would have good quality with a maximum tolerance of the concaveness 1.5 mm. Figure 1 shows the pictures of the new samples.

Figure 1 New samples of the finalized new self-de-icing signal housing, made of PC material Markrolon 2807 for UL certificate using revised mass production technology to correct the defective concaved lens surface of the plastic housing in mass production, with a maximum tolerance of 1.5 mm.

- The problem of defective signal light housing with concave lens surface made during the production process has been solved with improved molding technology. A total of 100 new samples are made of Markrolon 2807 and tested with a maximum tolerance of 1.5 mm for mass production.

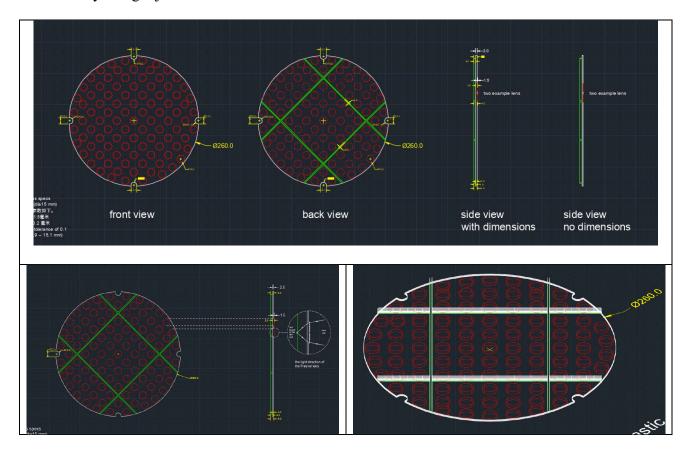
Secondly, we have improved the design of the new fresnel disc with 96 small fresnel lenses integrated on it, as shown in Figure 2. Improvements include (1) four stiffeners are now added on the back to support the large disc to make it even on the front surface, (2) enlarged the four installation holes from diameter 8 mm to diameter 12.1 mm, (3) slightly decreased the disc diameter from 261 mm to 260 mm. The new lens disc has requirements on materials as UV stabilized clear PC materials with light transmittance of 85% - 90%, and

stable temperature from -30° C (-22° F) to +120° C (+248° F), ideally with some UL94 rating for fire resistance. A good choice is Markrolon 2807 or similar. The new fresnel lens disc is currently being custom-made in a factory using injection mold.

Figure 2 Improved design of the new fresnel disc with 96 small fresnel lenses integrated on it

- A new fresnel disc with 96 small fresnel lenses integrated on it has been designed with the desired improvements, and is currently being custom-made in a factory through injection mold.
- We have installed the new remote monitoring system with mobile communication in the Lawrence test site, in addition to the original reliable "local" data monitoring system that kept running in the past year.
- The self-de-icing signals have survived both winter and summer functioning as expected, without any signs of snow and ice accumulation on the signal lens in cold winter, and abnormal performance in hot summer.

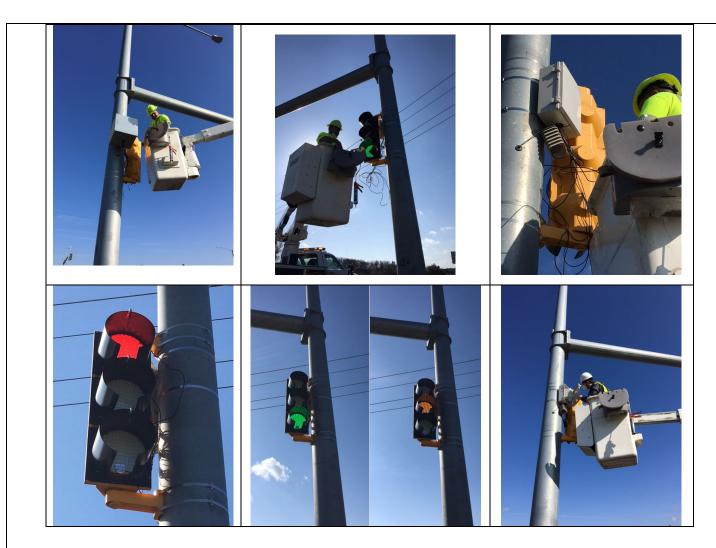
Furthermore, as shown in Figure 3, we have installed the new remote monitoring system with mobile communication in the Lawrence test site, in addition to the original reliable "local" data monitoring system that kept running in the past year. All performance data were retrieved from the Lawrence test site showing the self-de-icing signals have been working properly. The self-de-icing signals have survived both winter and summer functioning as expected, without any signs of snow and ice accumulation on the signal lens in cold winter, and abnormal performance in hot summer, as shown in Figure 4 on the hottest days and coldest days. Figure 5 shows some example pictures of the signals taken continuously at different time on different dates.

Figure 3 Improved design of the new fresnel disc with 96 small fresnel lenses integrated on it

- The field monitoring system has added mobile communication information device with data plan to remotely send the data of the signal performance back to the laboratory on daily basis for real-time performance monitoring, which is under testing on the roof.

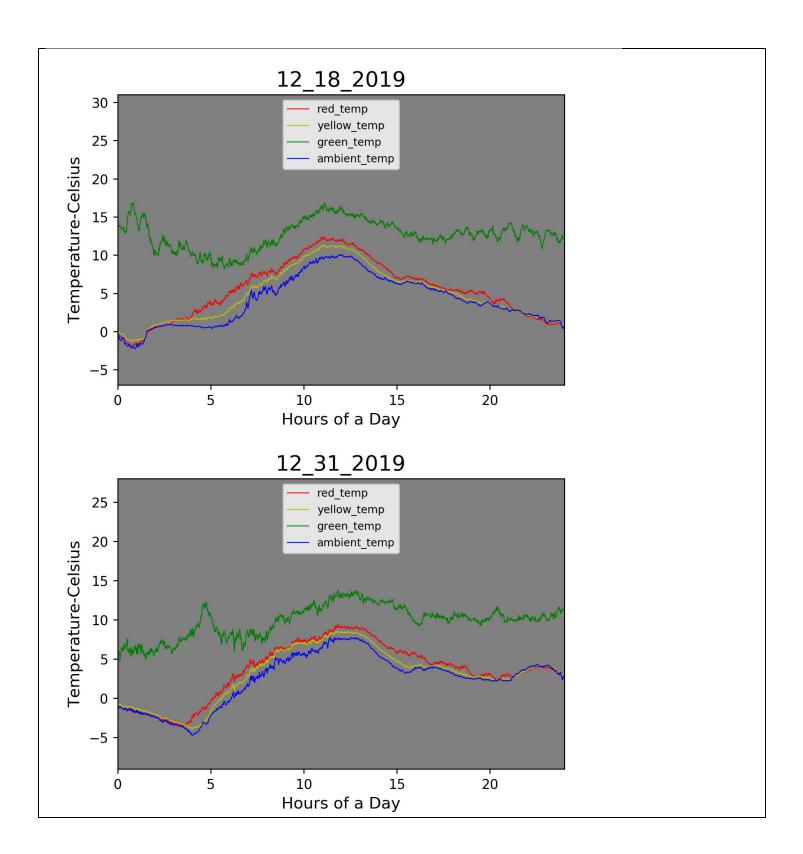
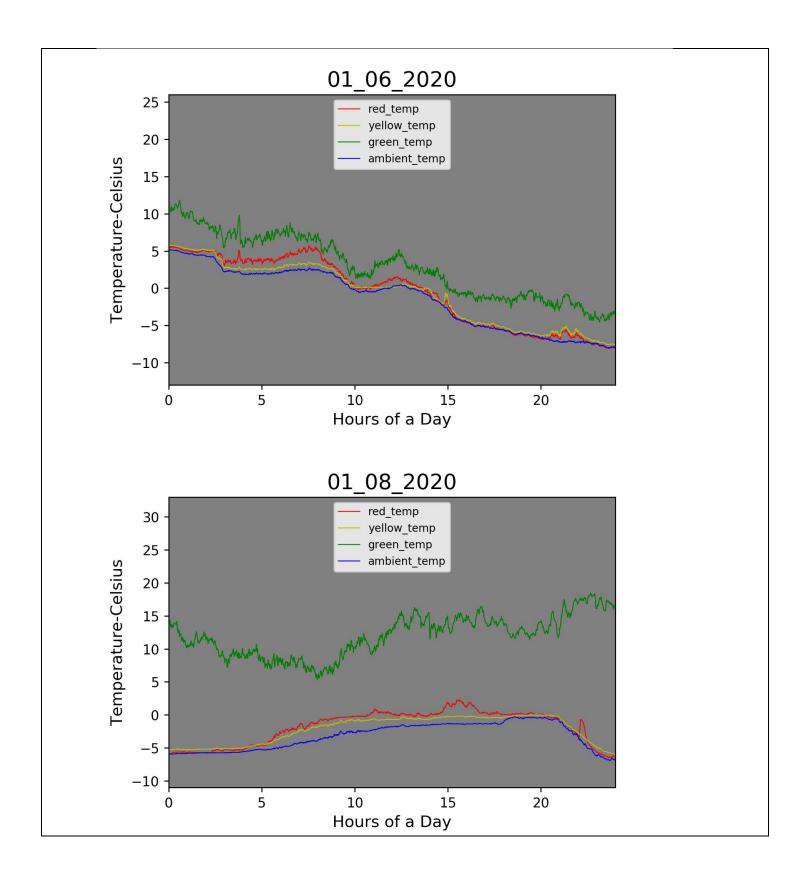
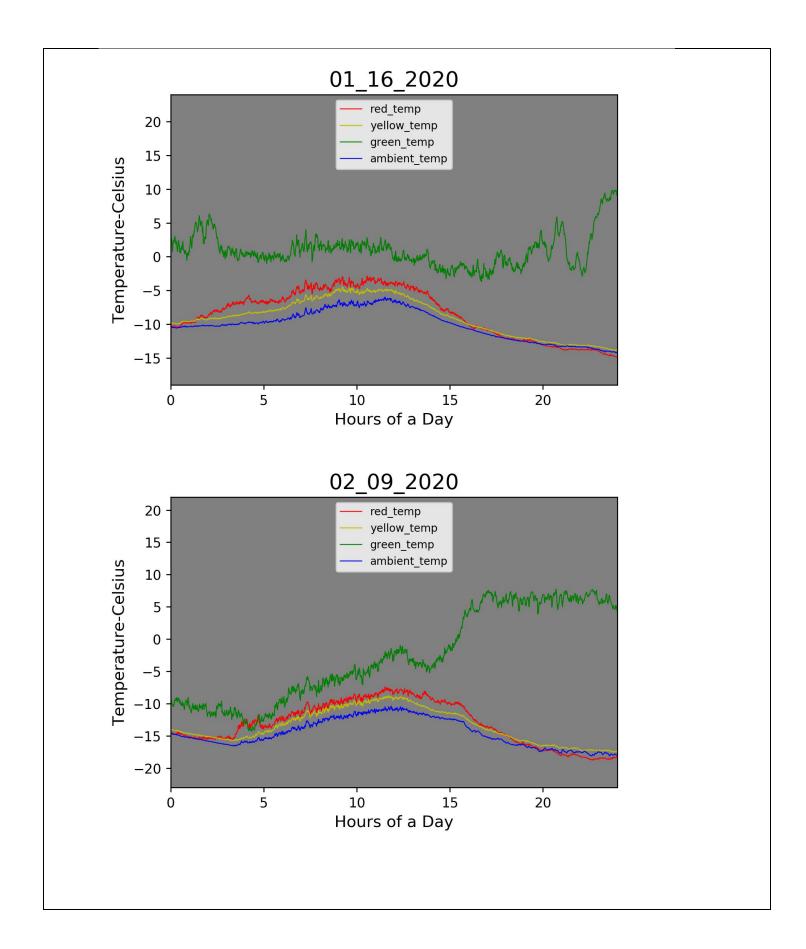
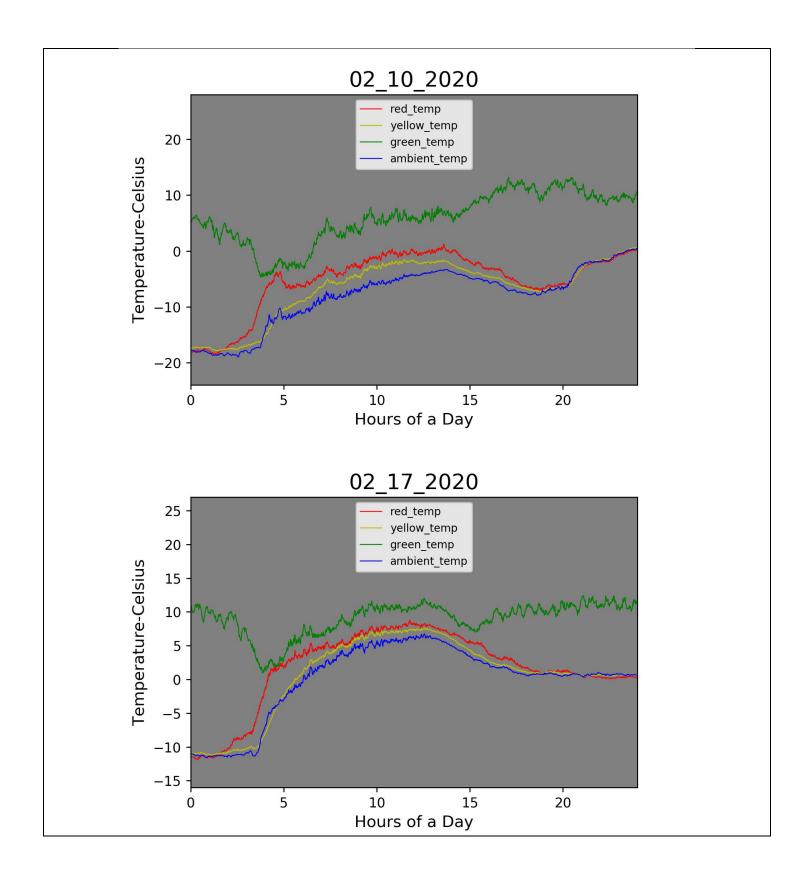
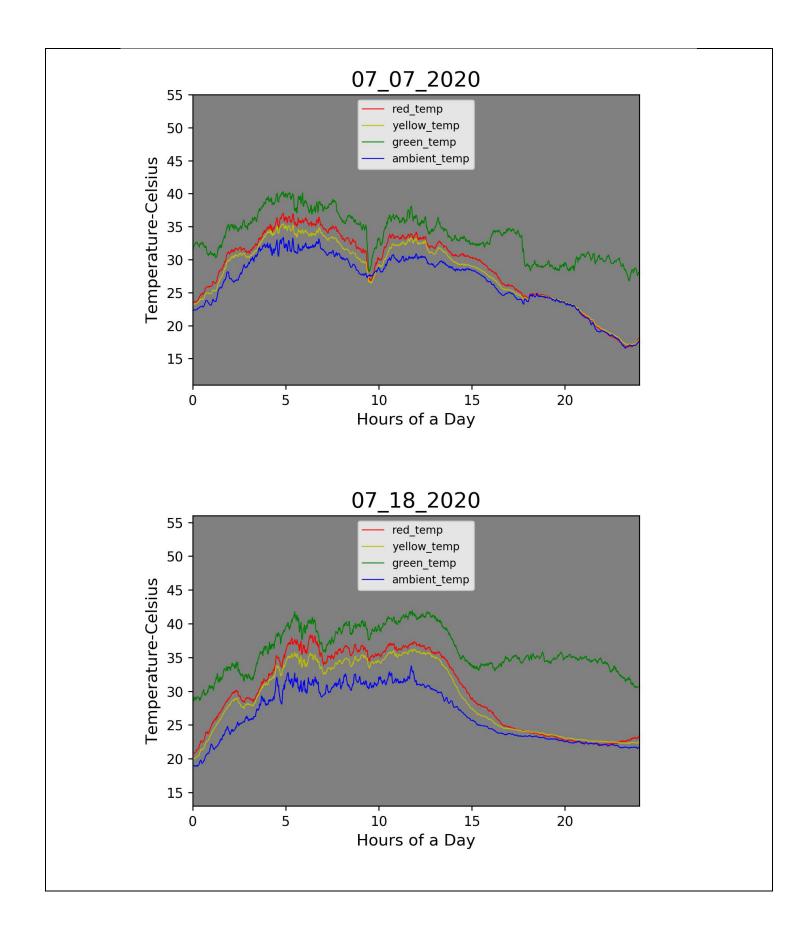
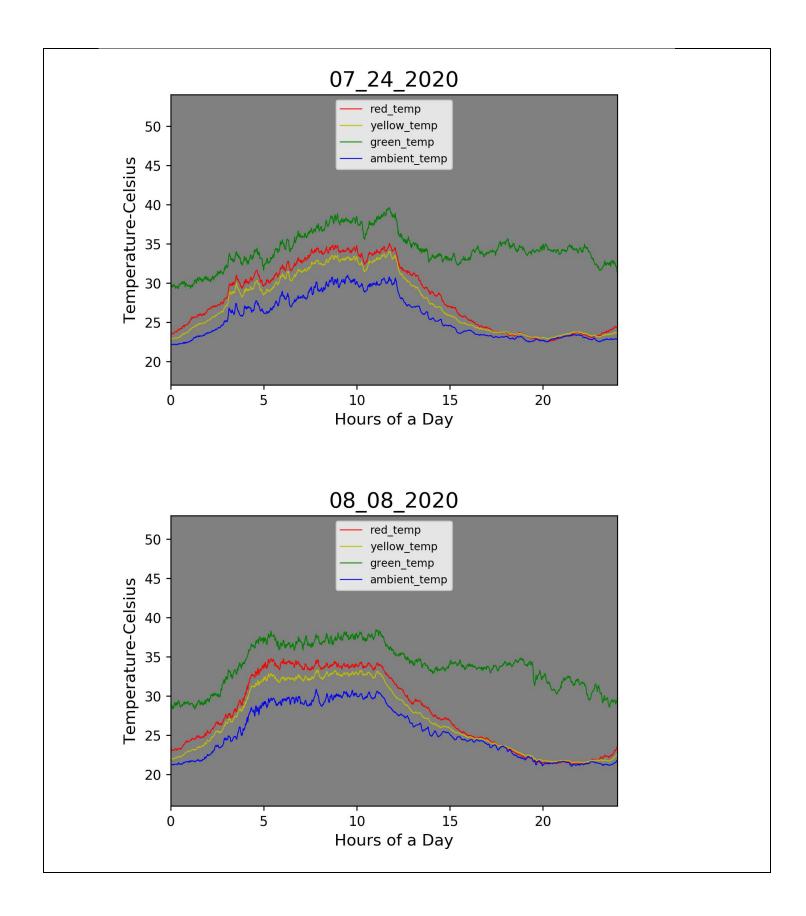
Figure 4 Lawrence field test data during the hottest days in summer 2020 and winter 2019-2020, showing the performance of the red, yellow, and green signal lights under different weather conditions.

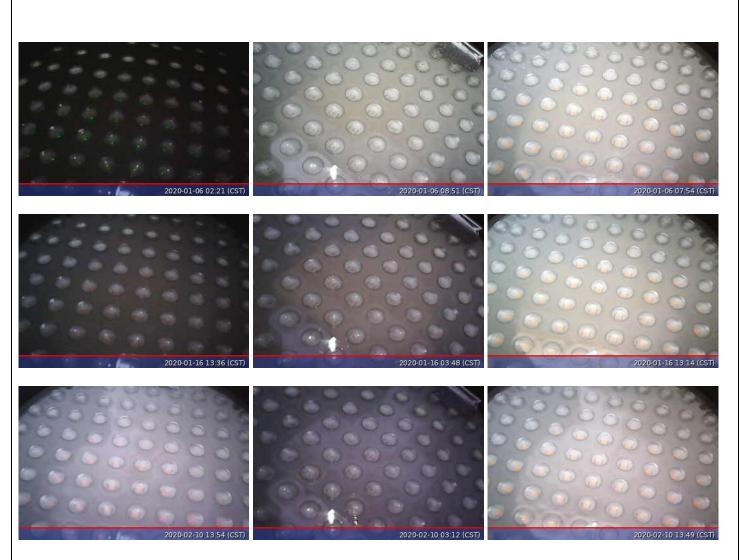
Figure 5 Example pictures of the signals tested in Lawrence field site in the coldest days in winter 2020, automatically taken by the monitoring system.
