Guidelines for Thermographic Inspection of Concrete Bridges

**Development of Hand-held Thermographic Inspection
Technologies**

**Revised Guidelines for Thermographic
Inspection of Concrete Bridges**

RI06-038

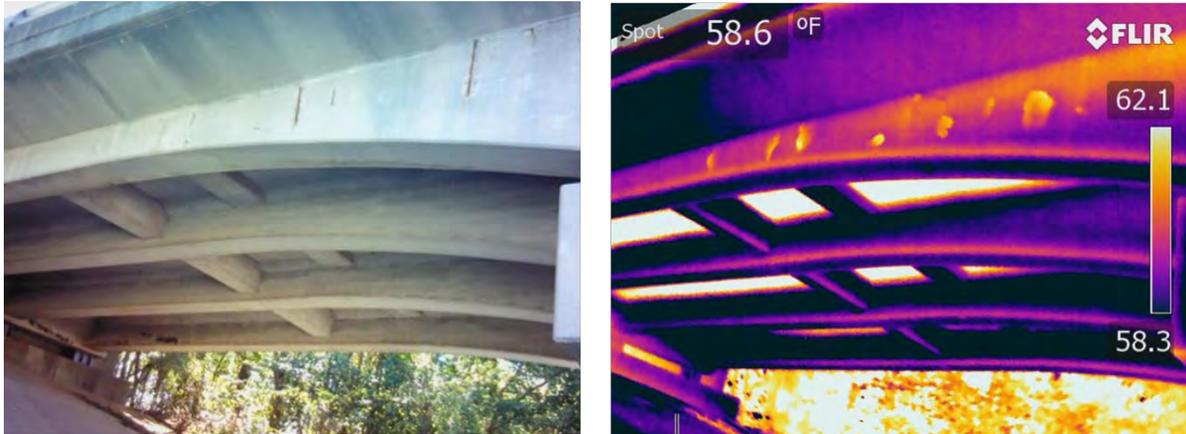
Figure 7: Standard and IR photos of bridge soffit delaminations (Mount Sterling, Kentucky)

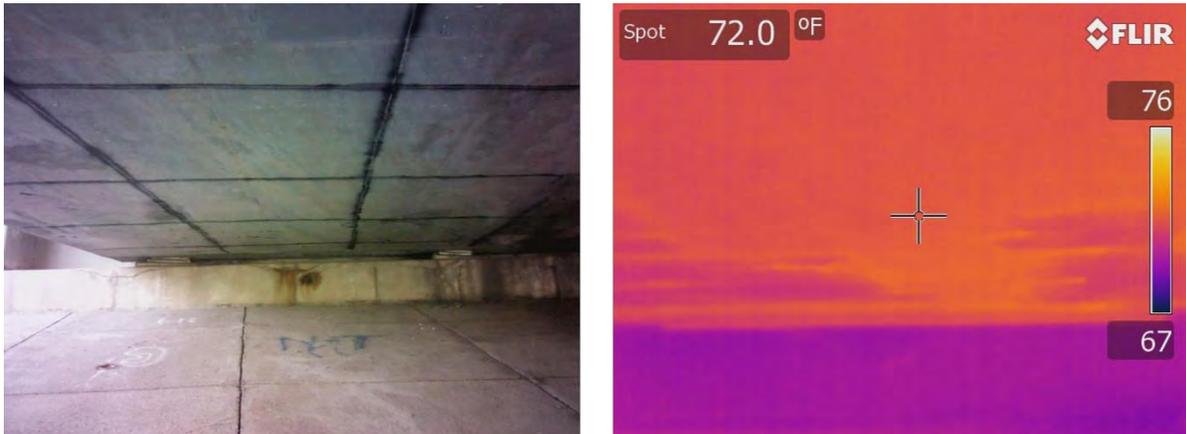
Figure 9: Standard and IR photos of bridge soffit delaminations (Duluth, Minnesota)
