**Investigation of the Long Term Effects of Magnesium Chloride and  
Other Concentrated Salt Solutions on  
Pavement and Structural Portland Cement Concrete**

Project Number: SD2002-01

**Quarterly Report**

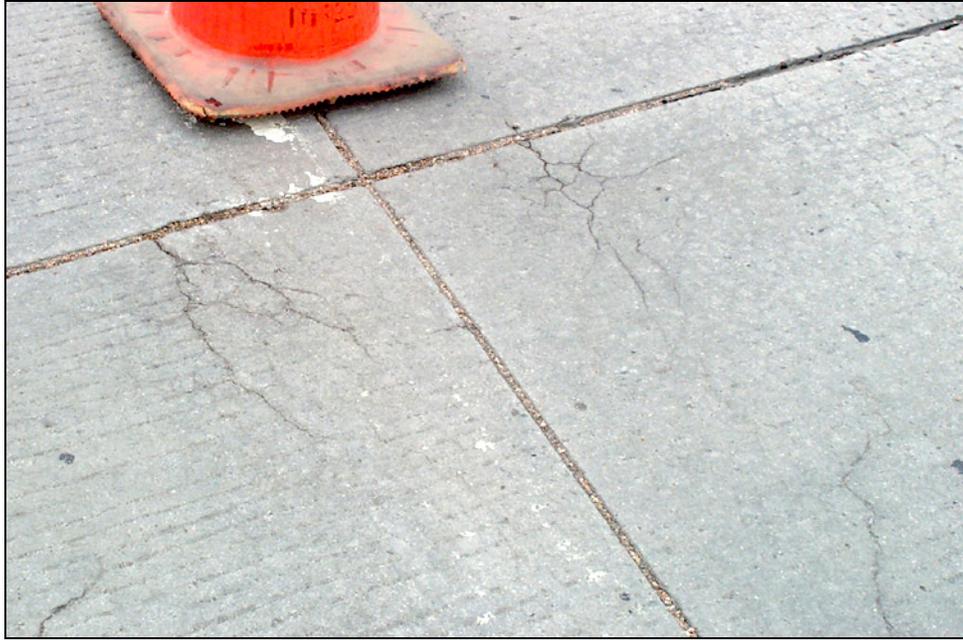
This pavement, constructed 1996, exhibited visible signs of deterioration. Figure CO-1 shows the type of cracking observed in the field. The pavement has been exposed primarily to NaCl deicer. Figure CO-2 shows where the cores were taken, and Figures CO-3 and CO-4 show photographs of the individual cores. Two of the cores were cut into slabs and polished: core CO-1 (near a joint), and core CO-5 (mid-panel). Figures CO-5 through CO-8 show the slabs as polished, after staining with phenolphthalein, and after treatment to enhance air voids and cracks. The phenolphthalein stain showed normal carbonation depths. The black and white treatment did not reveal any macro-cracking in either of the cores. Table CO-1 summarizes the air void parameters. Both sets of slabs showed adequate entrained air, with spacing factors of 0.182 mm and 0.175 mm for cores CO-1 and CO-5 respectively. Figure CO-9 shows an example stereomicroscope image of the air void structure. Some alkali silica reactivity was observed with minor gel production and cracking, as illustrated in Figure CO-10. A w/c ratio estimation was performed on a thin section prepared from the top of core CO-6. Figures CO-11 and CO-12 show the images used to make the measurements. The results of the w/c estimation are summarized in Table CO-2, with an average w/c value of 0.47 as compared to the 28-day moist cured mortar sample standards. Figures CO-13 through CO-16 show chloride profiles from cores CO-6 and CO-8. Figure CO-17 shows fly ash particles present in the concrete.

Figure CO-1: Photograph of cracks in pavement.

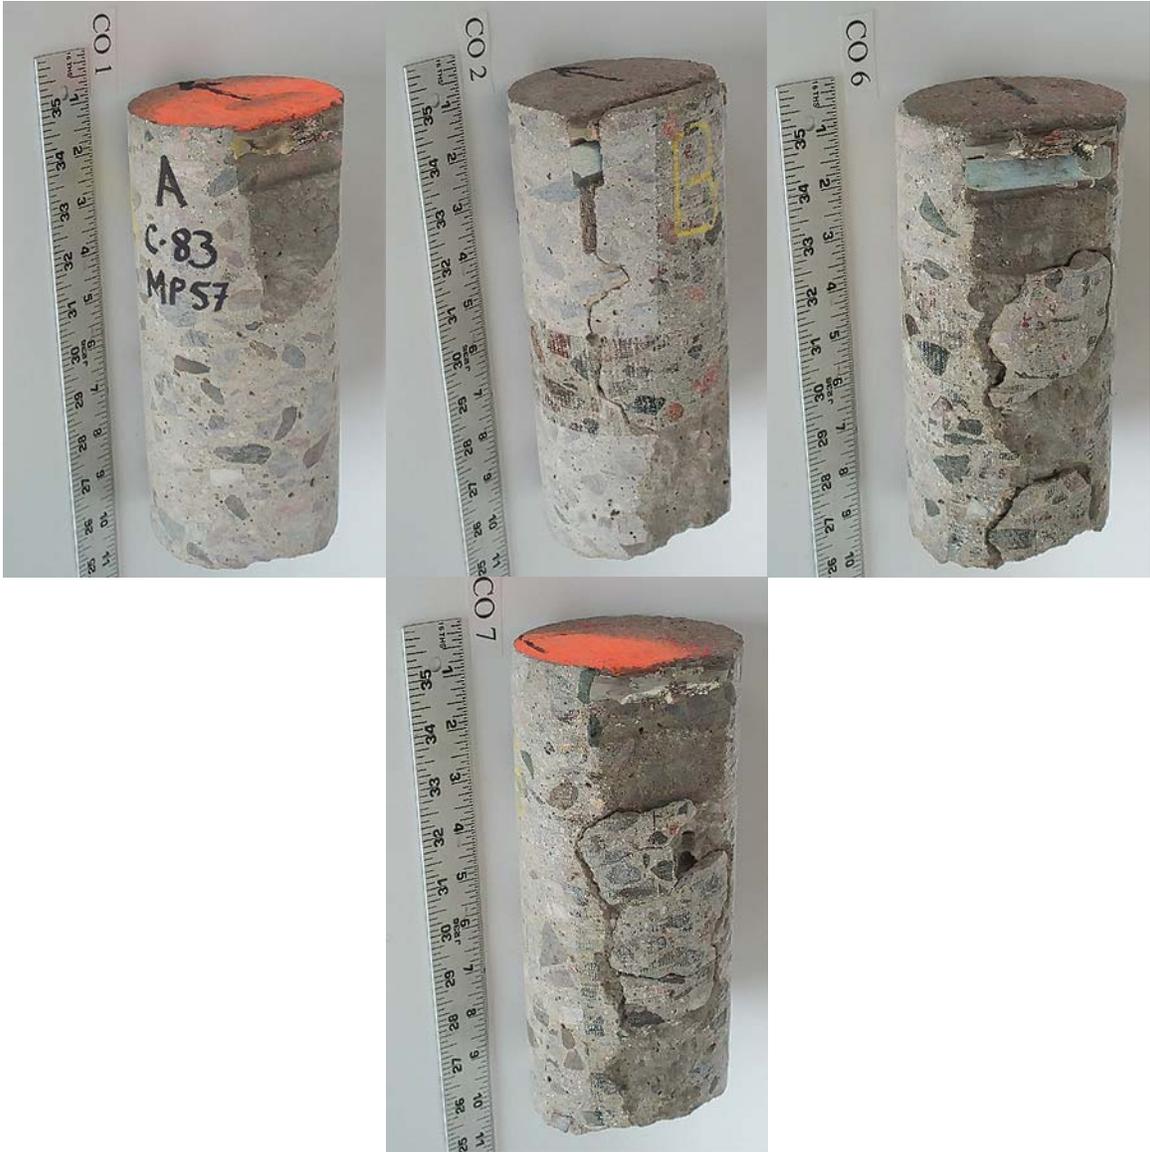
Figure CO-3: Cores taken at joint.

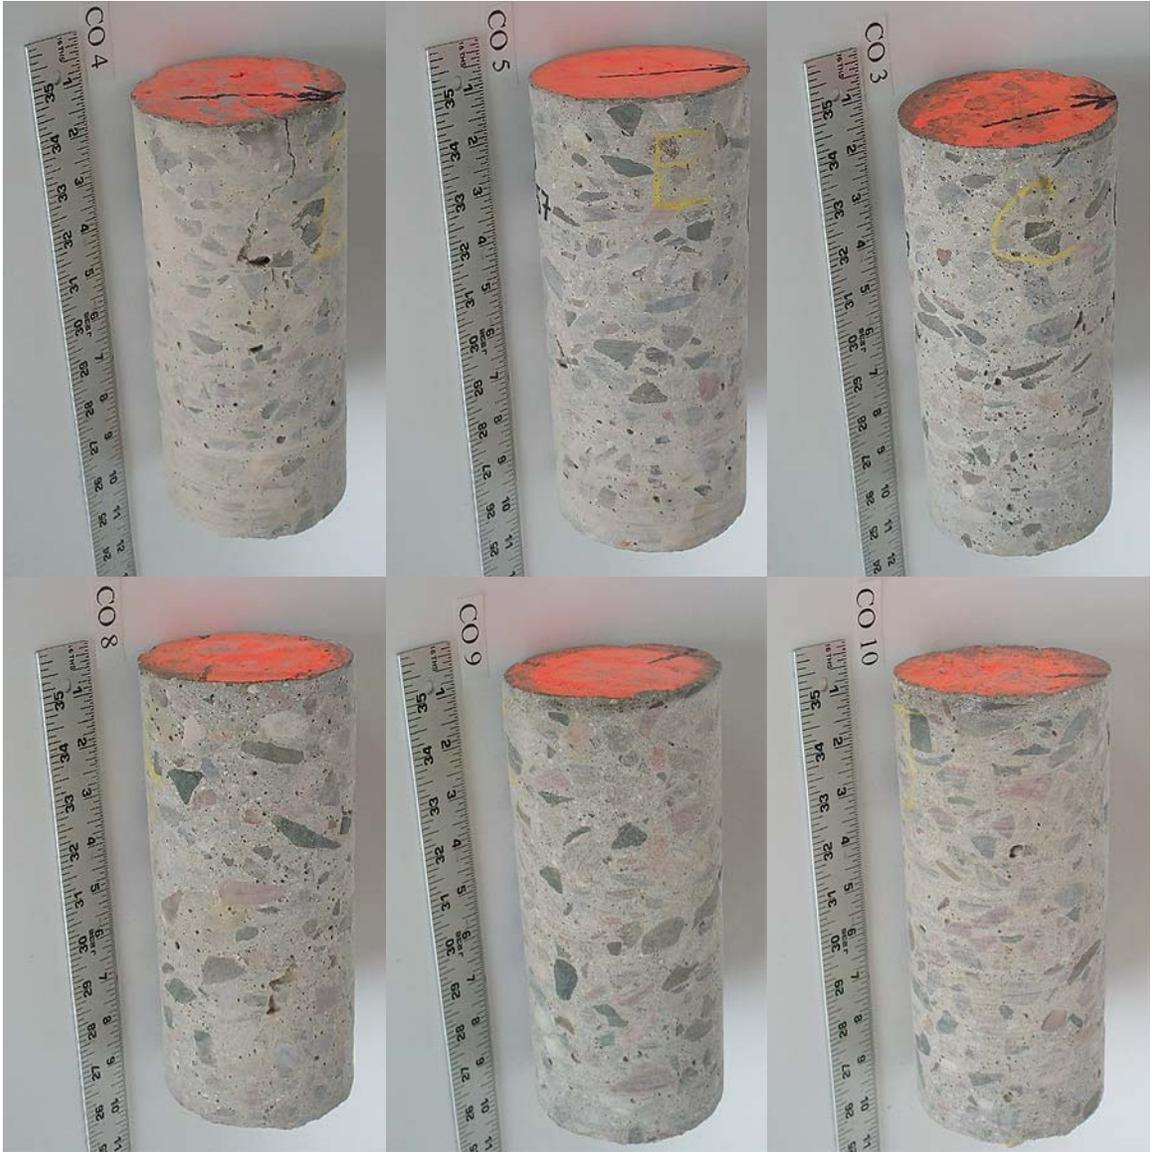
Figure CO-4: Cores taken away from joint.

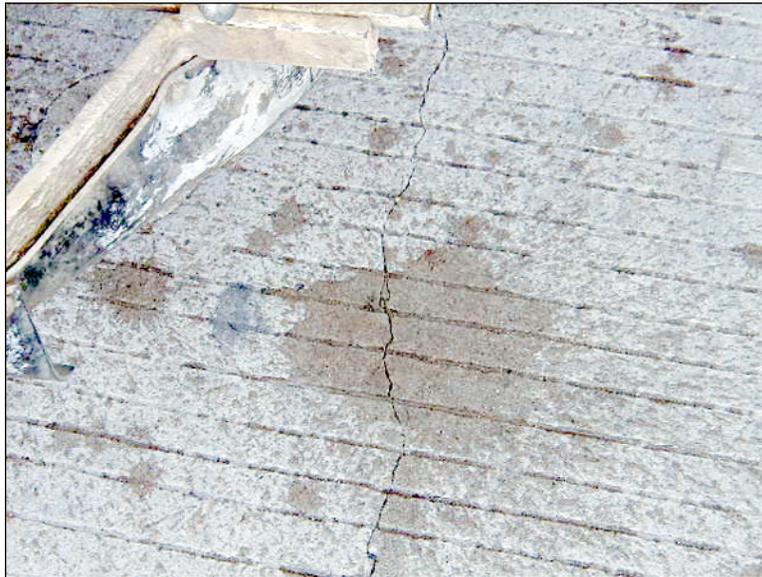
This bridge deck is reported to have been exposed exclusively to calcium magnesium acetate deicer. Figure IA-1 shows the locations of the cores, and Figure IA-2 shows an example of surface cracking observed in the field. Figures IA-3 and IA-4 show photographs of the partial depth cores, which primarily sampled the approximately 2" thick concrete overlay. Two of the cores were cut into slabs and polished: core IA-6 (over a surface crack), and core IA-5 (no surface crack). Figures IA-5 and IA-6 show the slabs as polished, after staining with phenolphthalein, and after treatment to enhance air voids and cracks. The phenolphthalein stain showed normal carbonation depths. The black and white treatment did not reveal any macro-cracking in either of the cores, other than the obvious surface crack of core IA-6, which extended both through the overlay and into the original concrete below. Table IA-1 summarizes the air void parameters. The overlay from both slabs exhibited borderline entrained air parameters, with spacing factors of 0.276 mm and 0.217 mm for cores IA-5 and IA-6 respectively. Figure IA-7 shows an example stereomicroscope image of the air void structure. Some alkali silica reactivity was observed with minor gel production but no cracking, as illustrated in Figure IA-8. A w/c ratio estimation was performed on a thin section prepared from the top concrete overlay portion of core IA-3, and from the original concrete below in core IA-11. Figures IA-9 through IA-12 show the images used to make the measurements. The results of the w/c estimations are summarized in Tables IA-2 and IA-3, with an average w/c value of 0.30 for the overlay, and an average w/c value of 0.42 for the original concrete, (as compared to 28-day moist cured mortar sample standards). Figures IA-13 through IA-16 show chloride profiles collected from core IA-3 (over a surface crack) and core IA-11 (no surface crack). All of the profiles show an increase in Cl concentration near the pavement surface. Although CMA may have been used exclusively on the bridge deck, it is possible that contamination from the preceding roadway contributed to the observed Cl gradient. A careful comparison of the profiles from cores IA-3 and IA-11 shows an increased Cl penetration in core IA-3, which was taken directly over a surface crack in the pavement. Figure IA-17 shows secondary calcium hydroxide deposits in air voids, which were commonly observed in the concrete overlay.

Figure IA-2: Photograph of crack in bridge deck.

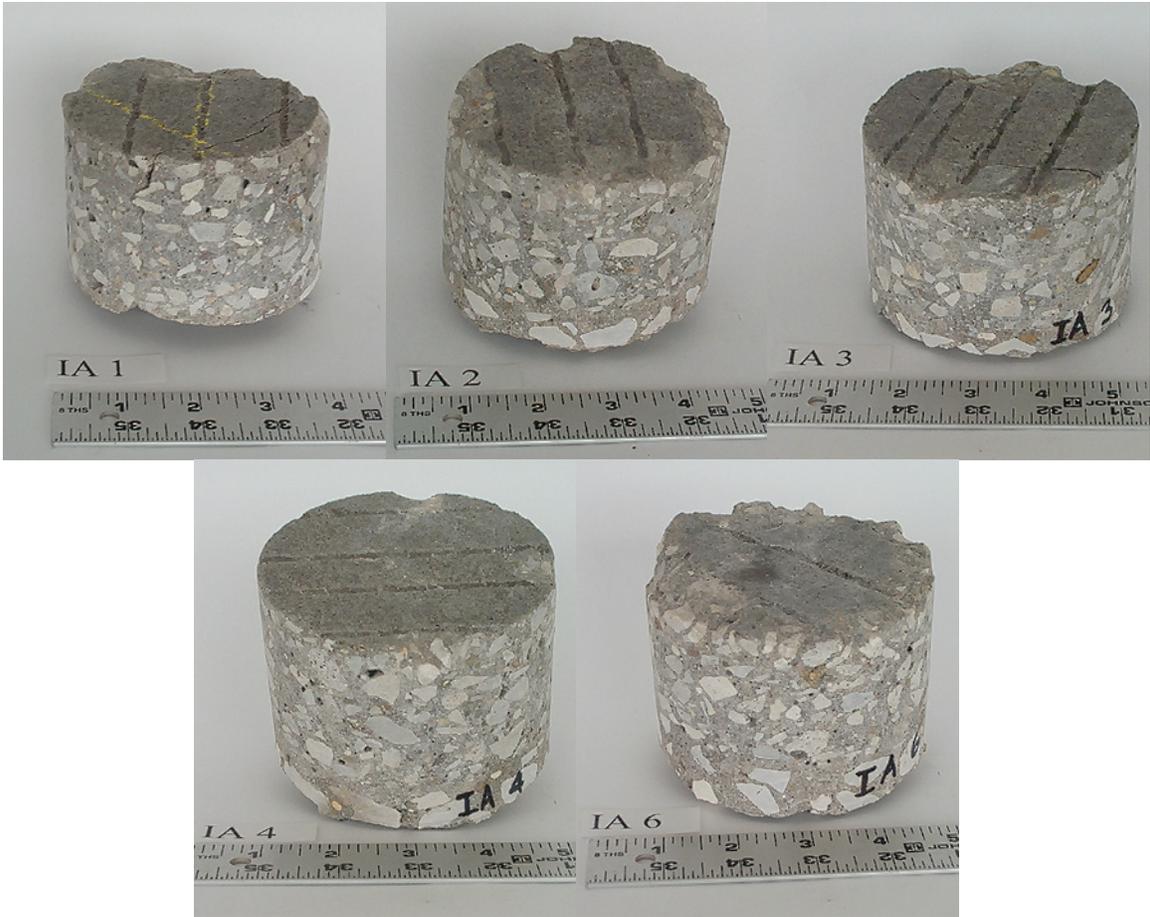
Figure IA-3: Partial depth cores through bridge deck from right hand side of lane.

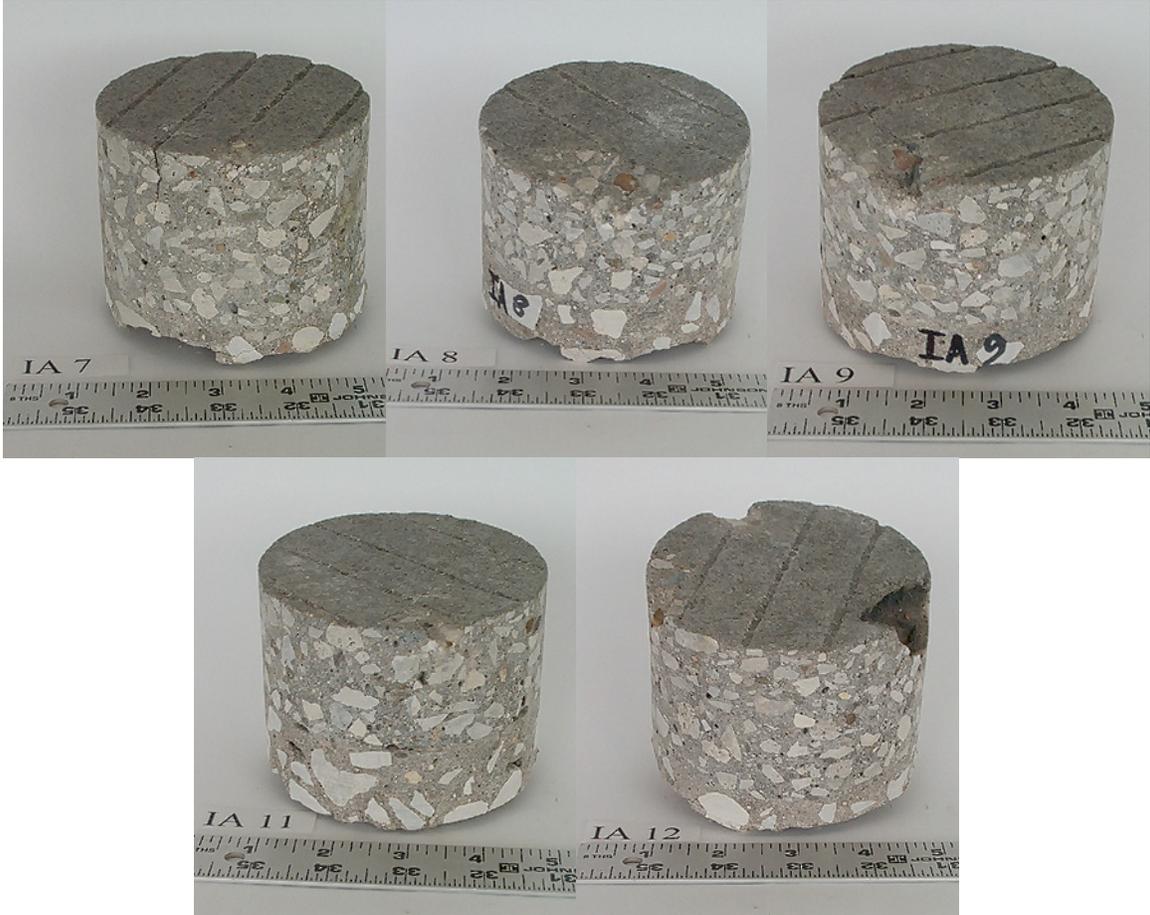
Figure IA-4: Partial depth cores through bridge deck from left hand side of lane.

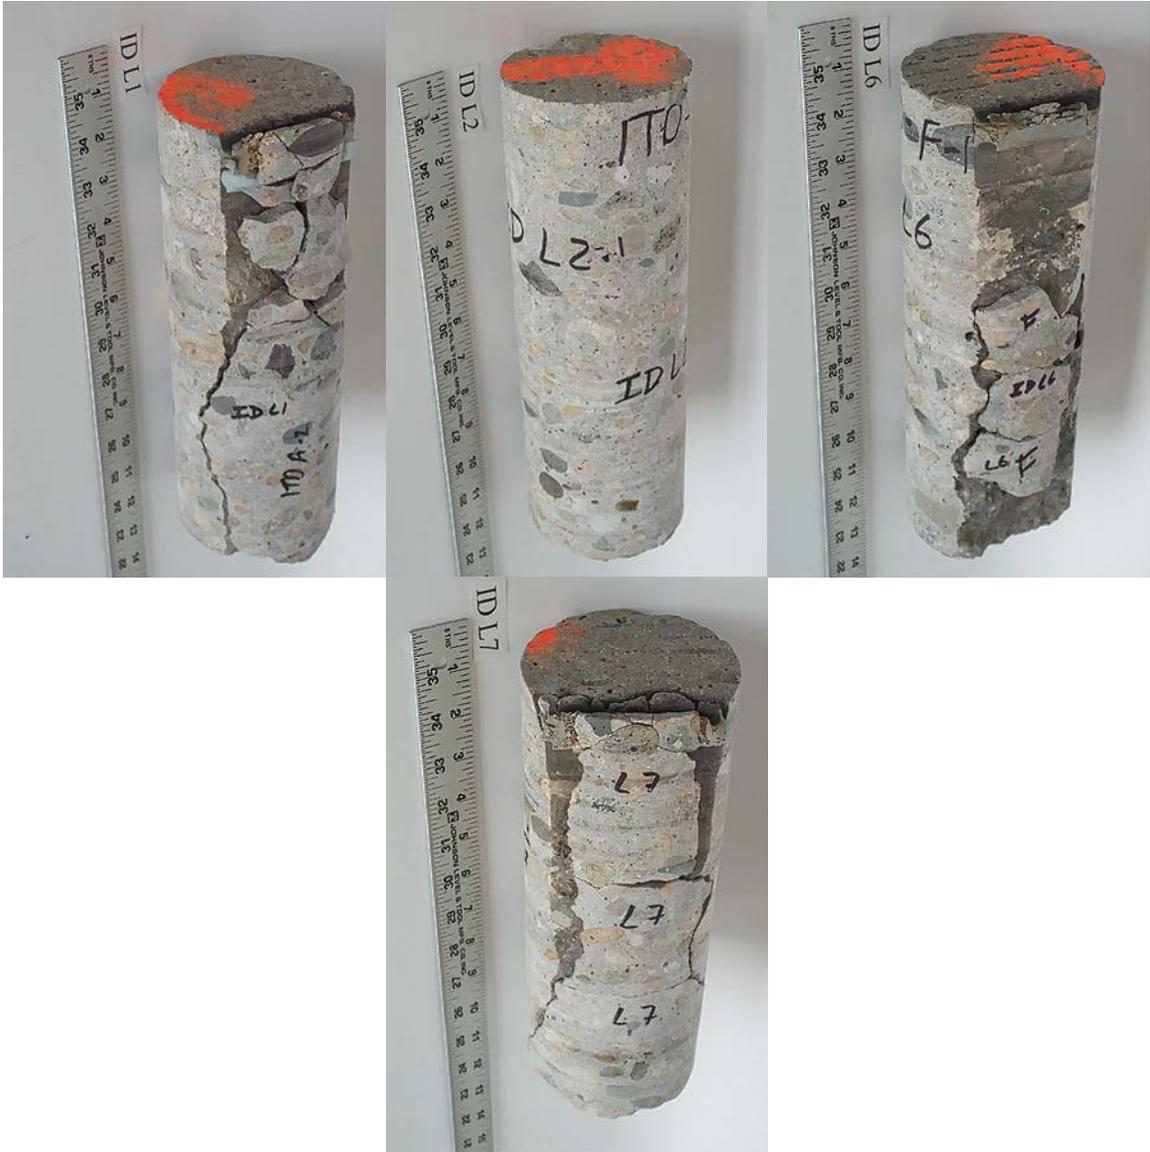
Figure ID-2: Cores from left lane taken near pavement joints.

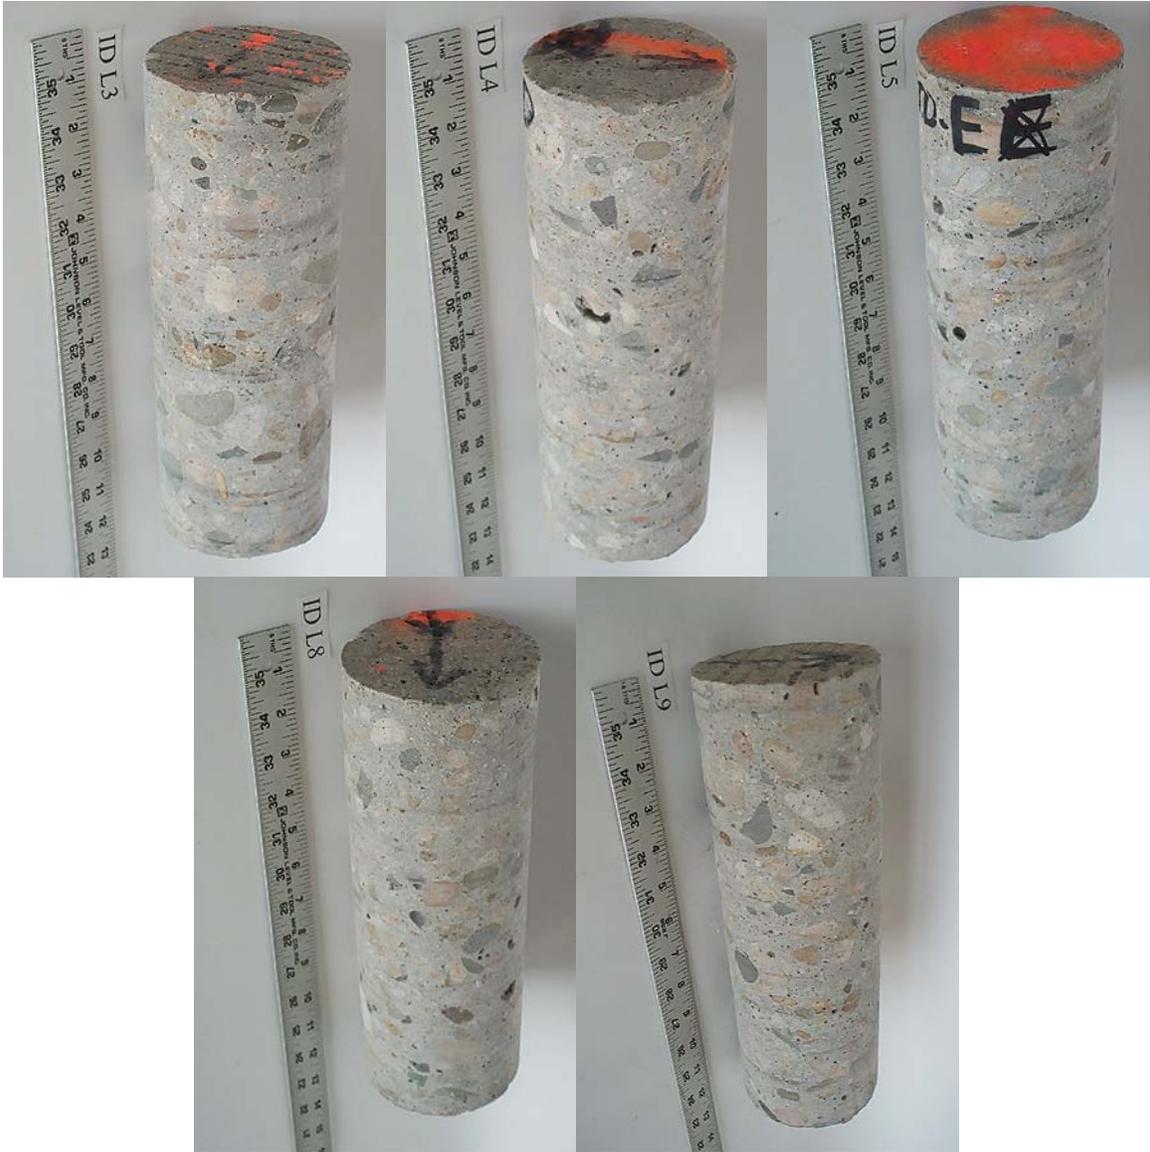
Figure ID-3: Cores from left lane taken away from pavement joints.

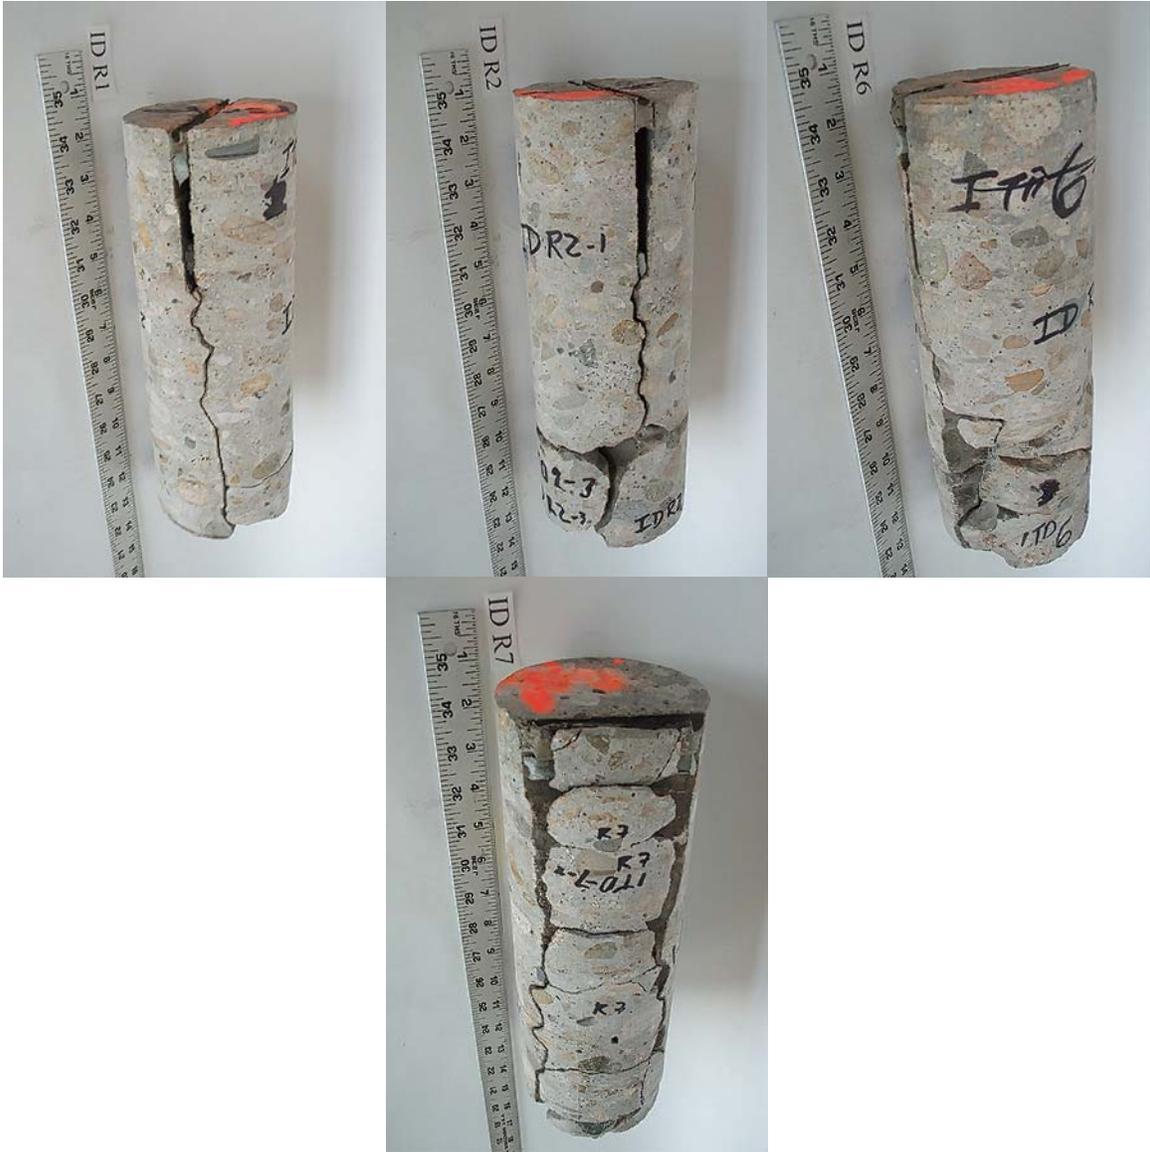
Figure ID-4: Cores from right lane taken near pavement joints.

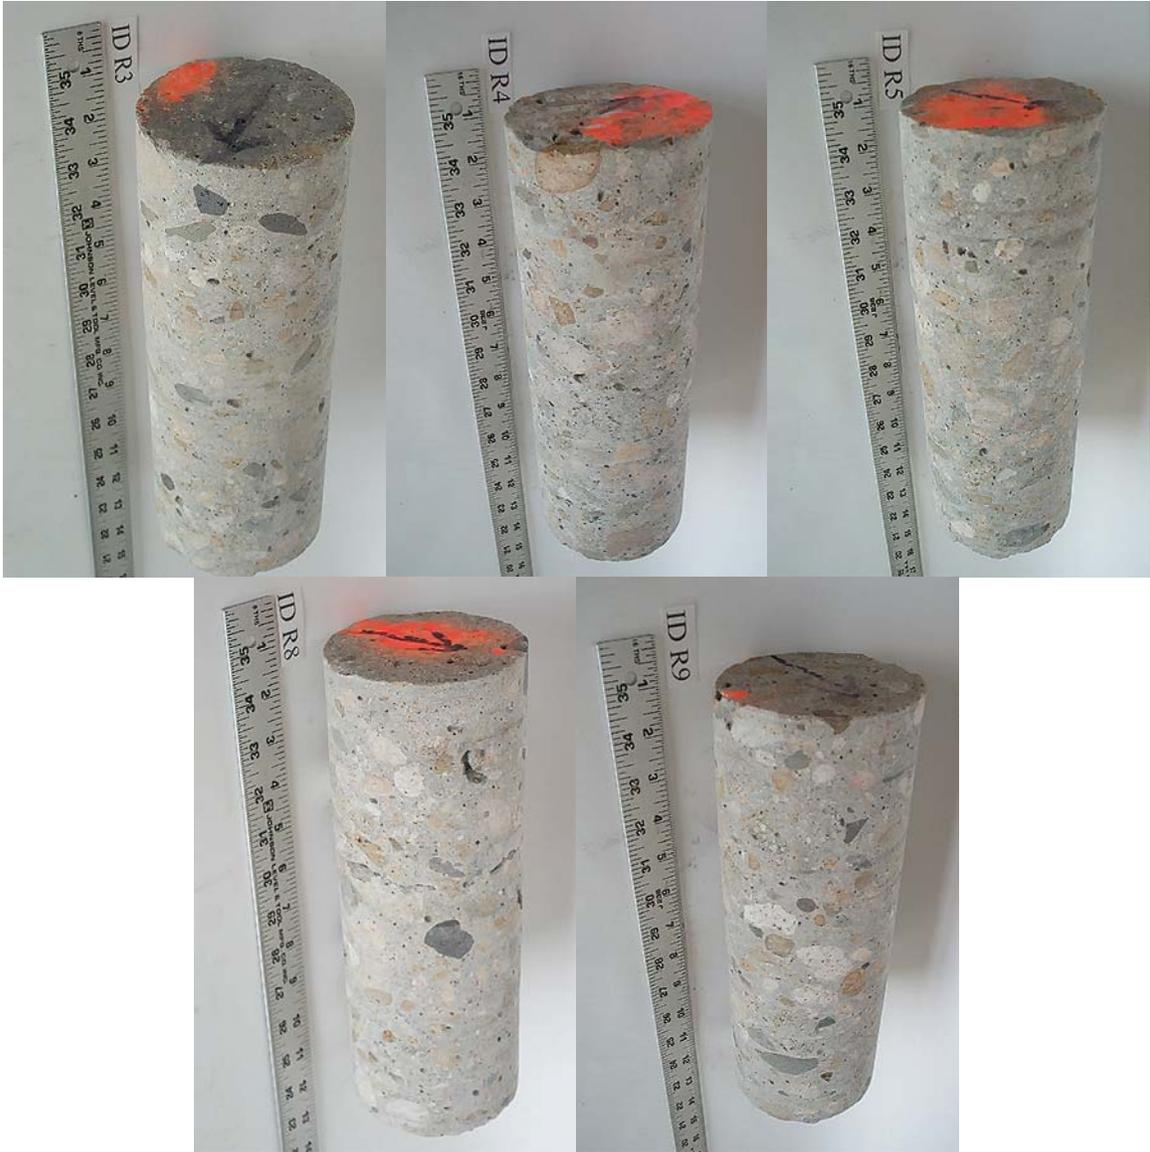
Figure ID-5: Cores from right lane taken away from pavement joints.

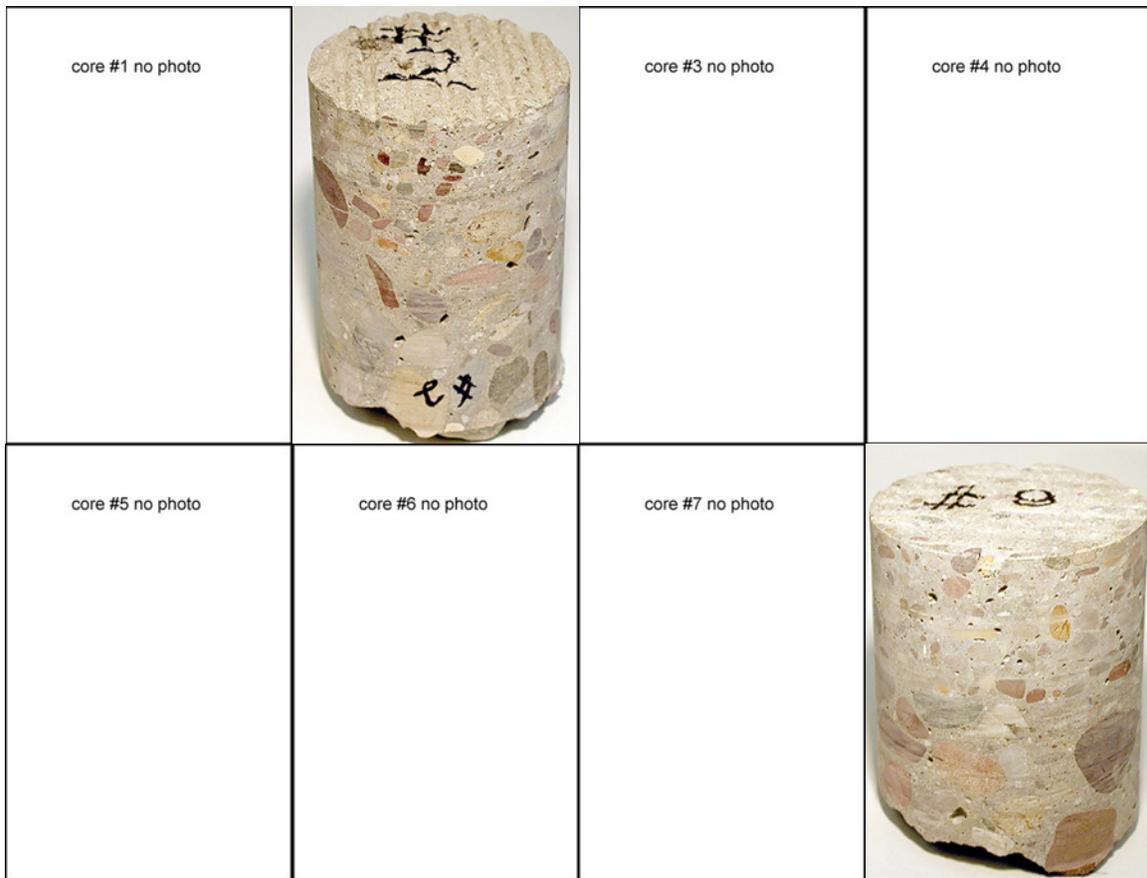
Partial depth cores 5 to 6" in depth were received from this bridge deck. The top 2" of the cores consisted of a latex modified concrete overlay. The deck is reported to have been exposed to  $MgCl_2$  for anti-icing, and NaCl for deicing. Figure MT-1 shows the locations of the cores, and Figure MT-2 shows an incomplete series of photographs of the cores as received. Figure MT-3 shows the variation in surface wear observed on some of the cores. Two of the cores were cut into slabs and polished: core MT-2 and core MT-8. Figures MT-4 through MT-6 show the slabs as polished, after staining with phenolphthalein, and after treatment to enhance air voids and cracks. The phenolphthalein stain showed normal carbonation depths. The black and white treatment did not reveal any macro-cracking in either of the cores. Table MT-1 summarizes the air void parameters. The overlay from both slabs exhibited inadequate entrained air parameters, with spacing factors of 0.432 mm and 0.687 mm for cores MT-2 and MT-8 respectively. However, considering the extreme density of the cement paste, air entrainment is not likely a requirement for the latex-modified overlay. Figure MT-7 shows an example stereomicroscope image of the air void structure. A w/c ratio estimation was performed on a thin section prepared from the top concrete overlay portion and from the original concrete portion of core MT-3. Figures MT-8 through MT-11 show the images used to make the measurements. The results of the w/c estimations are summarized in Tables MT-2 and MT-3, with an average w/c value of 0.13 for the overlay, and an average w/c value of 0.42 for the original concrete. The unusual w/c value of 0.13 should not be interpreted as an accurate measure of the actual w/c, but rather as a comparison to the 28-day moist cured straight portland cement mortar standards. Figures MT-12 through MT-15 show chloride profiles collected from core MT-1 and core MT-3. The transition from overlay to original concrete is apparent in the profiles, and it appears that there is some diffusion of chlorine from the original concrete up into the base of the overlay.

Figure MT-2: Photographs of cores.

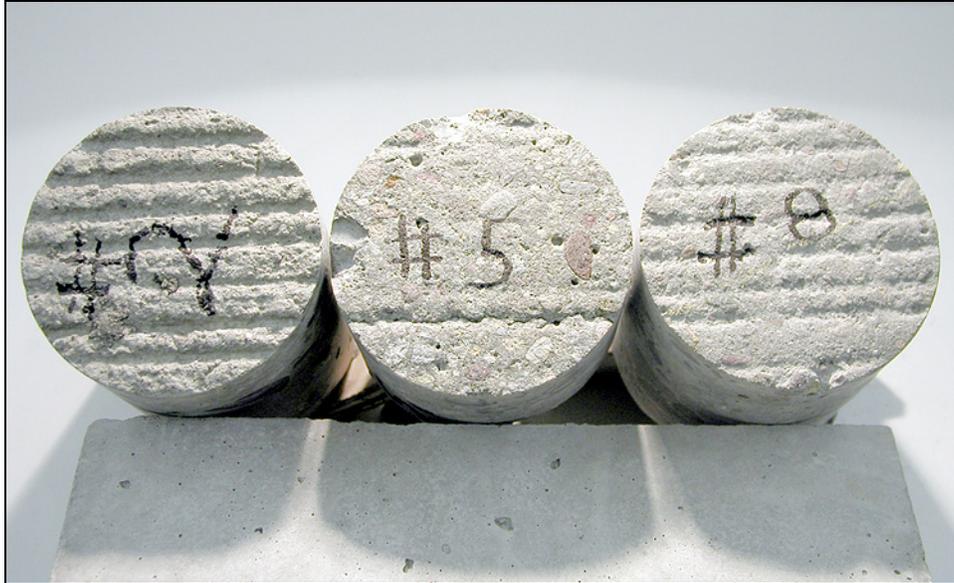
Figure MT-3: Photograph to show variation in surface wear from core to core.

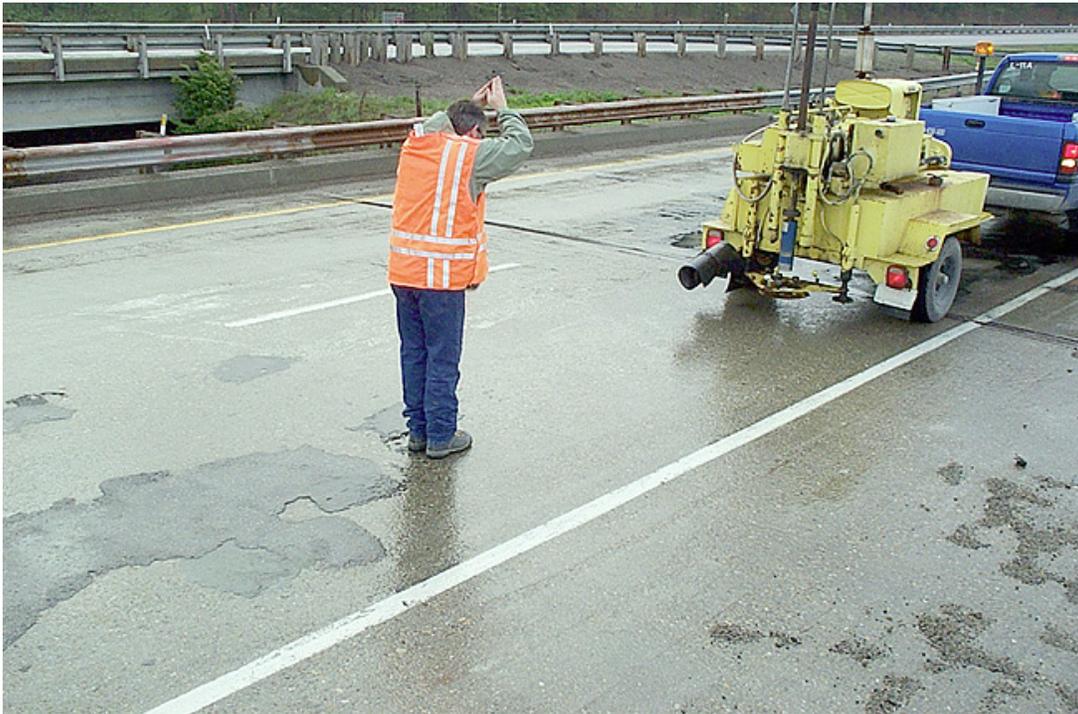
Figure T-2: Photograph of core site.

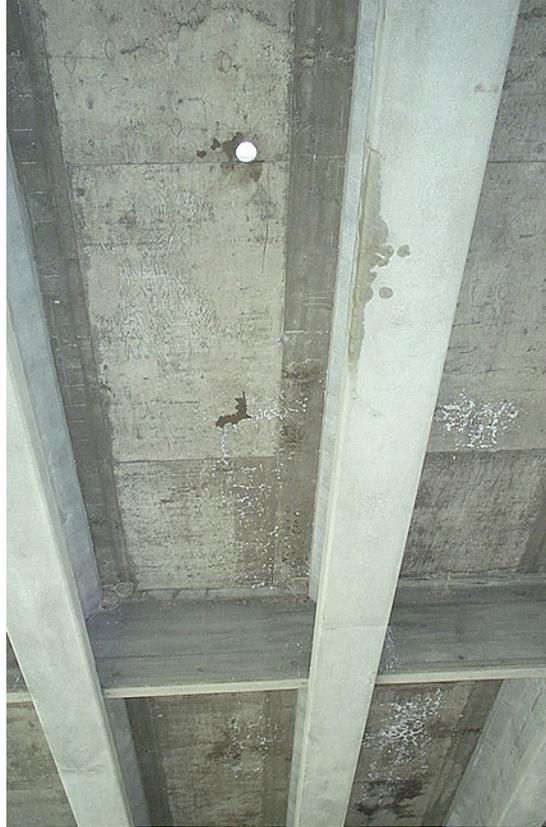
Figure T-3: Photograph from beneath bridge deck after coring operation. Hole from core T-2 is visible. Dampness permeating through cracks visible beneath the area of core T-1. White efflorescence common in areas directly below regions covered with cold patch material.

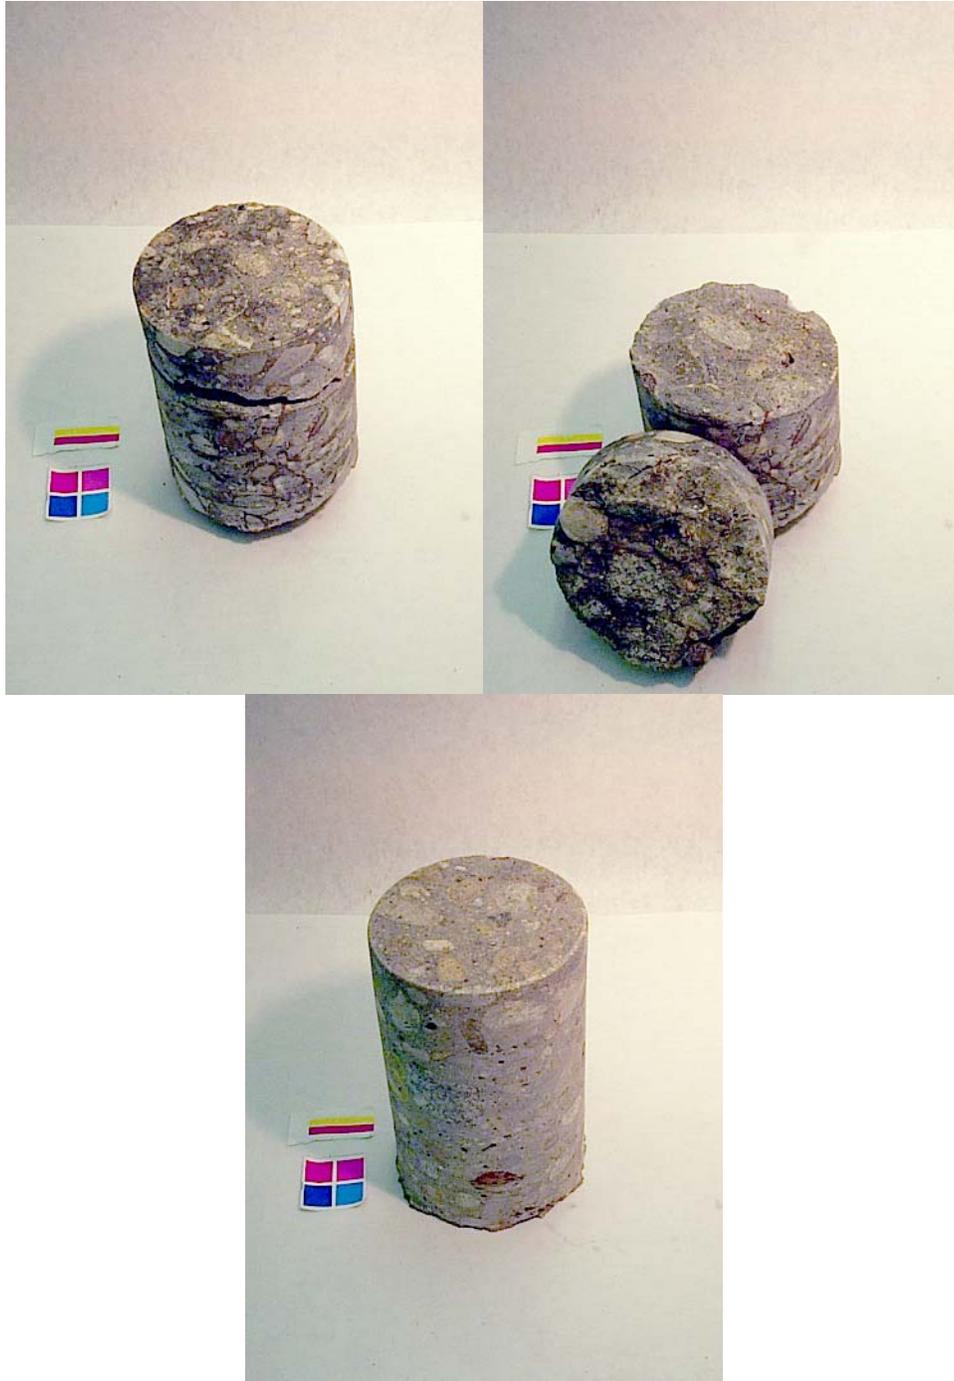
Figure T-4: Cores retrieved from site, core T-1 (top), core T-2 (bottom).

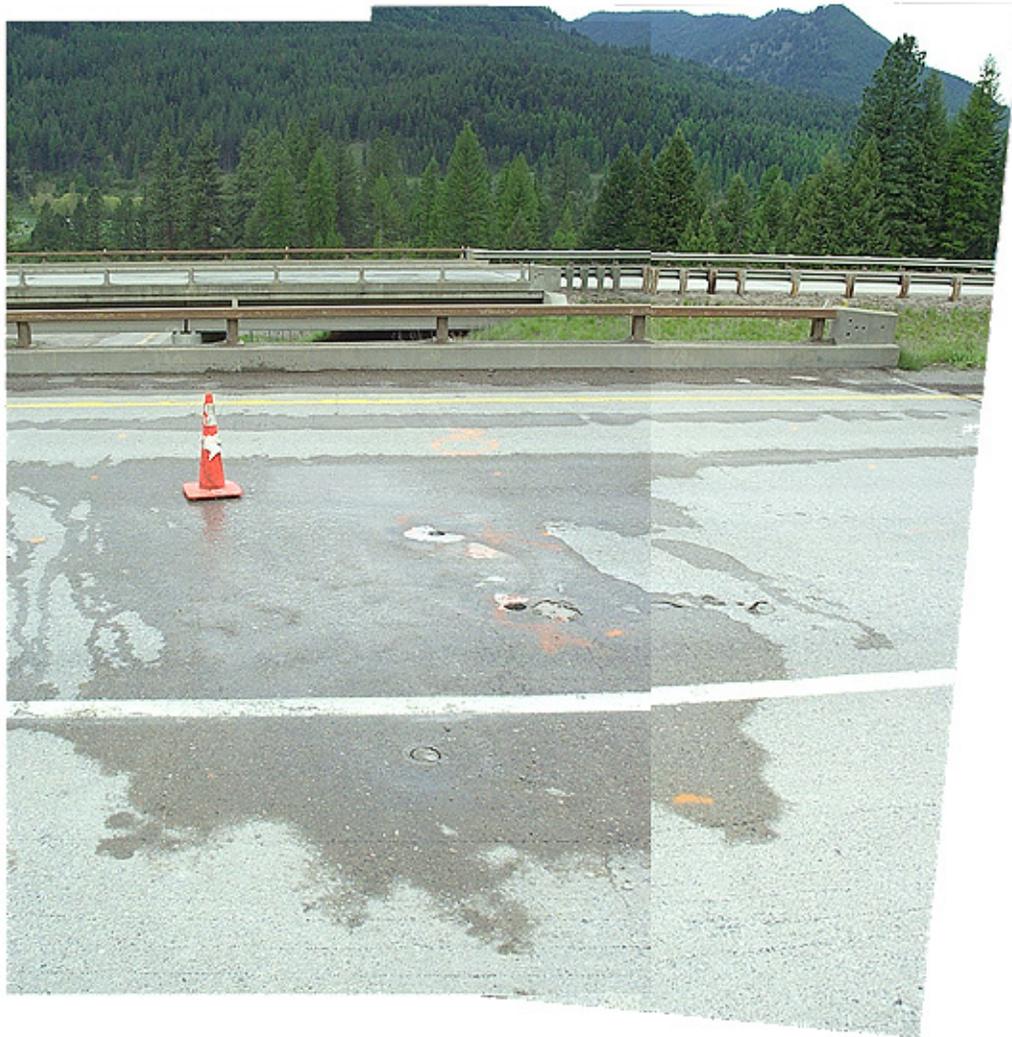
This bridge deck was in maintenance area 1114, and exposed to  $MgCl_2$  brine, and a combination of NaCl and sand. Figure S-1 shows the locations of the cores, and Figure S-2 shows the condition of the bridge deck, with some spalling. Figure S-3 shows the underside of the bridge deck. Figure S-4 shows photographs of the cores. Core S-1 exhibited a crack plane at a depth of about 30 mm coinciding with reinforcement steel. The entire core was vacuum impregnated with epoxy and used only for thin section preparation. Core S-2 was intact, and cut into slabs and polished. Figures S-5 and S-6 show the slab as polished, after staining with phenolphthalein, and after treatment to enhance air voids and cracks. The phenolphthalein stain showed normal carbonation. The black and white treatment did not reveal any macro-cracking, with the exception of a small crack perpendicular to the pavement surface. Table S-1 summarizes the air void parameters. The slab showed adequate entrained air, with a spacing factor of 0.173 mm. Figure S-7 shows an example stereomicroscope image of the air void structure. A w/c ratio estimation was performed on a thin section prepared from the top of core S-2. Figures S-8 and S-9 show the images used to make the measurements. The results of the w/c estimation are summarized in Table S-2, with an average w/c value of 0.33 as compared to the 28-day moist cured mortar sample standards. Figures S-10 and S-11 show chloride profiles from cores S-2. Figure S-12 shows the locations on the thin sections prepared from core S-1 that were used for elemental mapping. Regions were mapped to represent the pavement surface and the crack at depth. Figures S-13 and S-14 show the elemental maps from the two regions. Chloride profiles were not recorded from core S-1 because it had been epoxy impregnated; the epoxy contains chlorine. The most interesting feature of the elemental maps is the Cl map from Figure S-14 that shows chlorine enrichment along the top surface of the crack at depth.

Figure S-2: Photograph of core site.

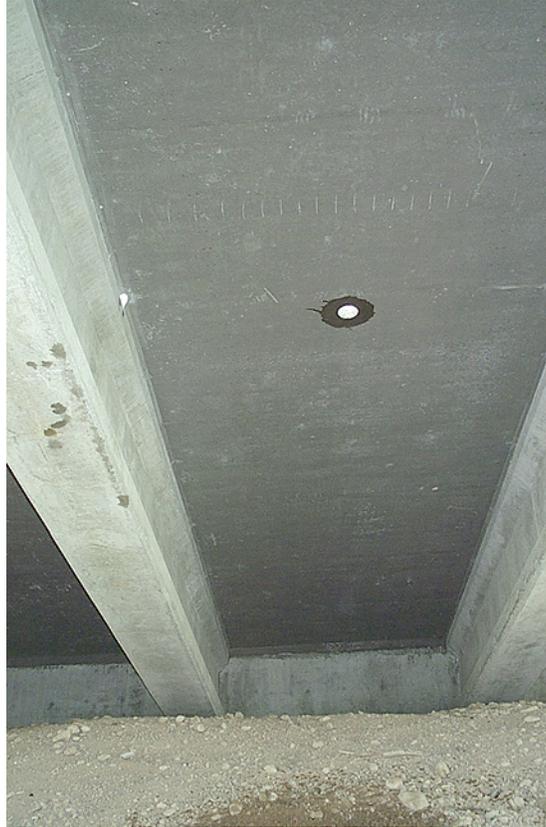
Figure S-3: Photograph from beneath bridge deck after coring operation, hole from core S-1 is clearly visible, light coming through hole from core S-2 is partly obscured by the pre-stressed beam.

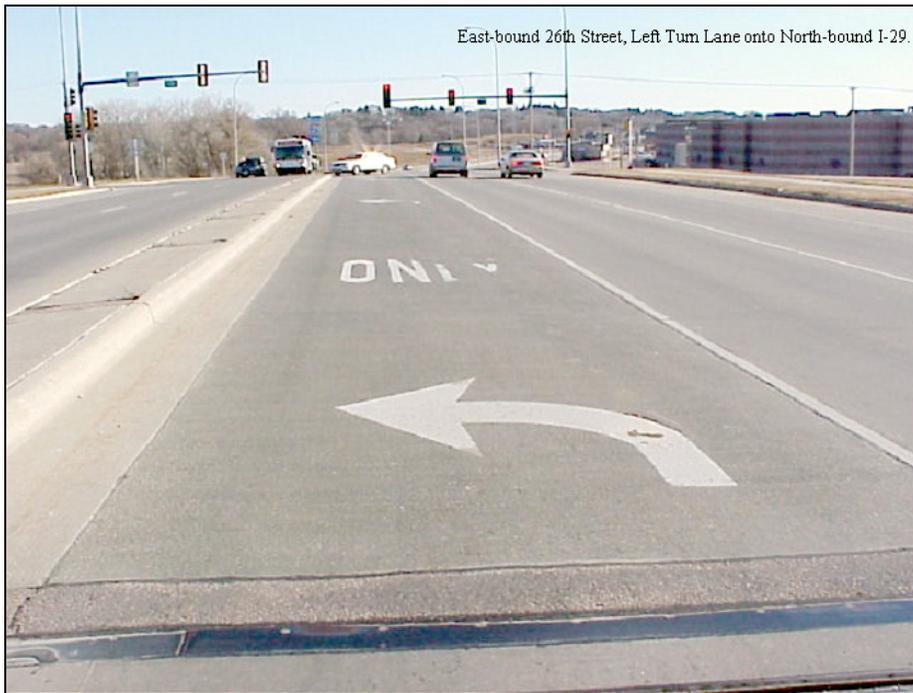
Figure SD-2: Photograph of core site.

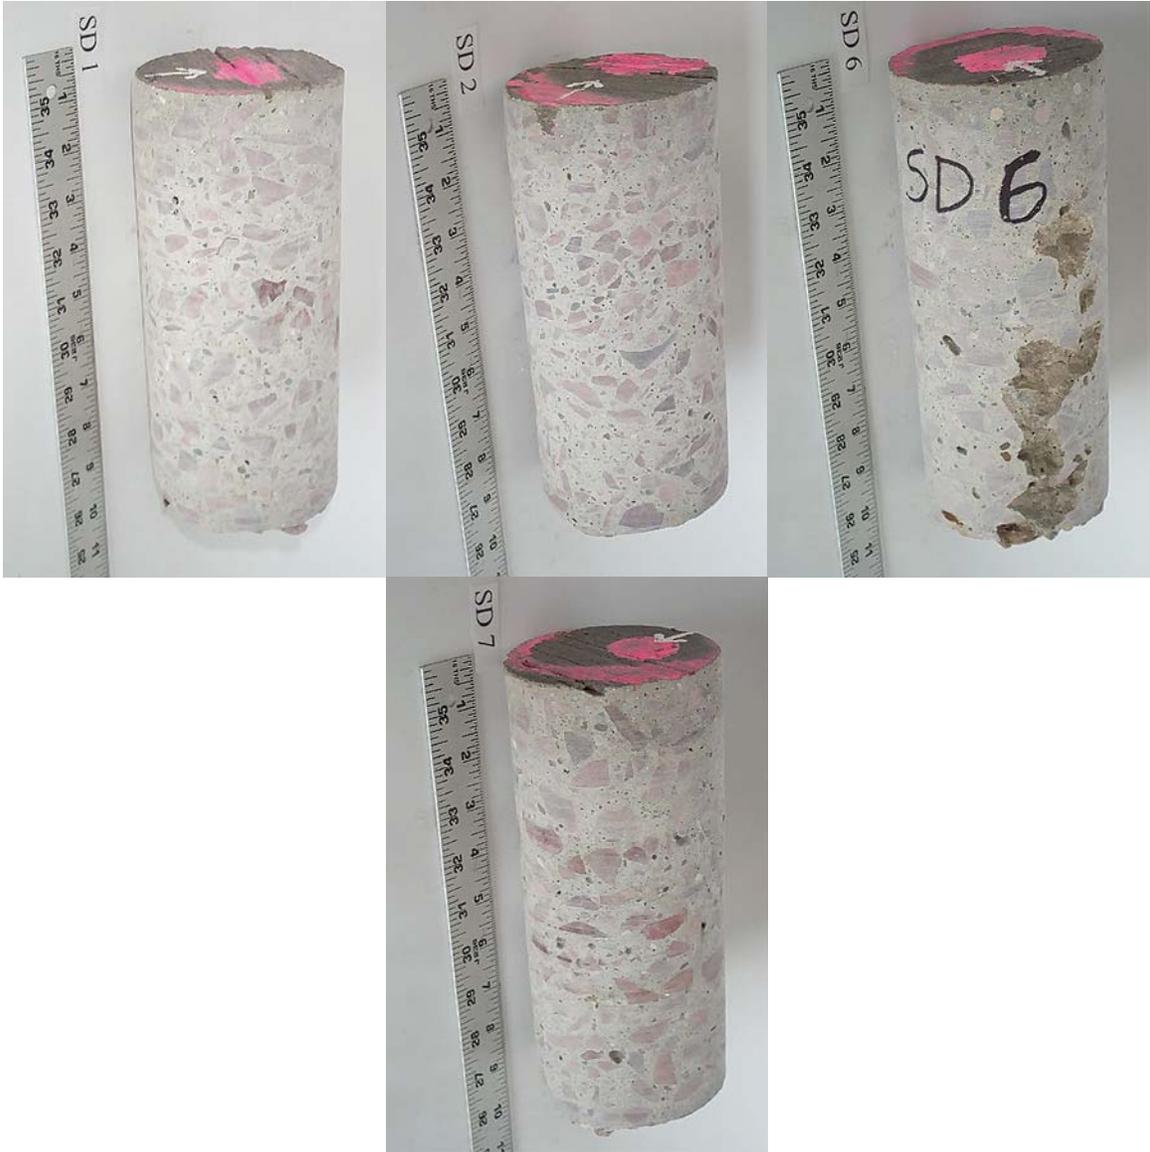
This pavement was placed on November 1, 1996, and exposed to  $MgCl_2$  brine shortly thereafter on November 15, 1996. A letter came with the cores which described the pavement surface to be in good condition, but stated that the cores taken near the joint looked like they had been eaten away. Figure SD-1 shows the locations of the cores, and Figure SD-2 shows an overview of the turn lane. Figure SD-3 shows the core holes from near the joint. What had been interpreted in the letter as deterioration was just the normal appearance of a concrete joint as exposed in cross section. Figures SD-4 and SD-5 show photographs of the individual cores. Two of the cores were cut into slabs and polished: core SD-1 (at a joint), and core SD-4 (mid-panel). Figures SD-6 through SD-9 show the slabs as polished, after staining with phenolphthalein, and after treatment to enhance air voids and cracks. The phenolphthalein stain showed normal carbonation depths. The black and white treatment did not reveal any macro-cracking in either of the cores. Table SD-1 summarizes the air void parameters. Both sets of slabs showed adequate entrained air, with spacing factors of 0.158 mm and 0.176 mm for cores SD-1 and SD-4 respectively. Figure SD-10 shows an example stereomicroscope image of the air void structure. Water to cement ratio estimations were performed on thin sections prepared from cores taken at the joint, and on thin sections prepared from cores taken at mid-panel. Figures SD-11 and SD-12 show the images used to make the measurements from a thin section prepared from the top of core SD-1 (at a joint). The results of the w/c estimation are summarized in Table SD-2, with an average w/c value of 0.47 as compared to the 28-day moist cured mortar sample standards. A second thin section was prepared from the top of core SD-1, and images recorded, as shown in Figure SD-13. These images were not masked and used for w/c measurement, but provided as a visual check on the first thin section. Figures SD-14 and SD-15 show the images used to make the measurements from a thin section prepared from the top of core SD-7 (at a joint). The results of the w/c estimation are summarized in Table SD-3, with an average w/c value of 0.45. Figures SD-16 and SD-17 show the images used to make the measurements from a thin section prepared from the top of core SD-4 (mid-panel). The results of the w/c estimation are summarized in Table SD-4, with an average w/c value of 0.38. A second thin section was prepared from the top of core SD-4, and images recorded, as shown in Figure SD-18. These images were not masked and used for w/c measurement, but provided as a visual check on the first thin section. Figures SD-19 and SD-20 show the images used to make the measurements from a thin section prepared from the top of core SD-5 (mid-panel). The results of the w/c estimation are summarized in Table SD-5, with an average w/c value of 0.35. Figure 21 compares cement paste fluorescence histograms from the four cores. The samples prepared from the joint fluoresced consistently brighter than the samples prepared from mid-panel. Figures SD-22 through SD-25 show chloride profiles from cores SD-3 and SD-7.

Figure SD-4: Cores taken at joint.
